# YOUR Inspection Report

175 Some Street  
Any Town, NC

Tuesday, February 8, 2022

RE: Report No. 6580  
175 Some Street  
Any Town, NC

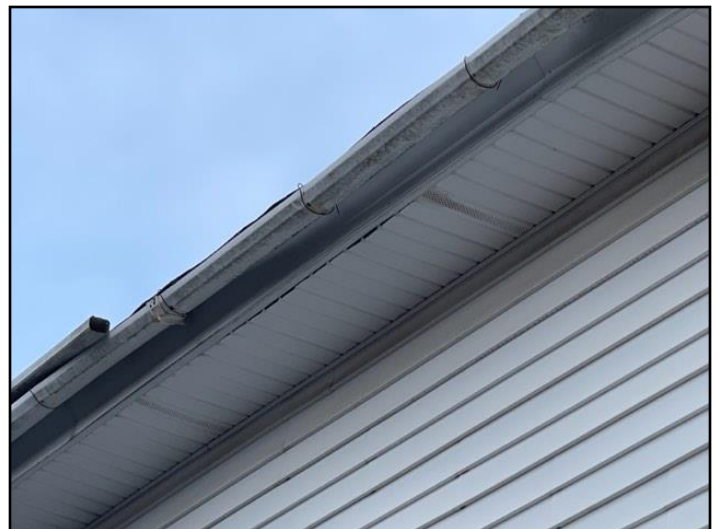
10. Loose or missing pieces

11. Loose or missing pieces

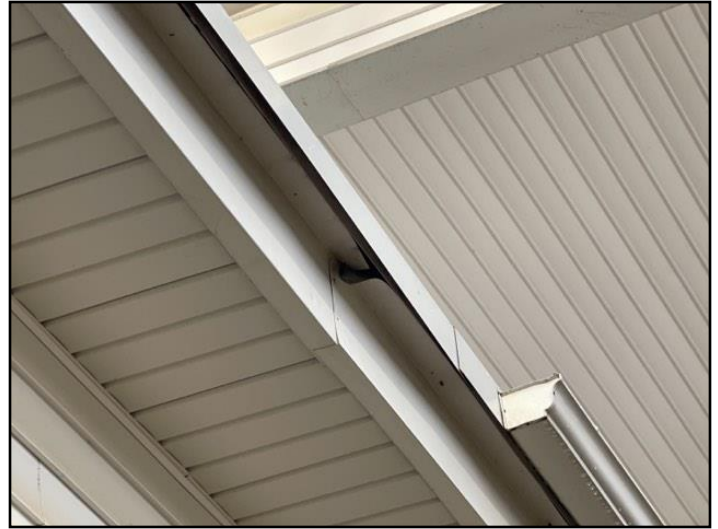
12. Loose or missing pieces

13. Loose or missing pieces

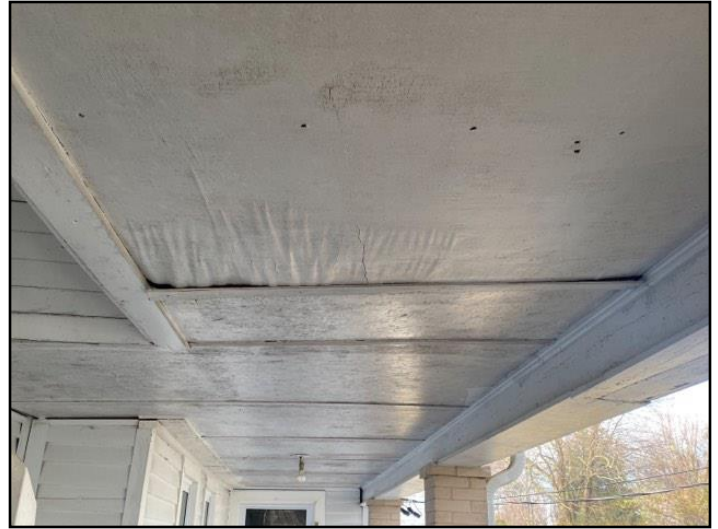
16. Loose or missing pieces

17. Loose or missing pieces

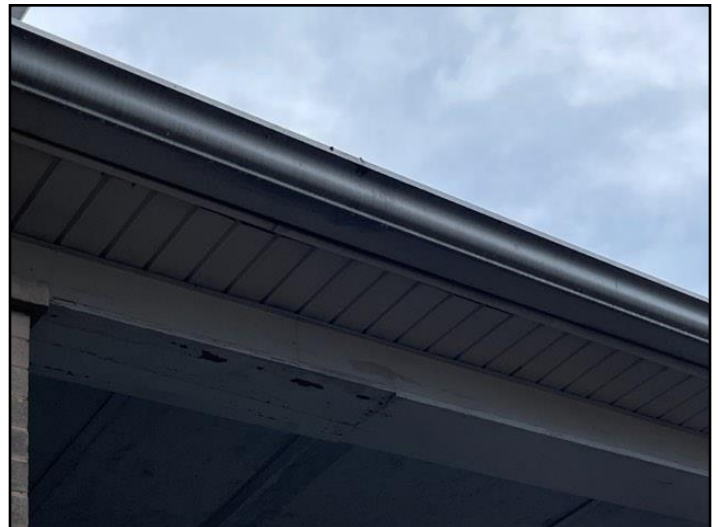
18. Loose or missing pieces

19. Loose or missing pieces

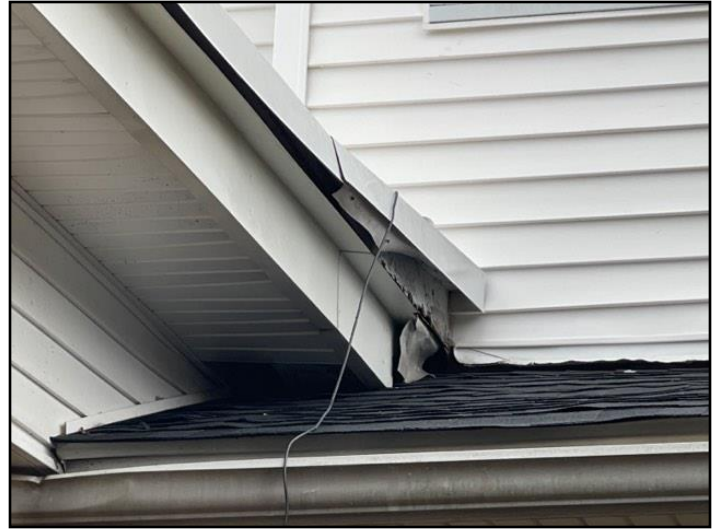
20. Loose or missing pieces

21. Loose or missing pieces

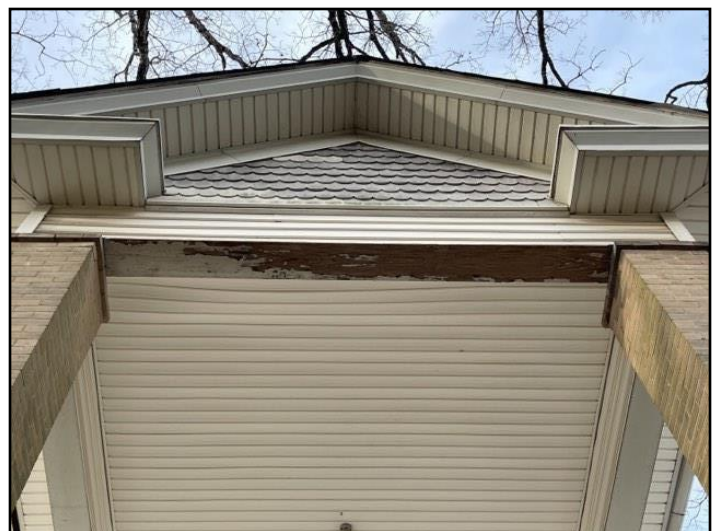
24. Paint or stain needed

25. Paint or stain needed

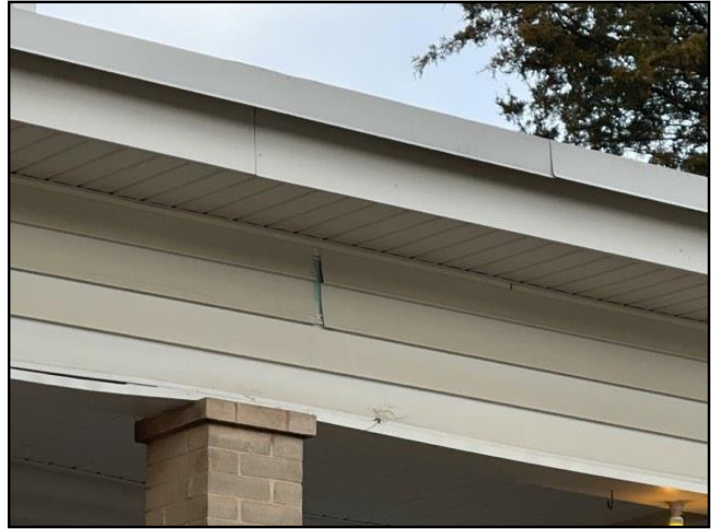
34. Loose Siding

35. Loose Siding

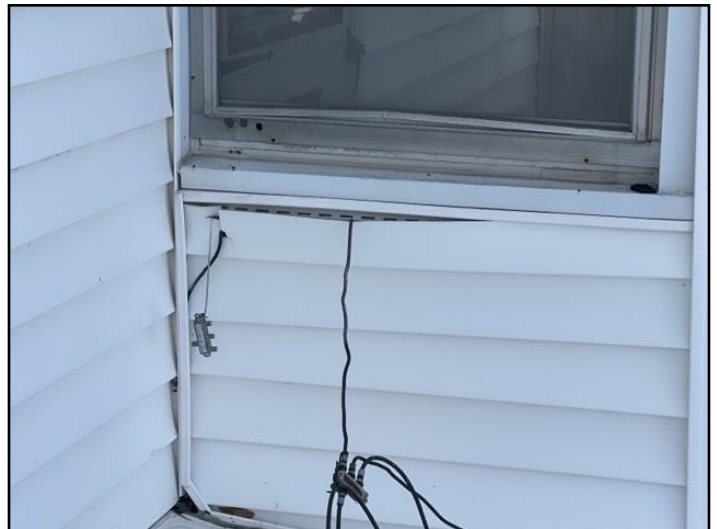
36. Loose Siding

37. Loose Siding

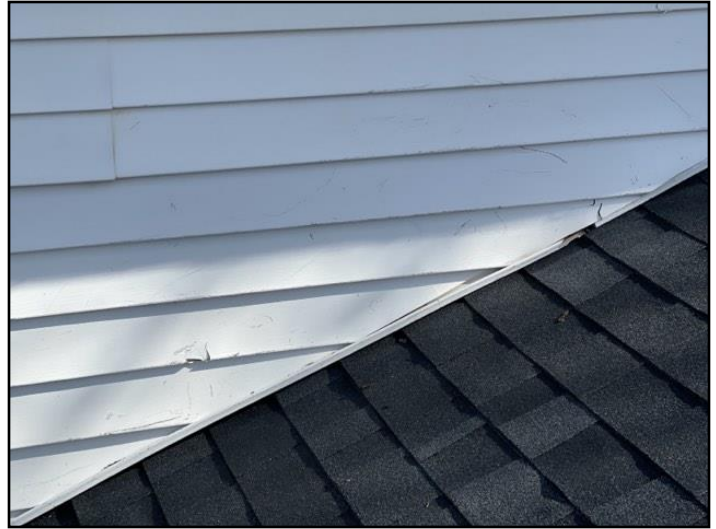
38. Loose Siding

39. Loose Siding

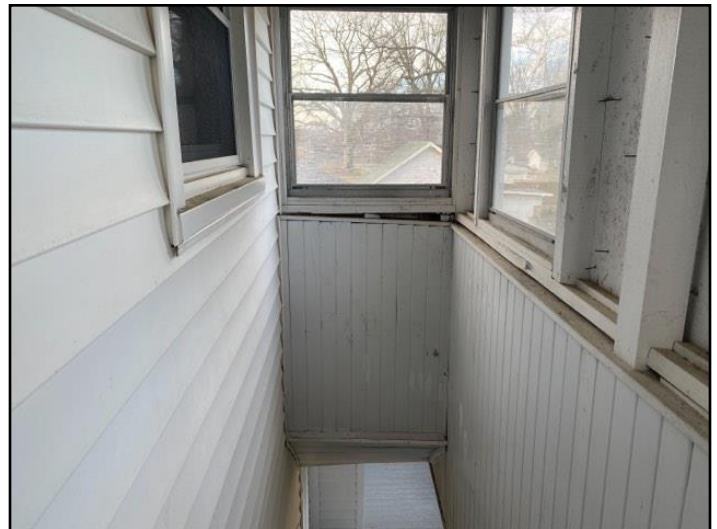
**45. Failing Support Beams**

**46. Failing Support Beams**

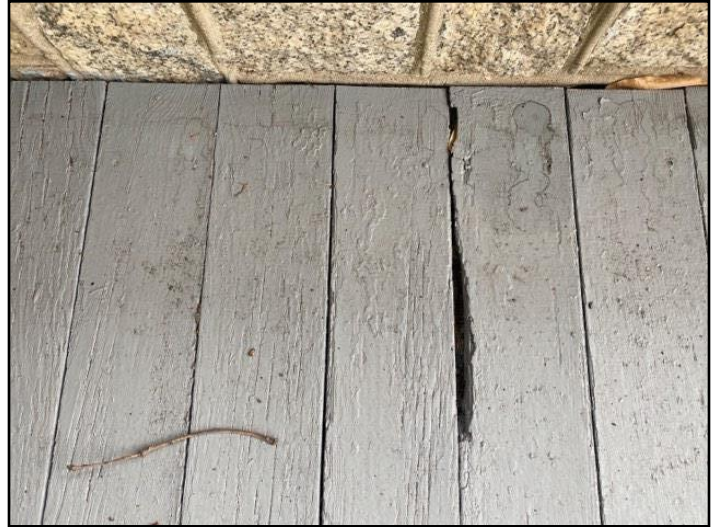
47. Damage

48. Damage

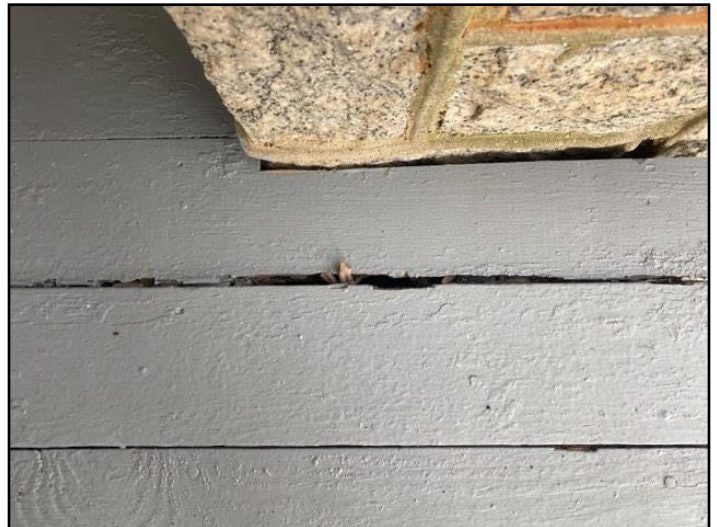
49. Damage

50. Damage

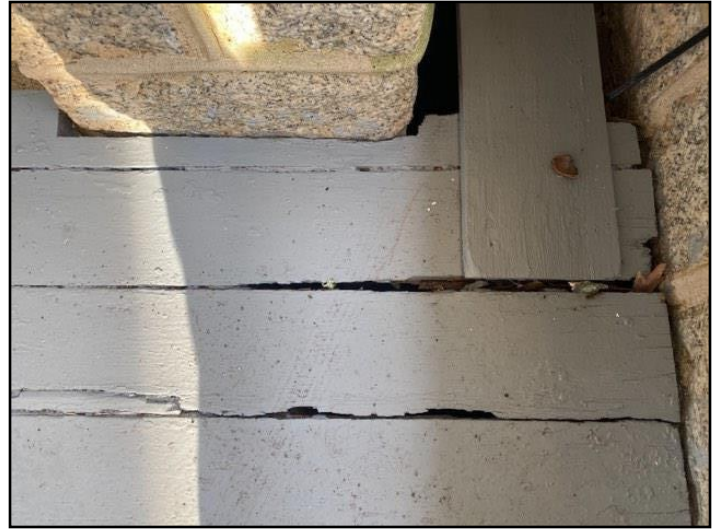
51. Damage

52. Damage

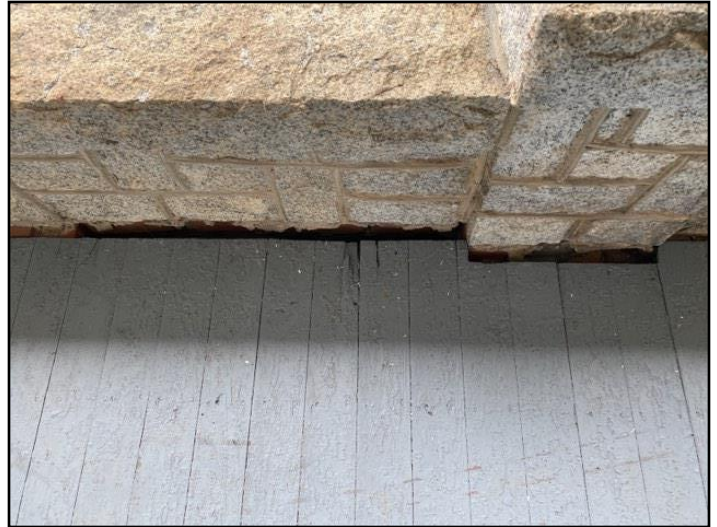
55. Trip Hazard

56. Trip Hazard

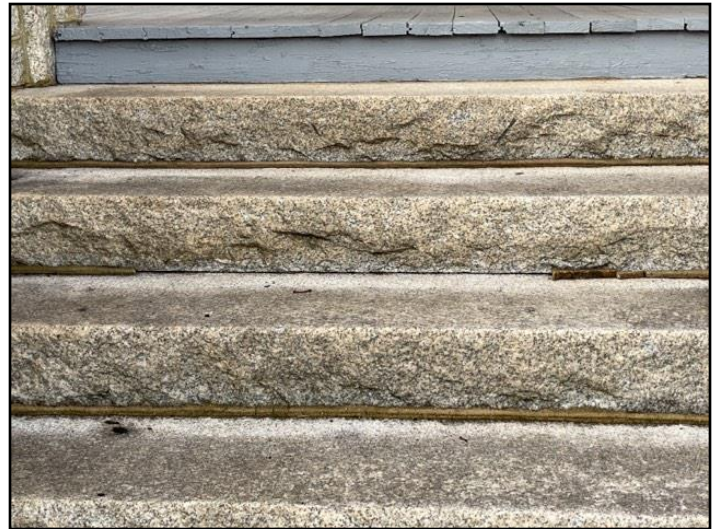
62. Missing or deteriorated mortar should be...

63. Missing or deteriorated mortar should be...

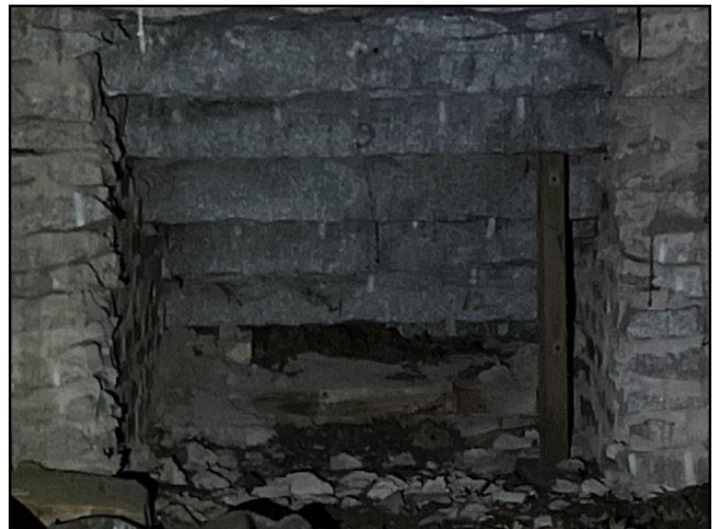
**24. Condition:** • Inadequate support for stair - stair stringers spanning over six foot in the horizontal plan should have additional support.

64. Inadequate support for stair - stair...

65. Inadequate support for stair - stair...

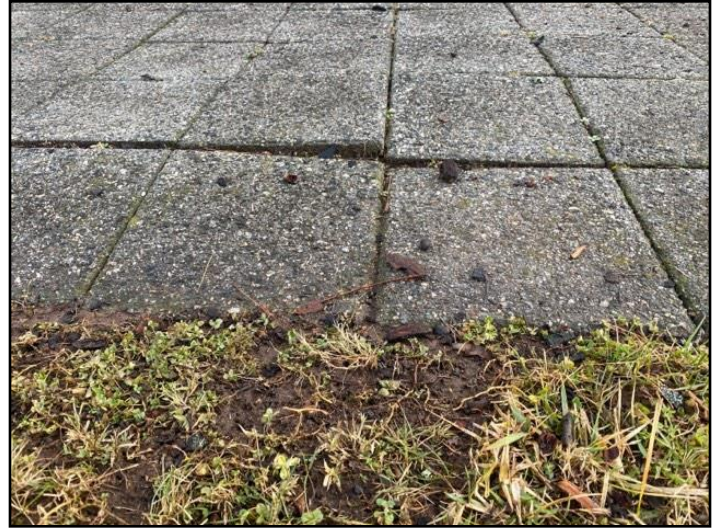
74. Trip hazards

75. Trip hazards

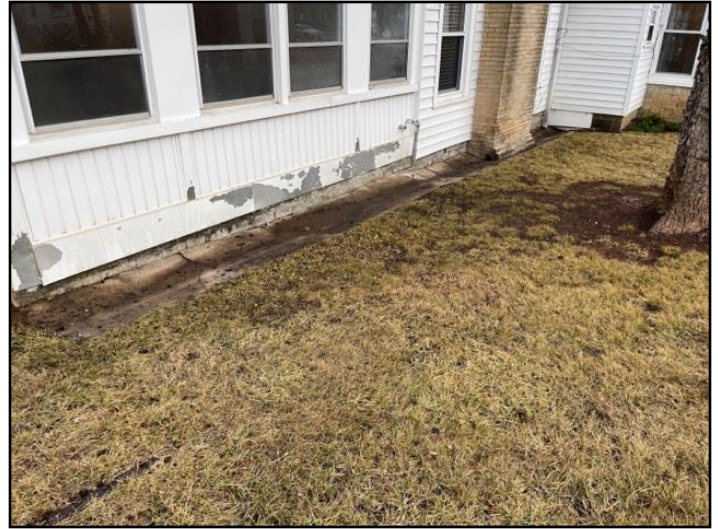
76. Improper slope or drainage

77. Improper slope or drainage

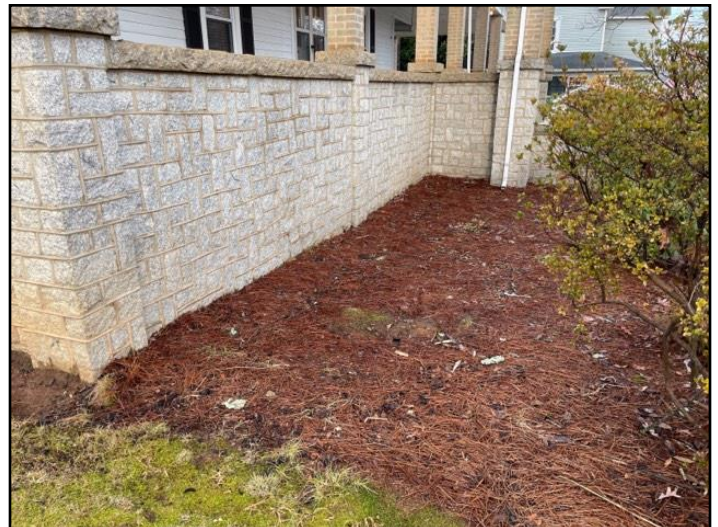
78. Improper slope or drainage

79. Improper slope or drainage

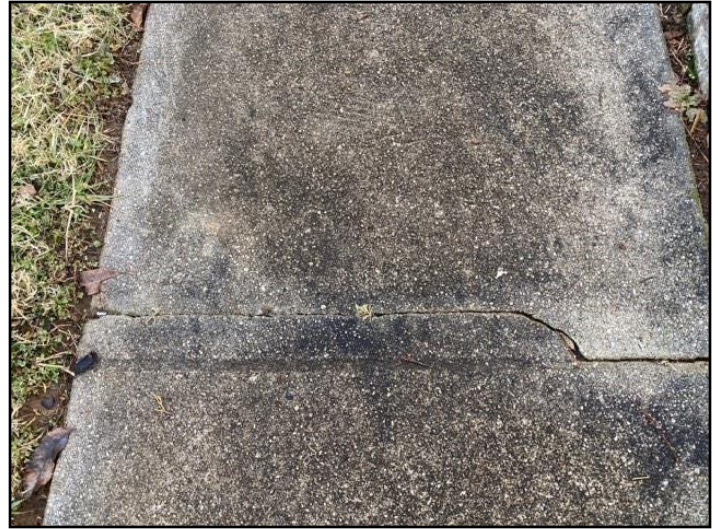
83. Cracked or damaged surfaces

84. Cracked or damaged surfaces

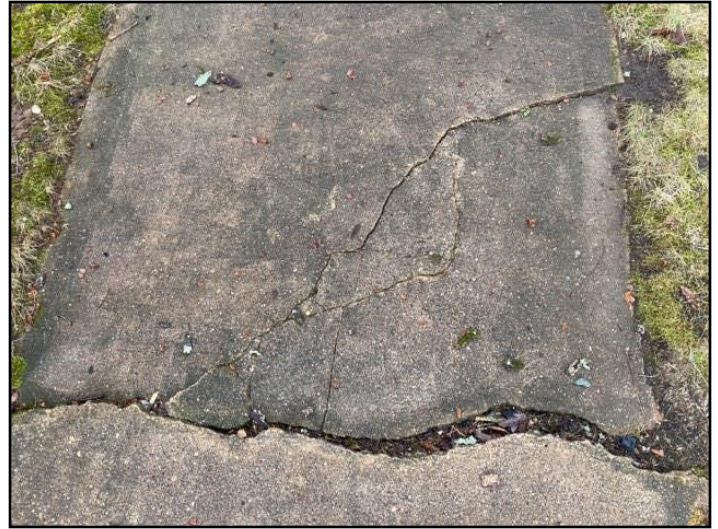
87. Cracked or damaged surfaces

88. Cracked or damaged surfaces

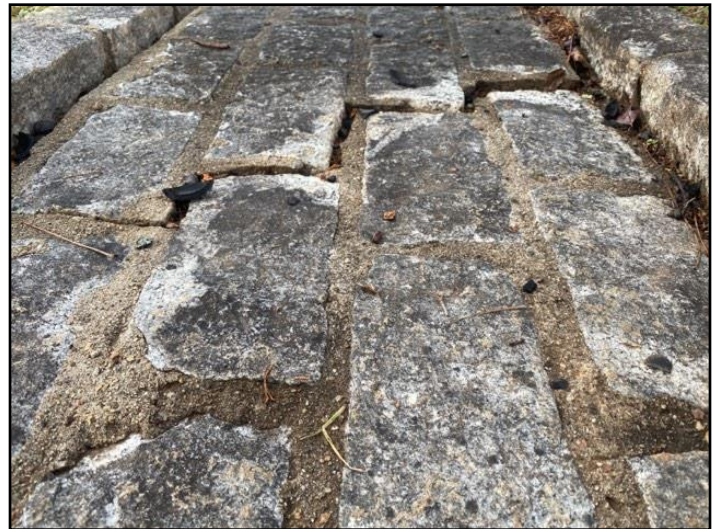
89. Uneven (trip hazard)

90. Uneven (trip hazard)

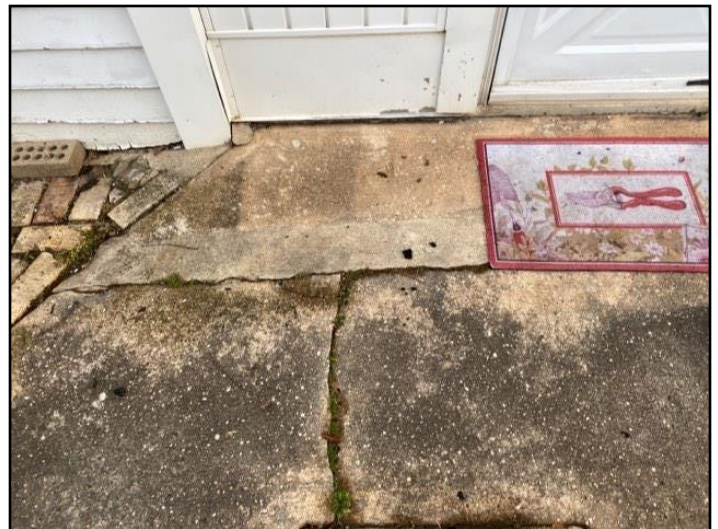
95. Cracked or damaged surfaces

96. Cracked or damaged surfaces

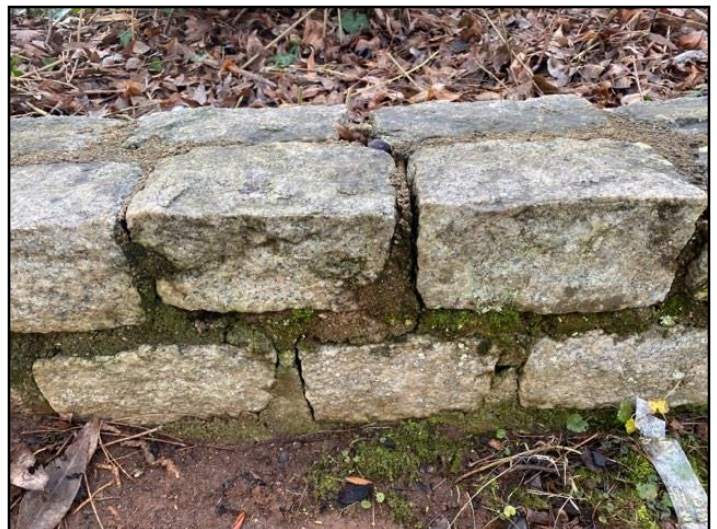
112. Cracked

113. Cracked

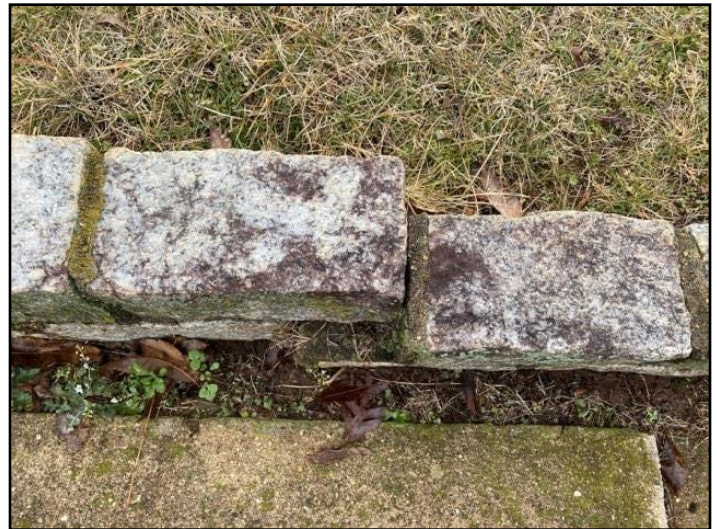
115. Settling or shifting

116. Settling or shifting

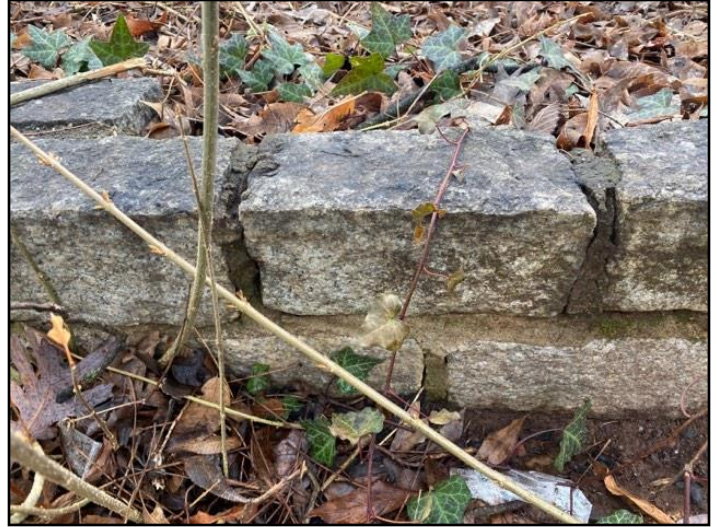
117. Mortar - deteriorated, missing

118. Mortar - deteriorated, missing

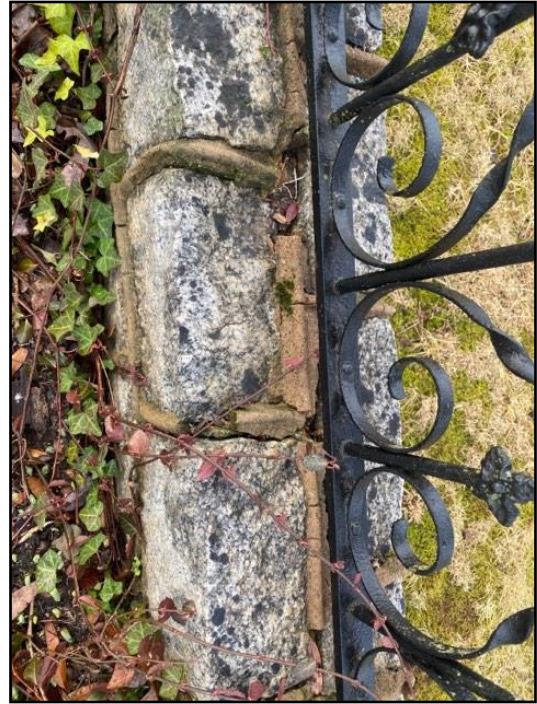
121. Mortar - deteriorated, missing

122. Mortar - deteriorated, missing

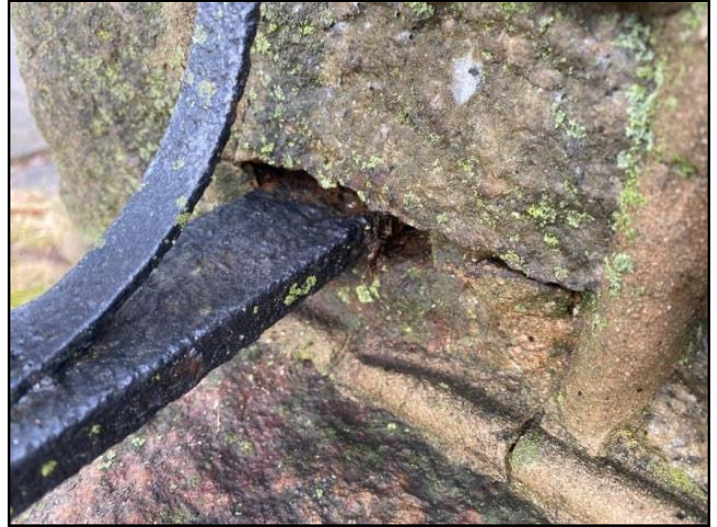
126. Loose Fence

127. Loose Fence

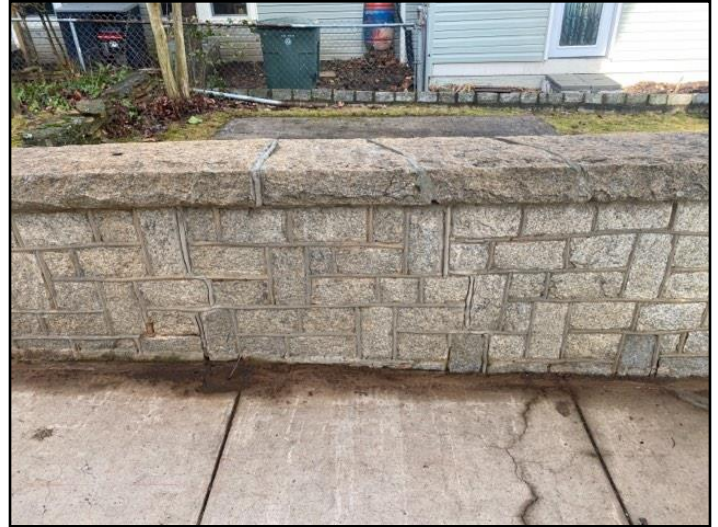
129. Patched Cracks

130. Patched Cracks

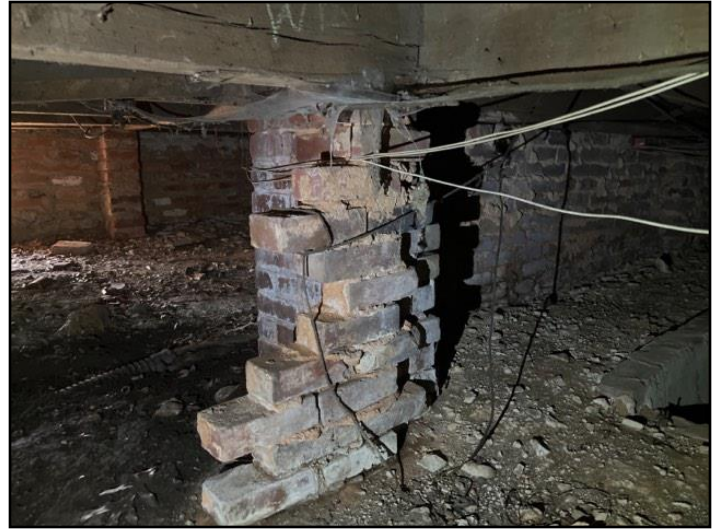
141. Poorly secured footing

142. Poorly secured footing

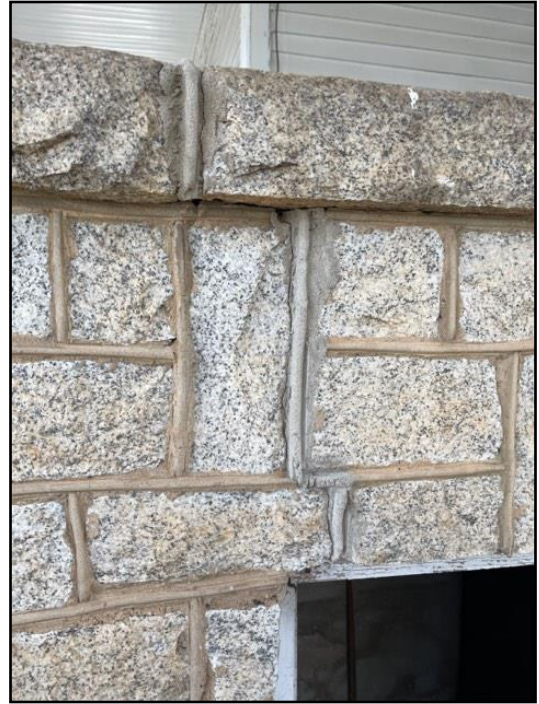
145. Typical minor cracks

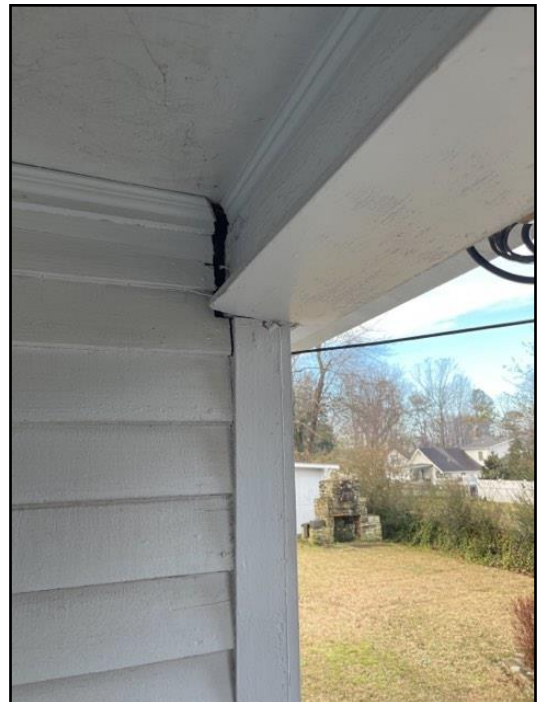
150. Bowed, bulging or leaning

151. Movement caused by foundation movement

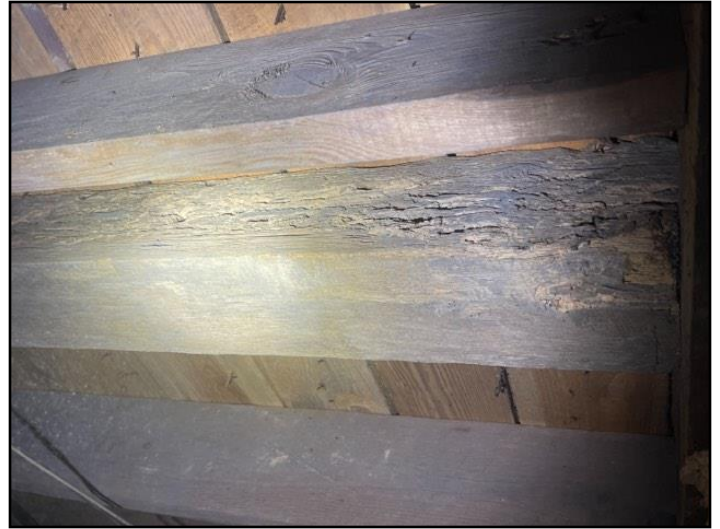
159. Evidence of wood destroying insects.

160. Evidence of wood destroying insects.

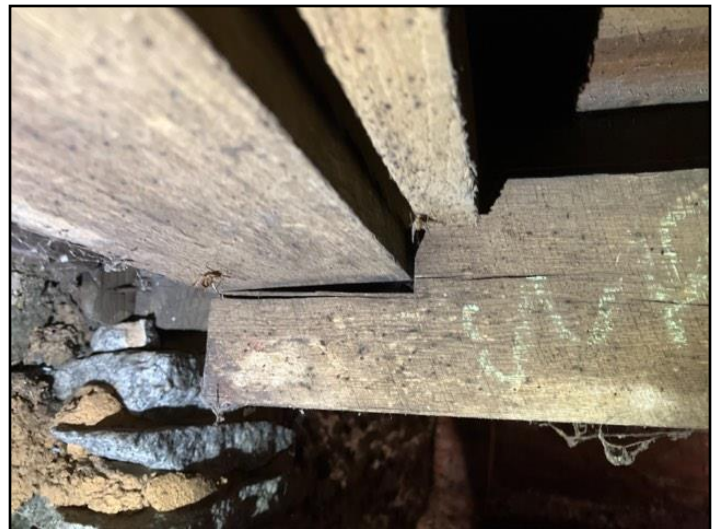
161. Poor bearing, crushed or loose shims

162. Poor bearing, crushed or loose shims

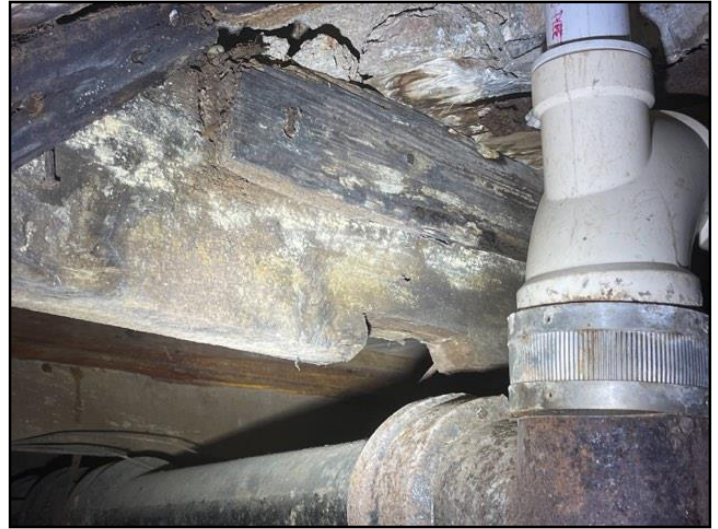
165. Notches or holes

166. Notches or holes

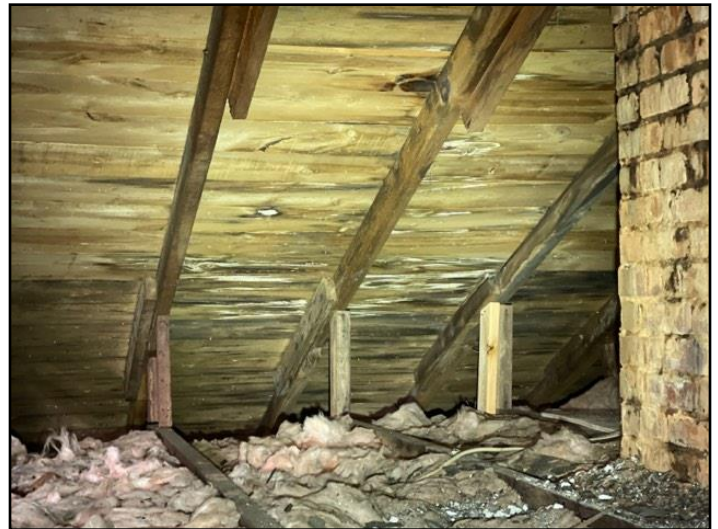
187. Water stains

188. Water stains

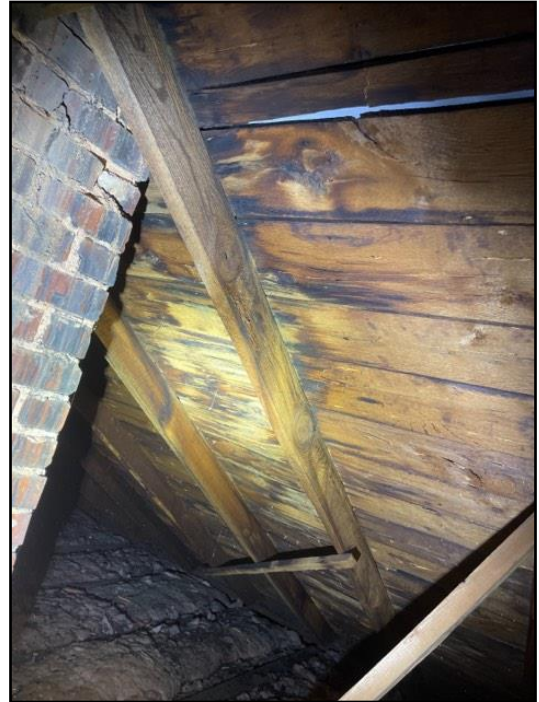
189. Water stains

190. Water stains

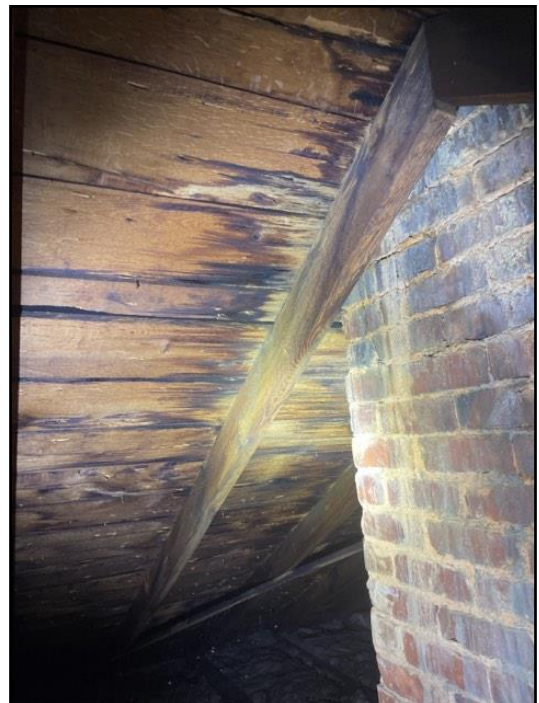
191. Water stains

192. Water stains

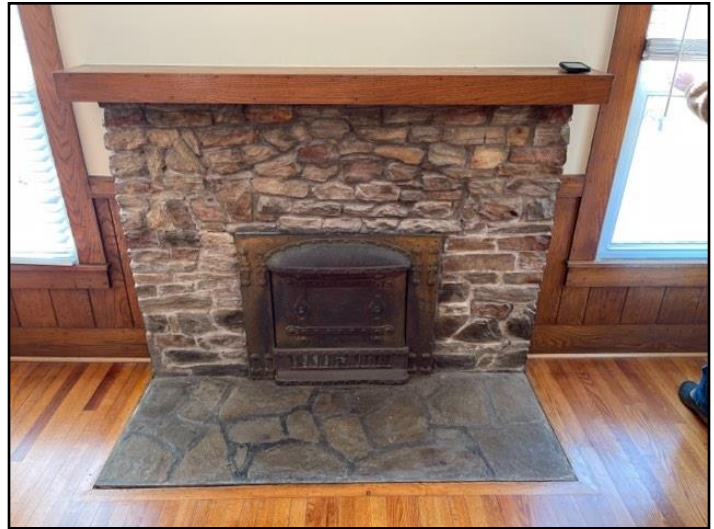
222. Coal-burning fireplace

223. Coal-burning fireplace

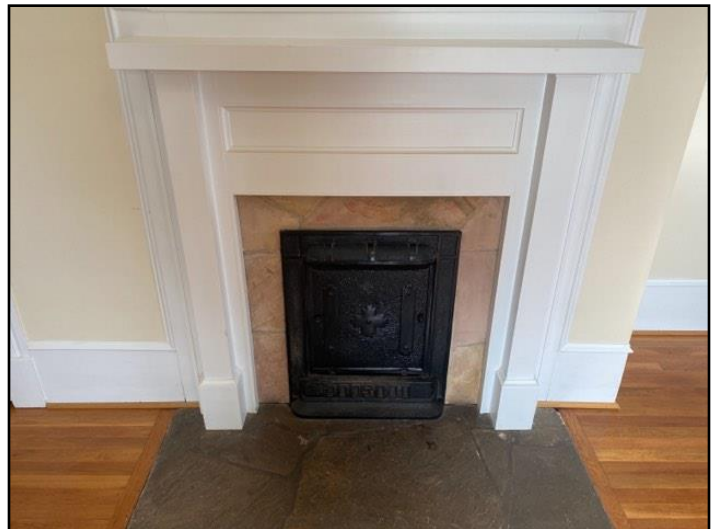
224. Coal-burning fireplace

225. Coal-burning fireplace

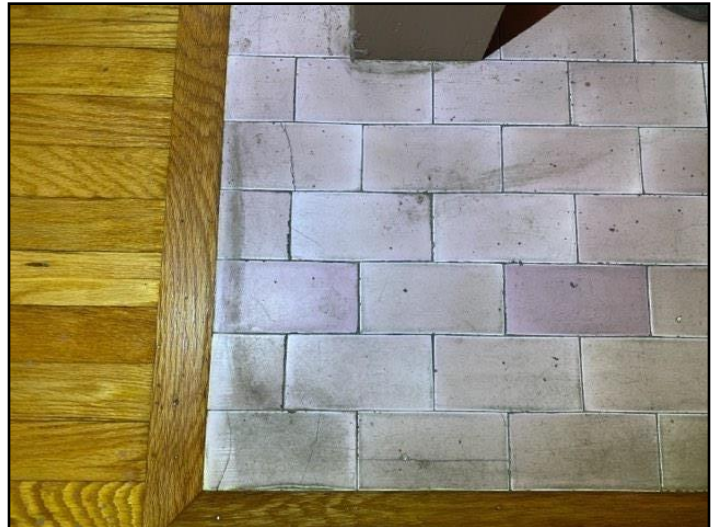
234. Gaps or cracks

235. Gaps or cracks

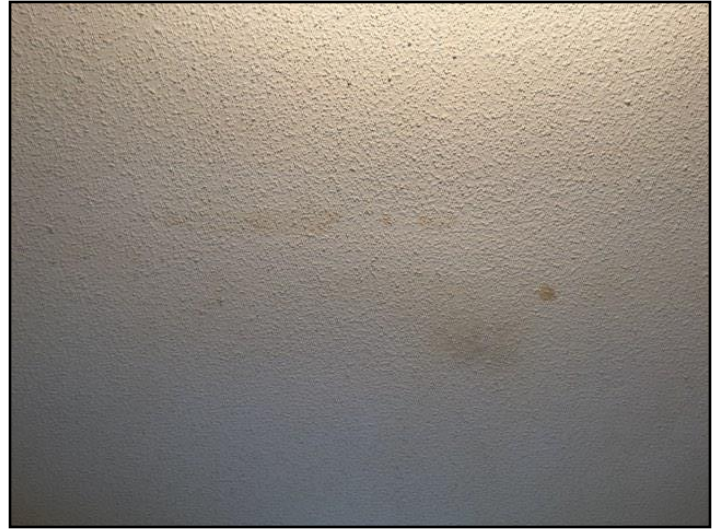
261. Water stains

262. Water stains

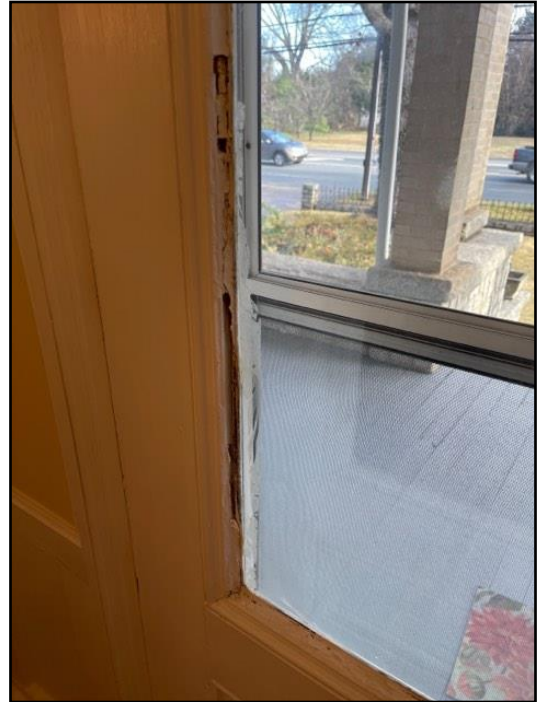
266. Putty Missing

267. Putty Missing

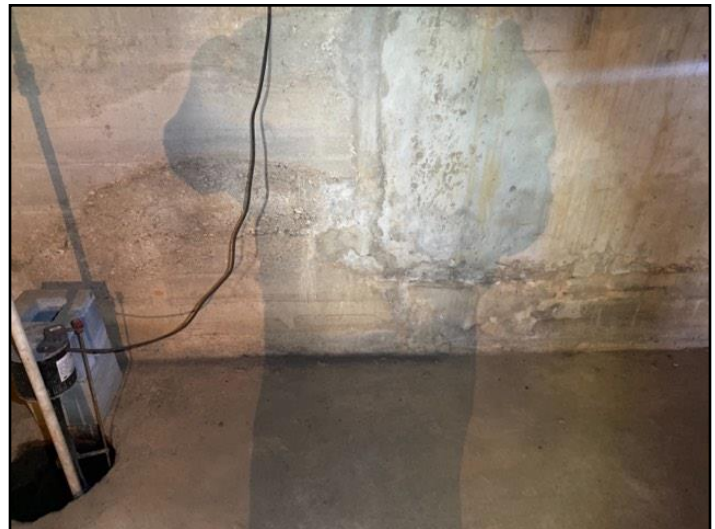
274. Stains

275. Stains
