# YOUR Inspection Report

175 Some Street  
Any Town, NC

Tuesday, February 8, 2022

RE: Report No. 6580  
175 Some Street  
Any Town, NC

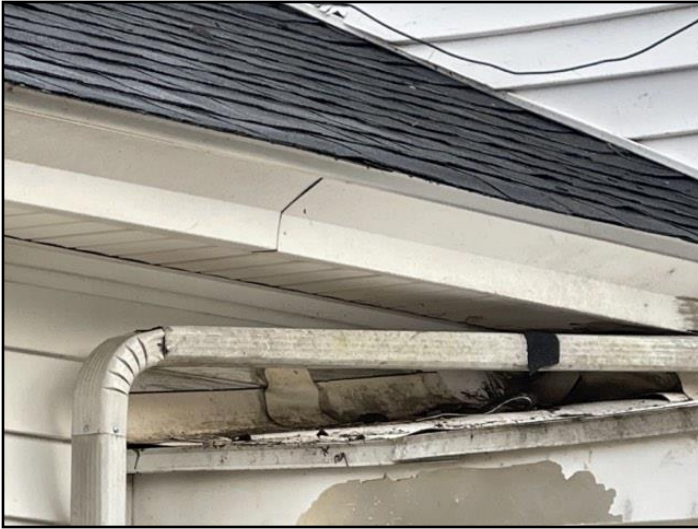
**Condition:** • [Openings at seams or flashings](#)

1. Openings at seams or flashings

**Task:** Repair

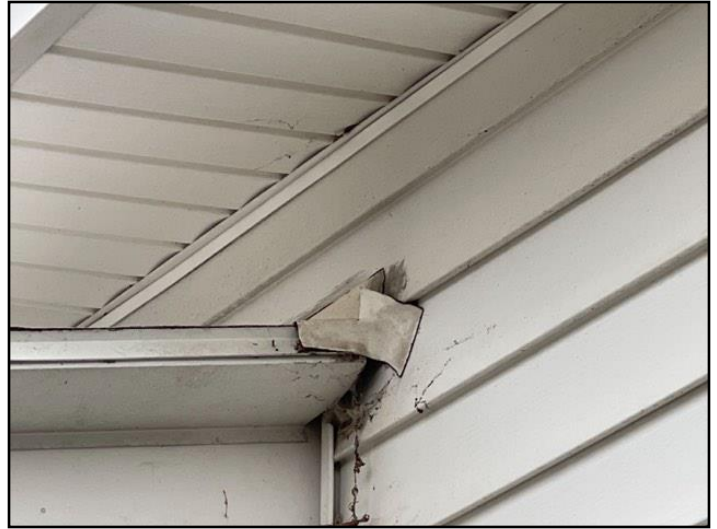
2. Openings at seams or flashings

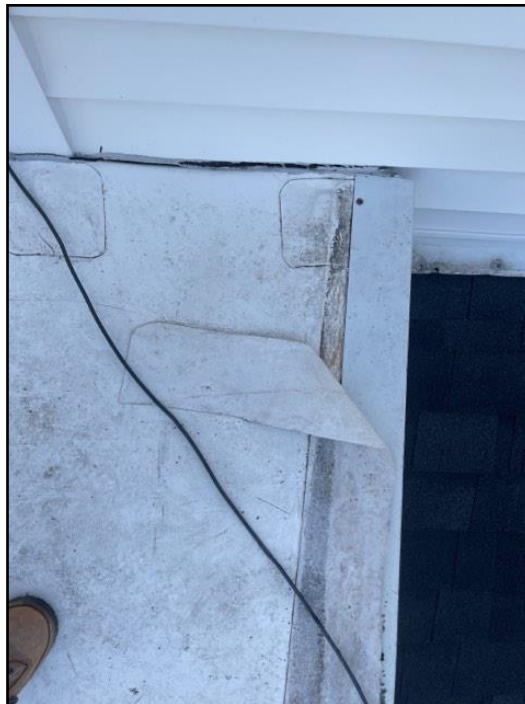
3. Openings at seams or flashings

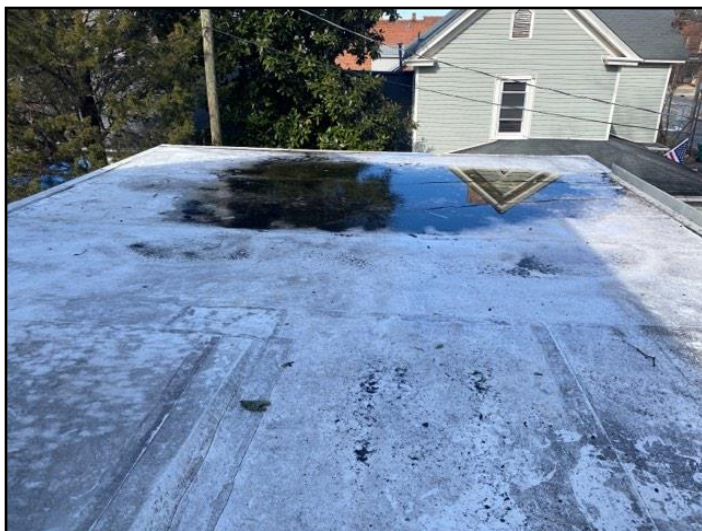
## 2. Condition: • [Ponding](#)

any roof that still has water on it after 48 hours is defined as a ponding roof

4. Ponding

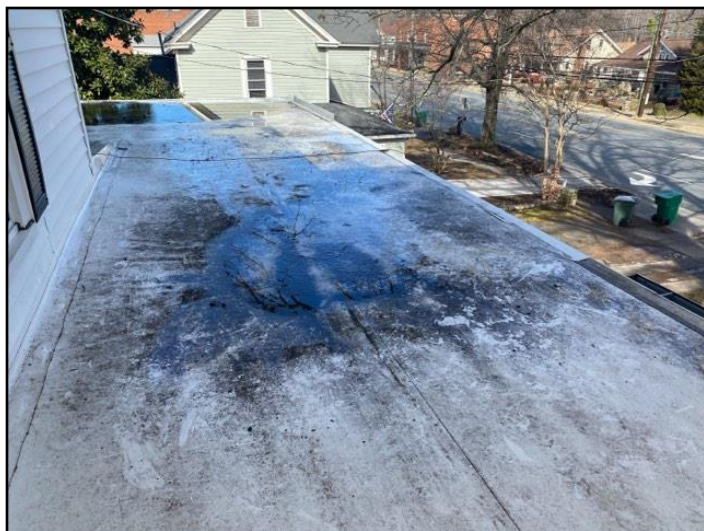
5. Ponding

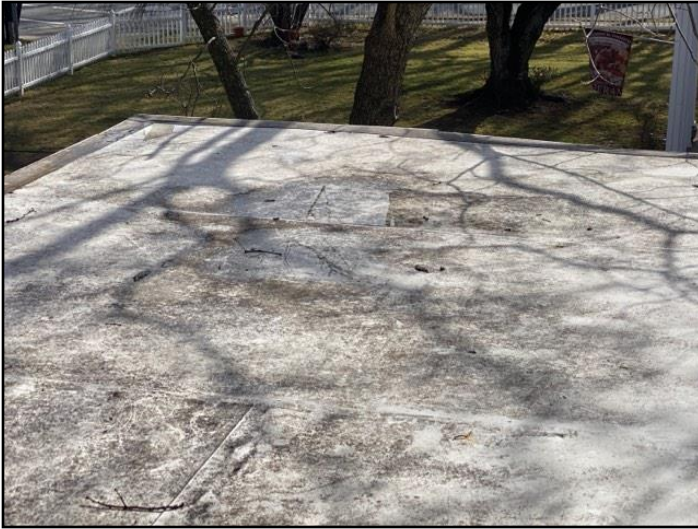
6. *Ponding*

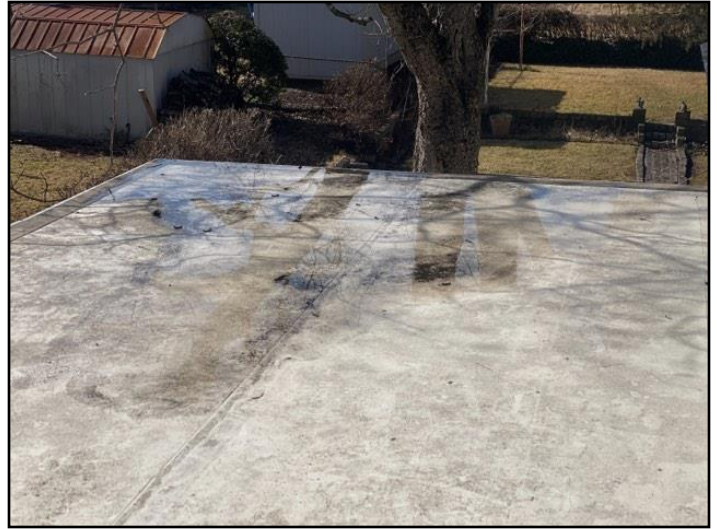
7. *Ponding*

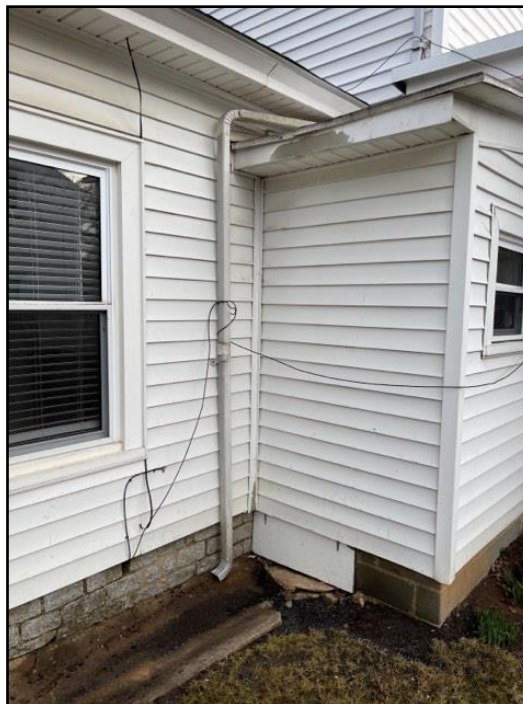
**Condition:** • [Discharge too close to building](#)

8. Discharge too close to building

**Task:** Repair

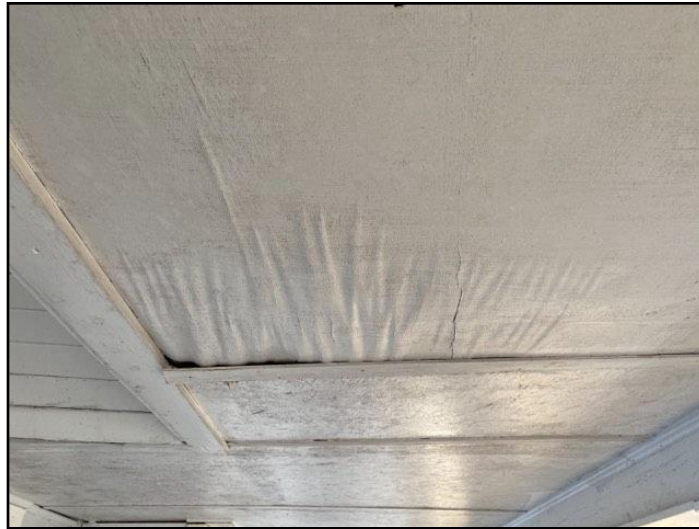
9. Rotten Soffit

**Task:** Further Evaluation

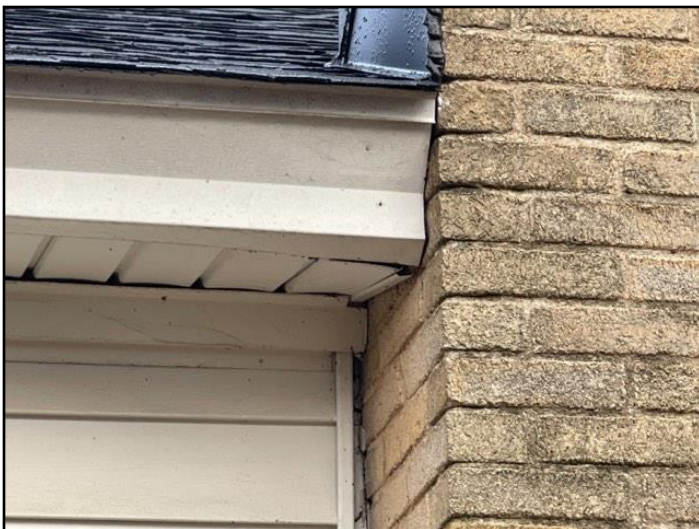
**7. Condition:** • [Loose or missing pieces](#)

10. Loose or missing pieces

**Task:** Repair

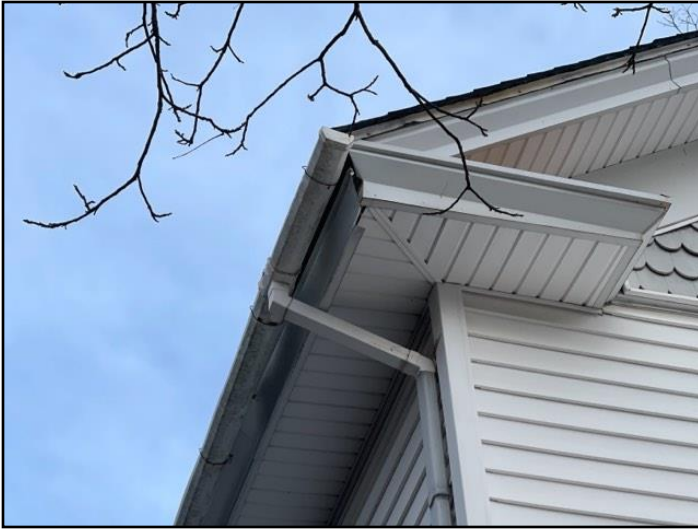
12. Loose or missing pieces

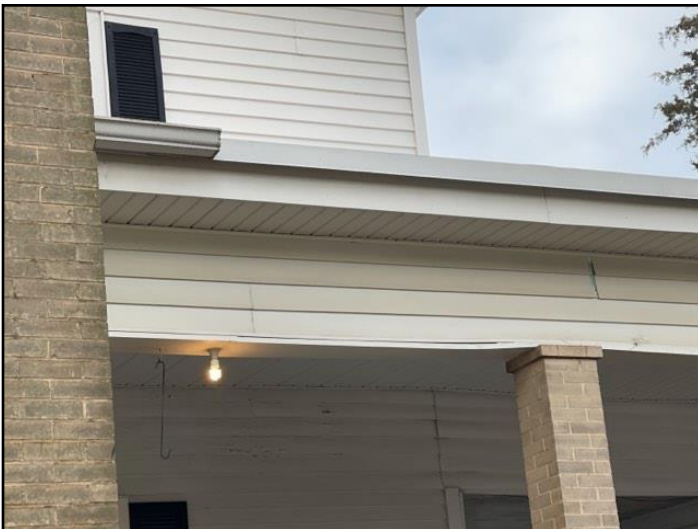
14. Loose or missing pieces

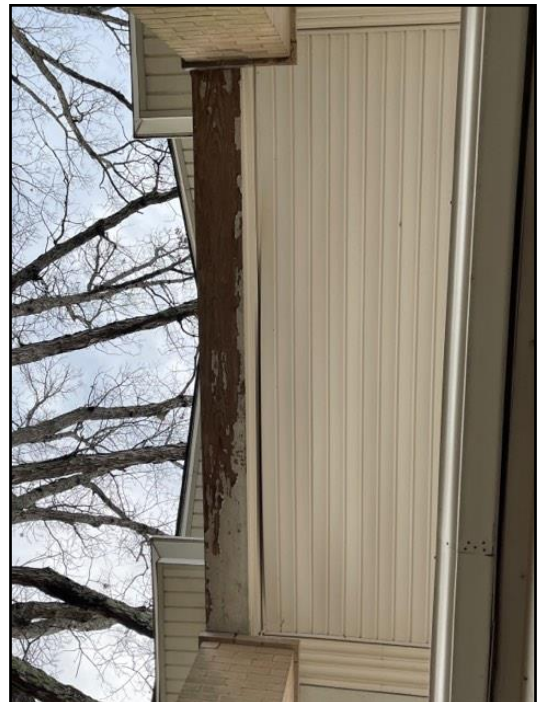
15. Loose or missing pieces

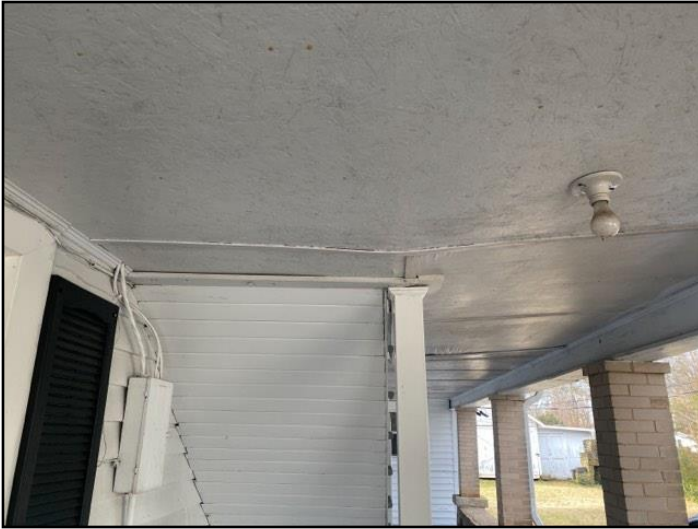
16. Loose or missing pieces

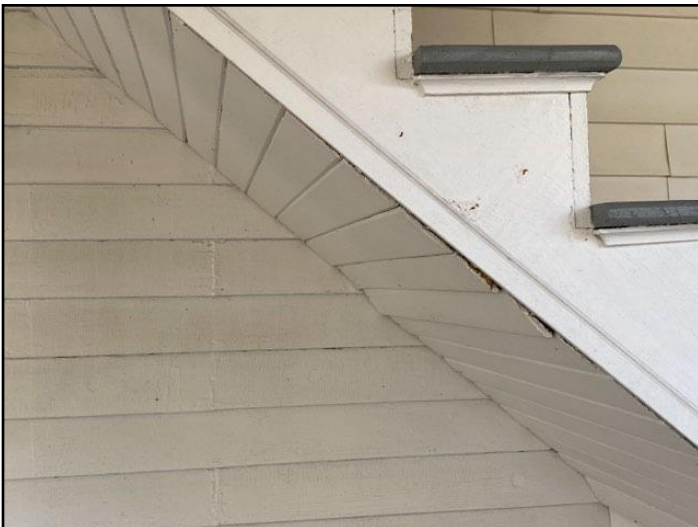
18. Loose or missing pieces

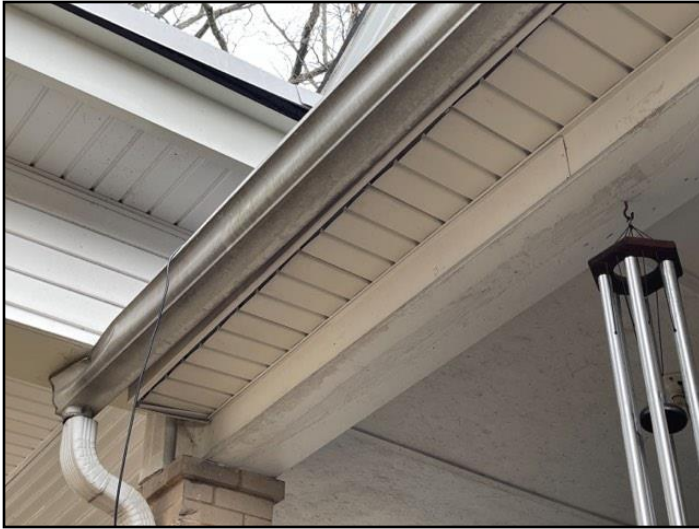
20. Loose or missing pieces

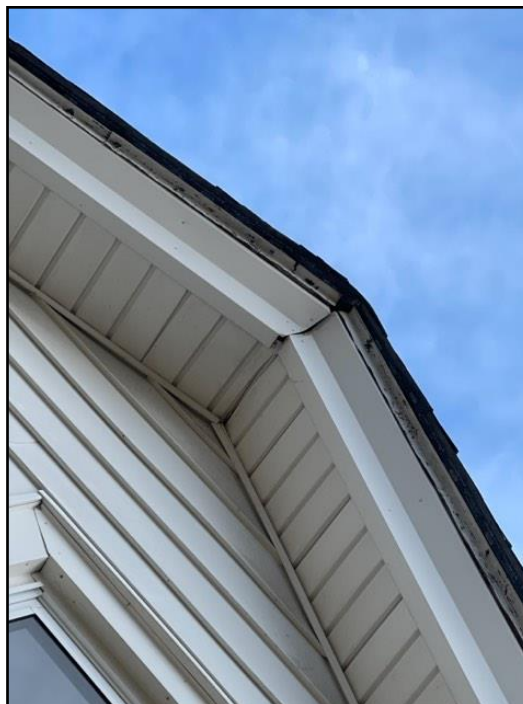
22. Loose or missing pieces

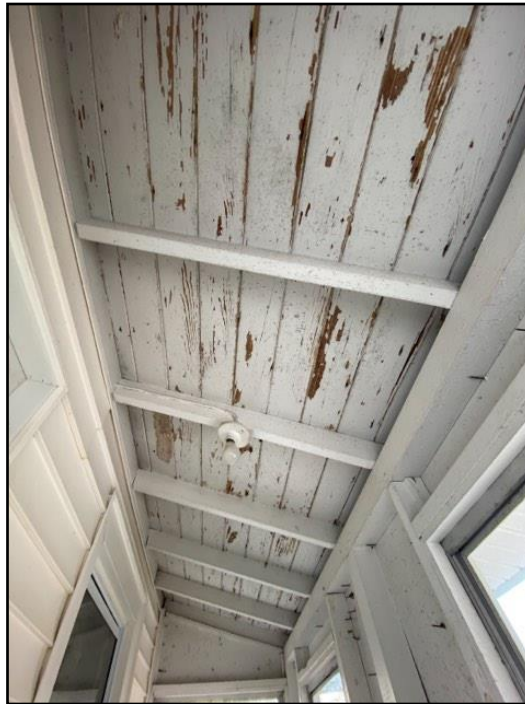
**8. Condition:** • Paint - deteriorated / missing

23. Paint - deteriorated / missing

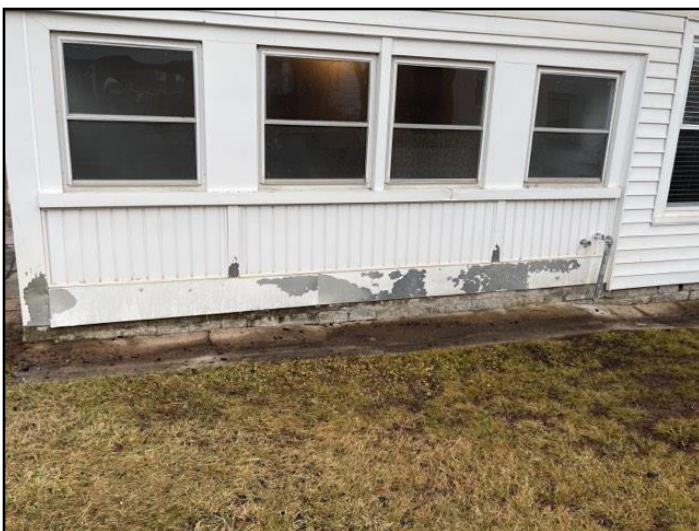
24. Paint or stain needed

Task: Repair

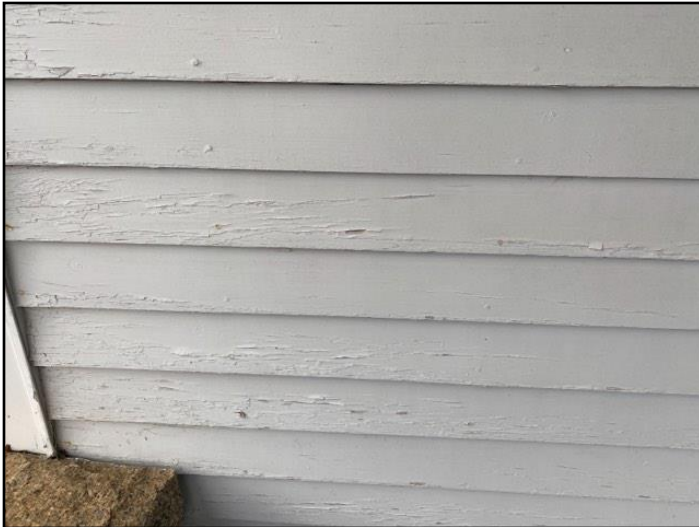
**26.** *Paint or stain - needed*

**Task:** Paint

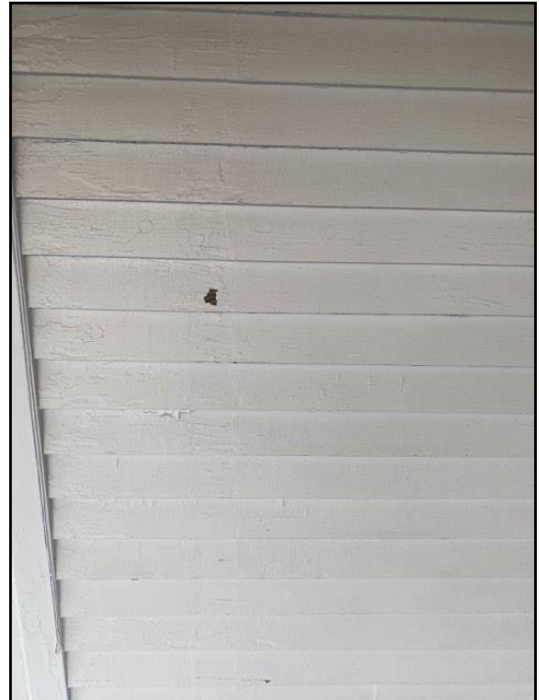
**27.** *Paint or stain - needed*

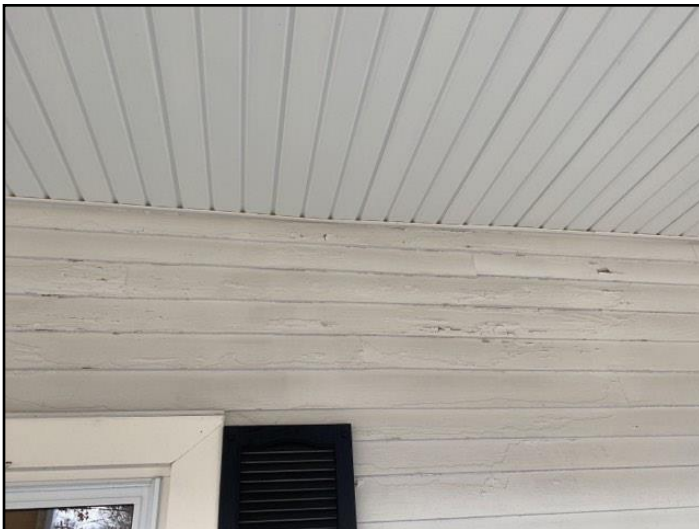
**28.** *Paint or stain - needed*

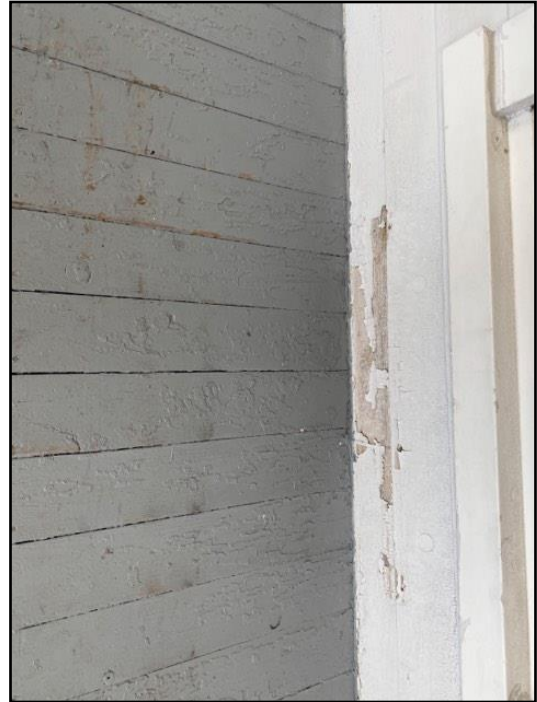
29. Paint or stain - needed

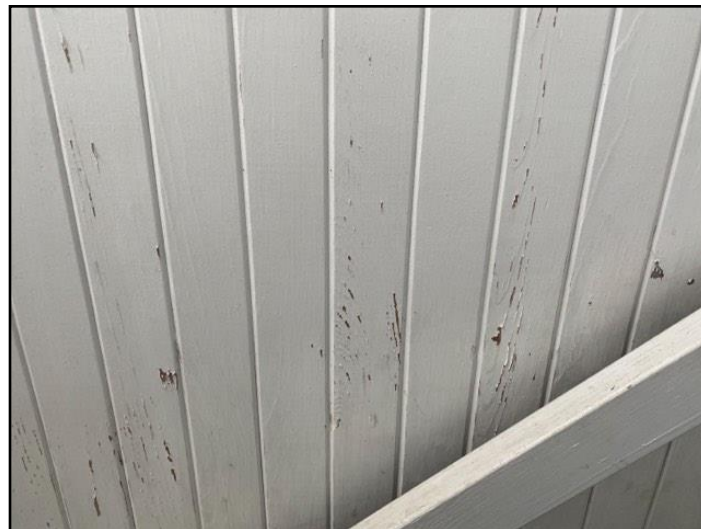
30. Paint or stain - needed

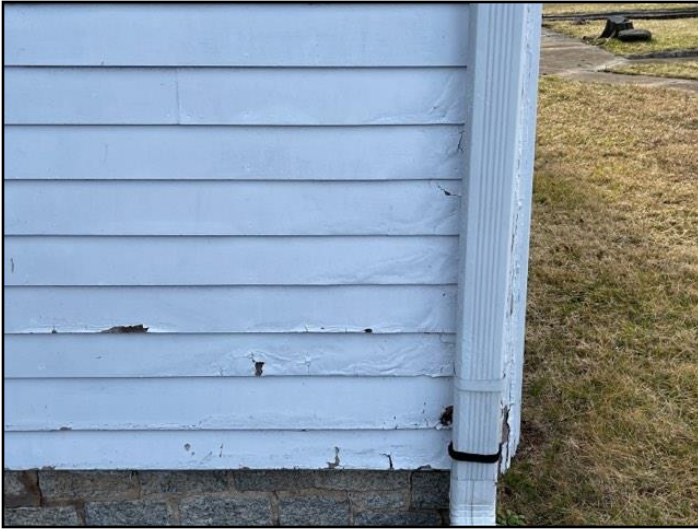
11. Condition: • [Rot](#)

31. Rotten Siding

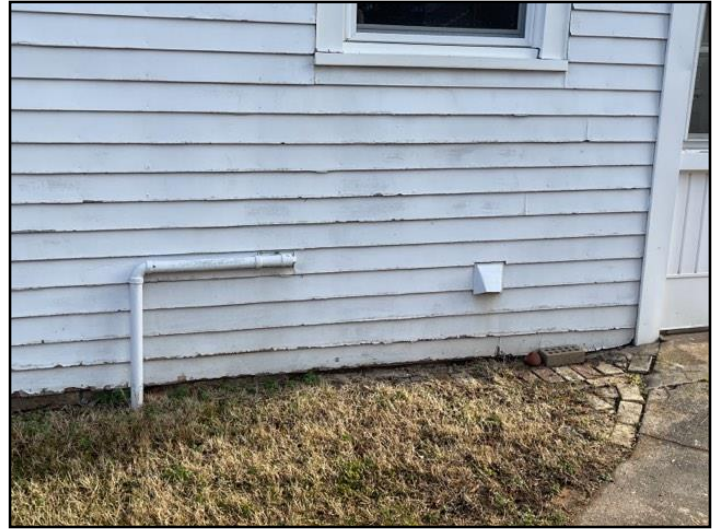
32. Rotten Siding

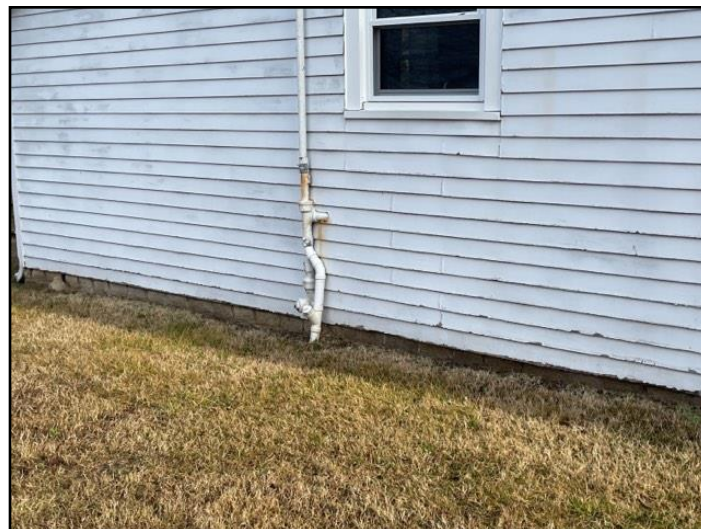
33. Rotten Siding

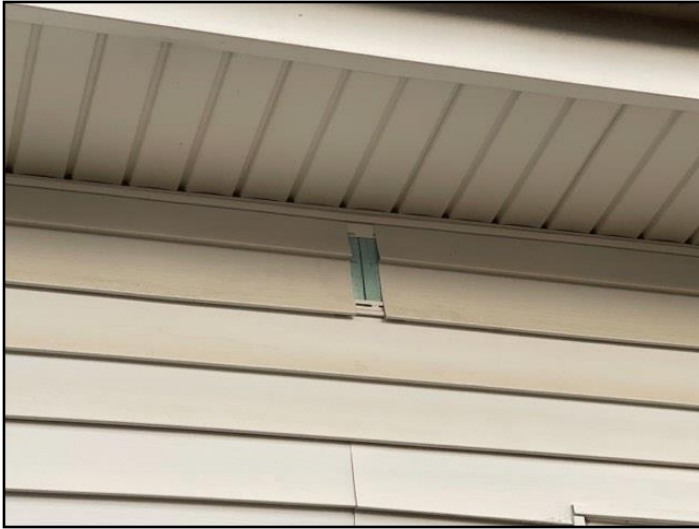
34. Loose Siding

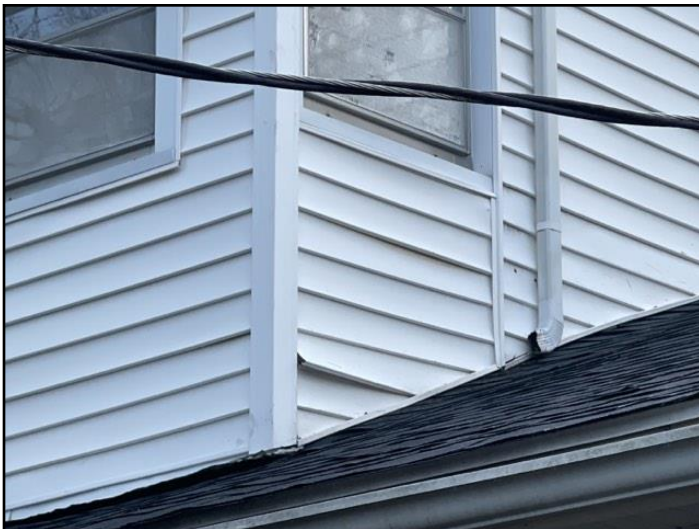
36. Loose Siding

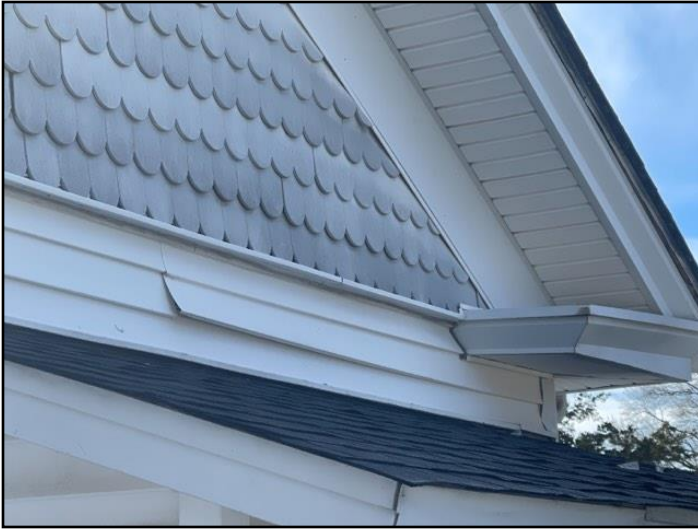
38. Loose Siding

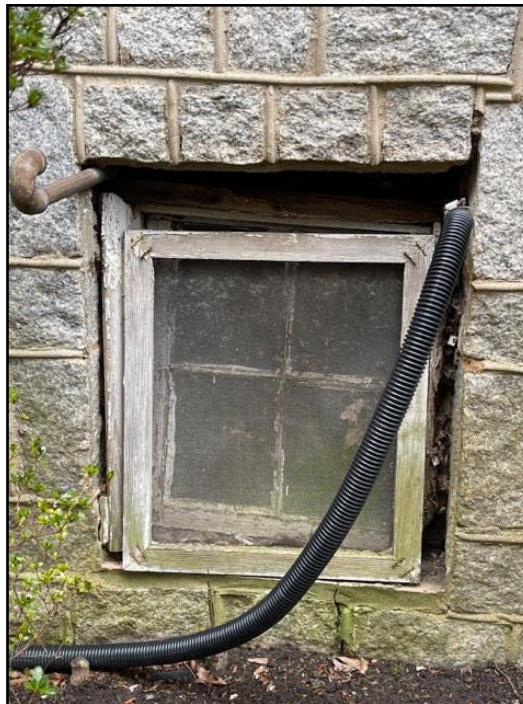
40. Rot

**Task:** Repair

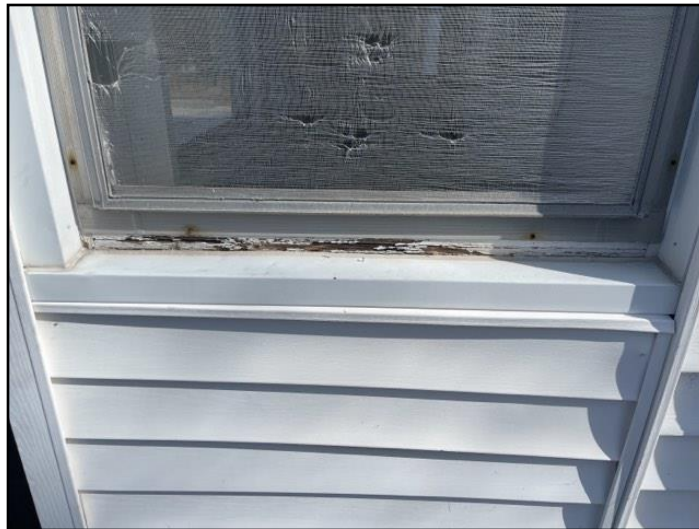
41. Rotten Window Frame

**Task:** Repair

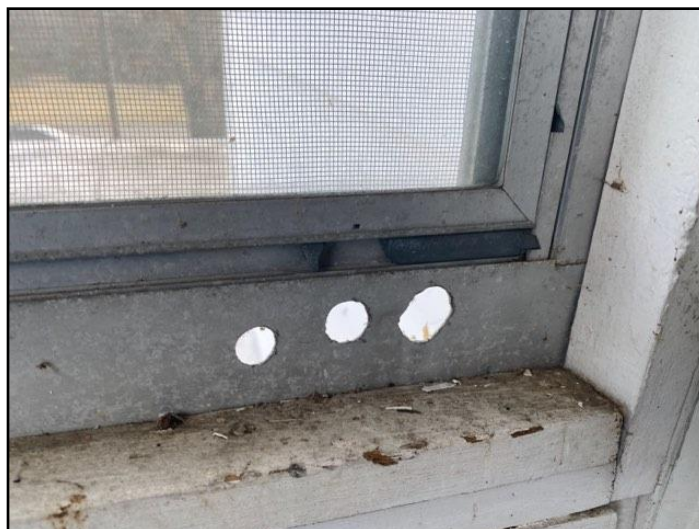
15. Condition: • [Damage](#)

42. Damaged Window

**Task:** Repair

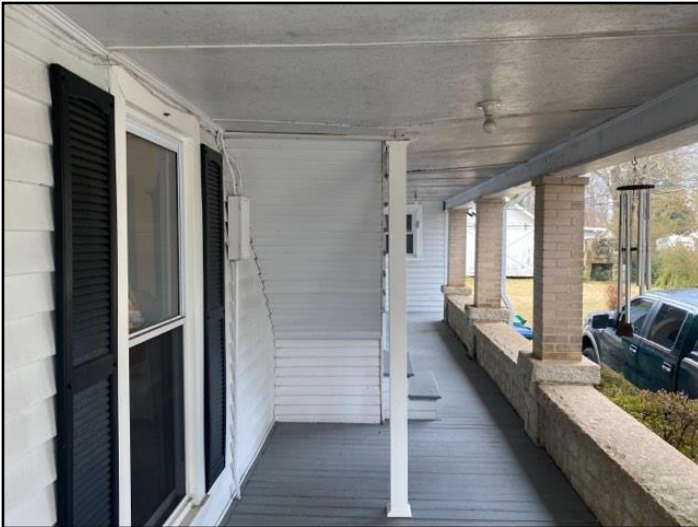
**Condition:** • Failing Roof Support Beams

**Implication(s):** Damage to structure

**43. Failing Support Beams**

**Task:** Further Evaluation

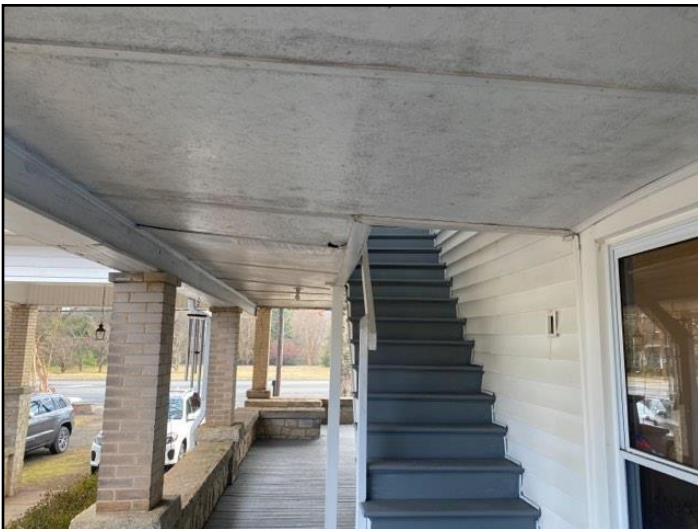
**16. Condition:** • Failing Roof Support Beams

**Implication(s):** Damage to structure

**45. Failing Support Beams**

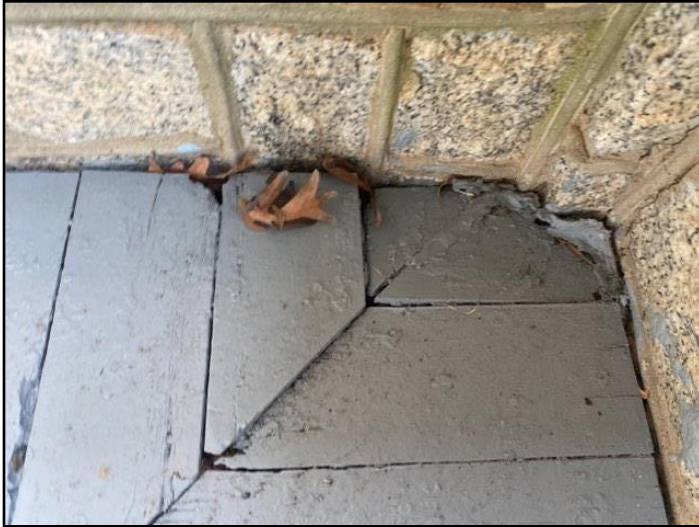
**17. Condition:** • [Damage](#)

47. Damage

**Task:** Repair

**Time:** Immediate

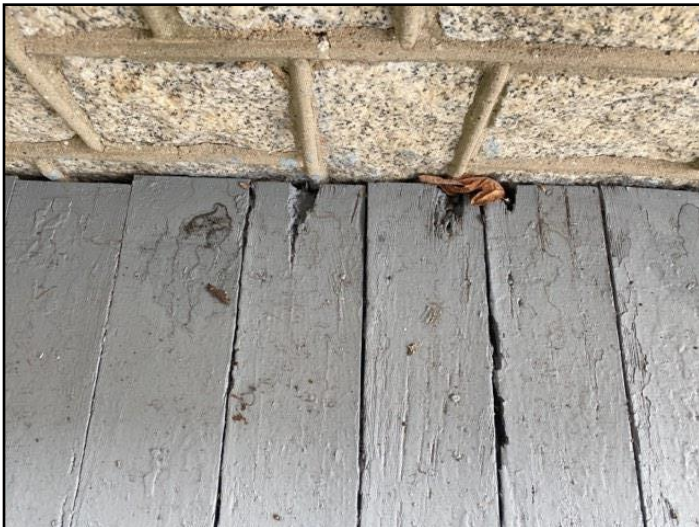
49. Damage

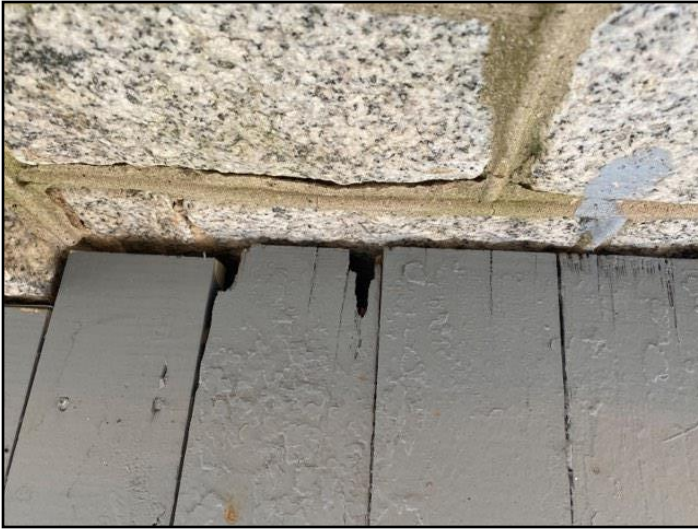
51. Damage

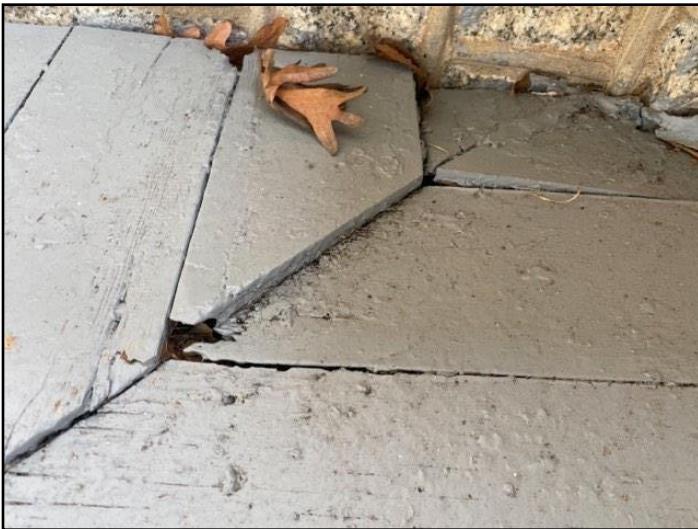
**18. Condition:** • Loose deck board

**Implication(s):** Trip or fall hazard

53. Loose deck board

**Task:** Repair

**Time:** Immediate

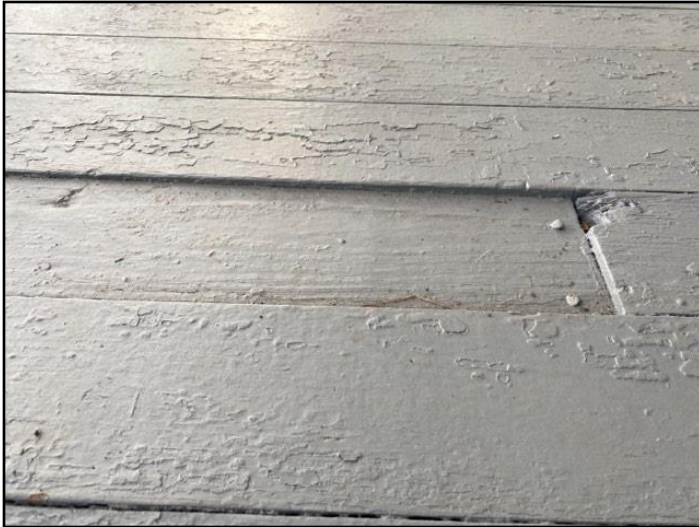
**19. Condition:** • Trip Hazard

**Implication(s):** Trip Hazard

55. Trip Hazard

**Task:** Repair

**Time:** Immediate

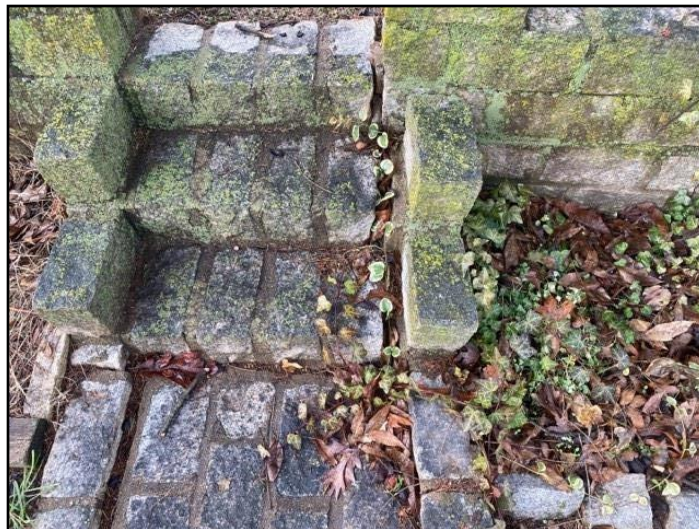
**20. Condition:** • Steps or landings settling or heaving

**Implication(s):** Weakened structure | Trip or fall hazard

57. Steps Settling

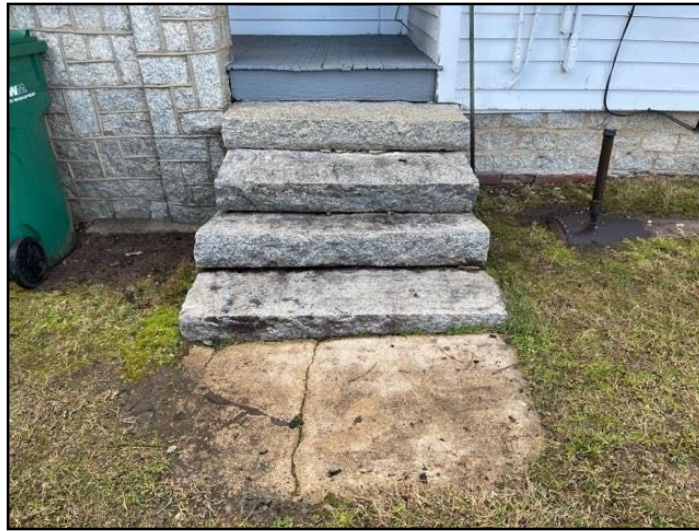
**21. Condition:** • Steps or landings settling or heaving

**Implication(s):** Weakened structure | Trip or fall hazard

58. Steps Settling

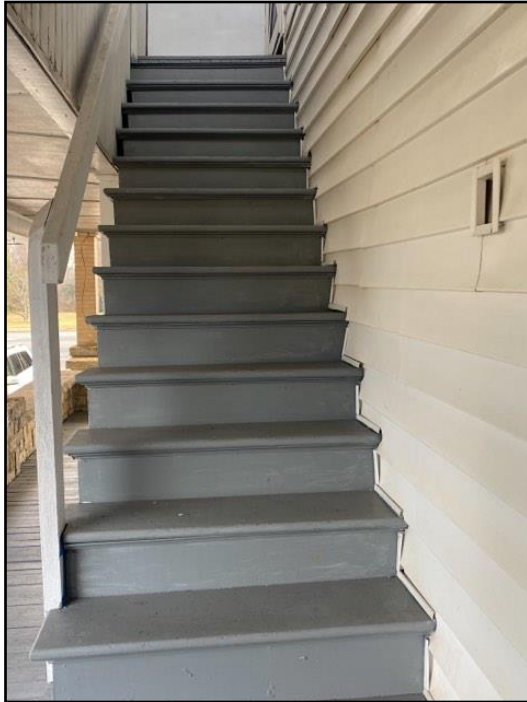
22. Condition: • [Steps slope](#)

Implication(s): Trip or fall hazard

59. Steps slope

Task: Further Evaluation

Time: Immediate

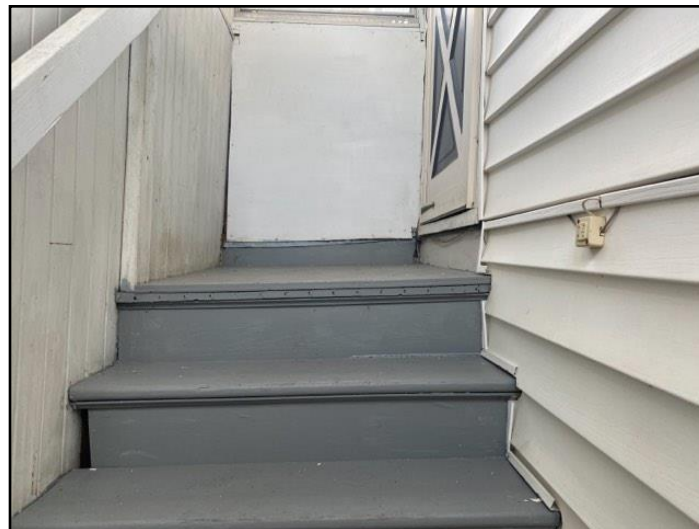
61. Steps slope

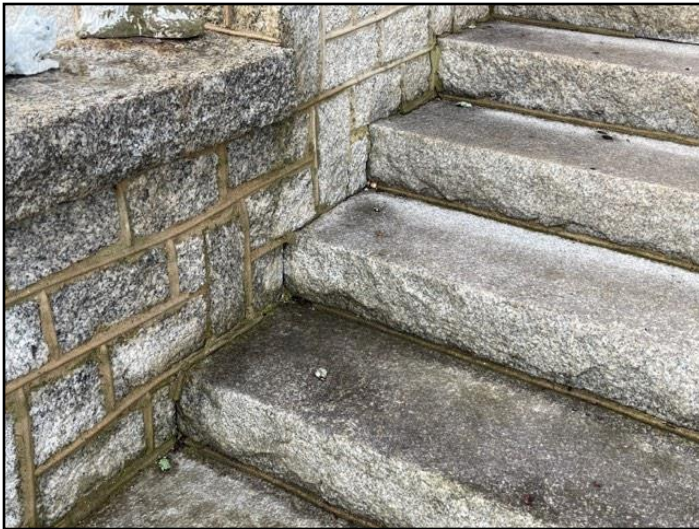
**23. Condition:** • Missing or deteriorated mortar should be repaired. Implication: Water freezing will cause additional damage over time.

62. Missing or deteriorated mortar should be...

**Task:** Repair

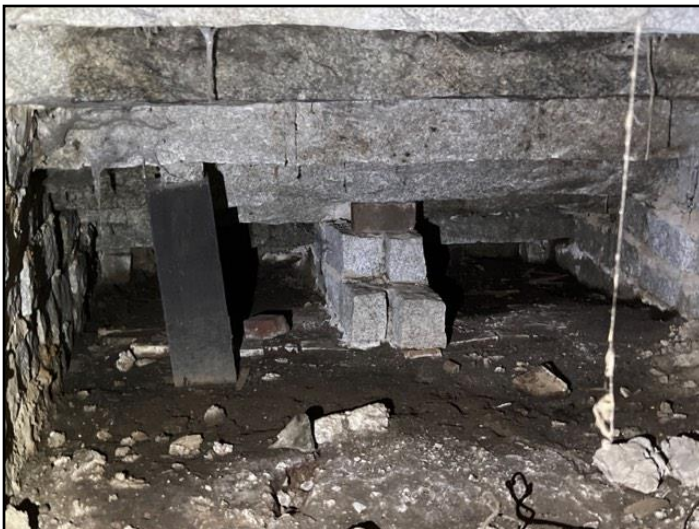
**24. Condition:** • Inadequate support for stair - stair stringers spanning over six foot in the horizontal plan should have additional support.

64. Inadequate support for stair - stair...

**Task:** Monitor

**Time:** Ongoing

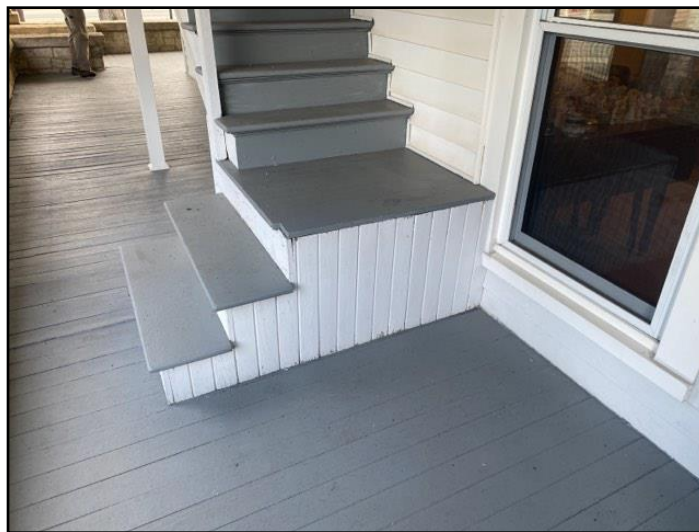
26. Condition: • [Missing](#)

Implication(s): Fall hazard

70. Missing Hand and Guardrail

Task: Repair

Time: Immediate

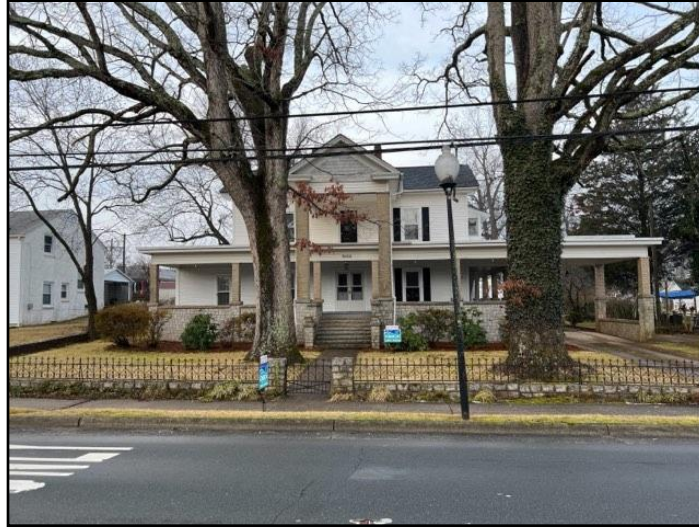
27. Condition: • [Missing](#)

**Implication(s):** Fall hazard

71. Missing guardrails

**Task:** Repair

**Time:** Immediate

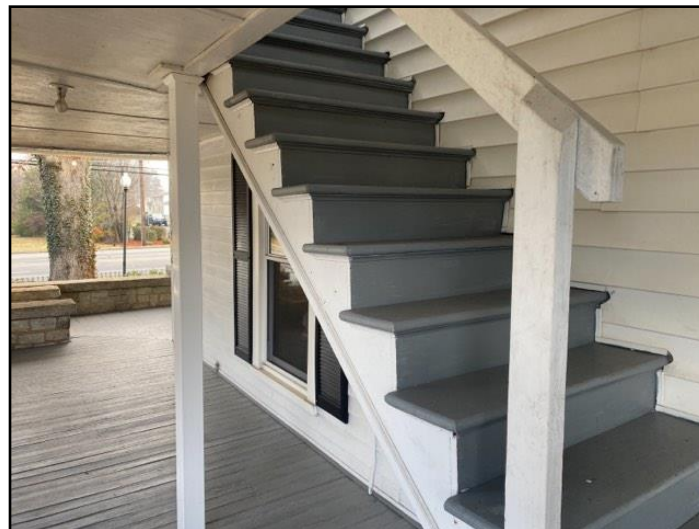
**29. Condition:** • [Spindles \(balusters\) missing](#)

**Implication(s):** Fall hazard

72. Spindles (balusters) missing

**Task:** Repair

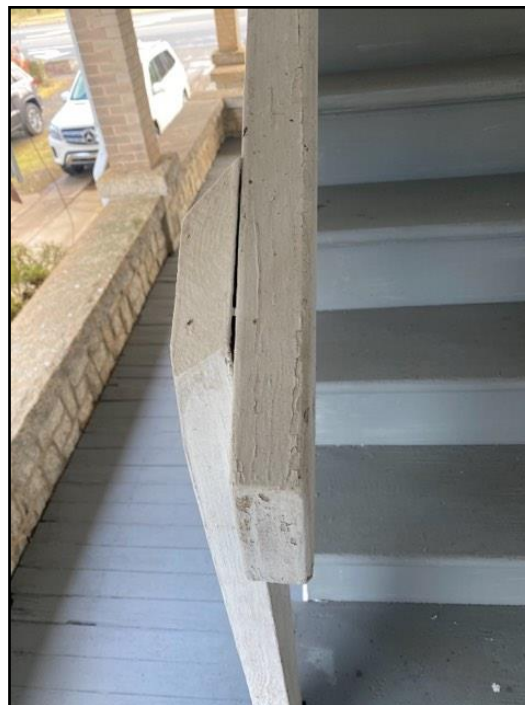
**30. Condition:** • Handrail hard to hold.

**Implication(s):** Fall hazard

73. Handrail hard to hold.

**Task:** Repair

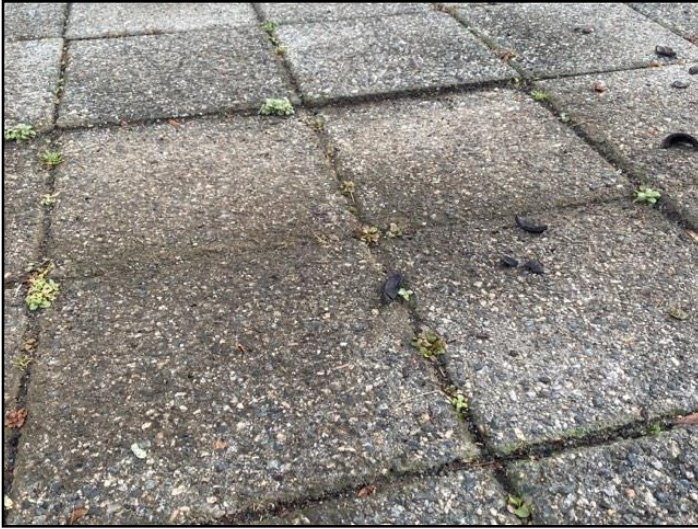
31. Condition: • [Trip hazards](#)

74. Trip hazards

**Task:** Repair

**Time:** Immediate

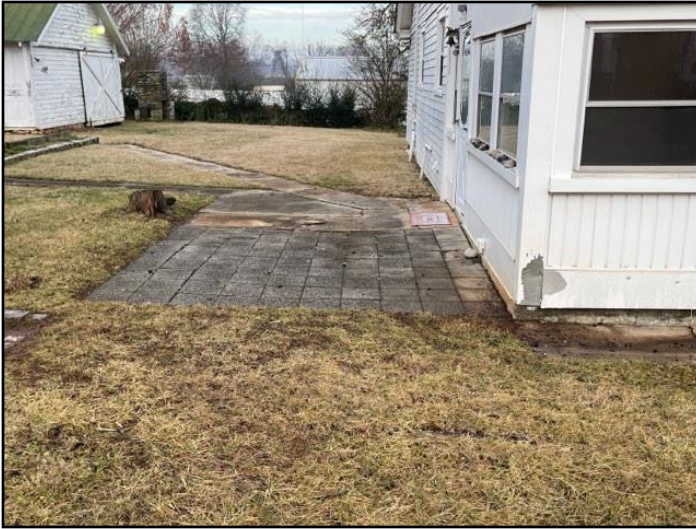
**32. Condition:** • Improper slope or drainage

**Implication(s):** Chance of water damage to structure, finishes and contents. This issue is commensurate with moisture issues and mold growth. A more detailed inspection, specifically addressing these concerns and mold testing, is advised.

76. Improper slope or drainage

**Task:** Repair

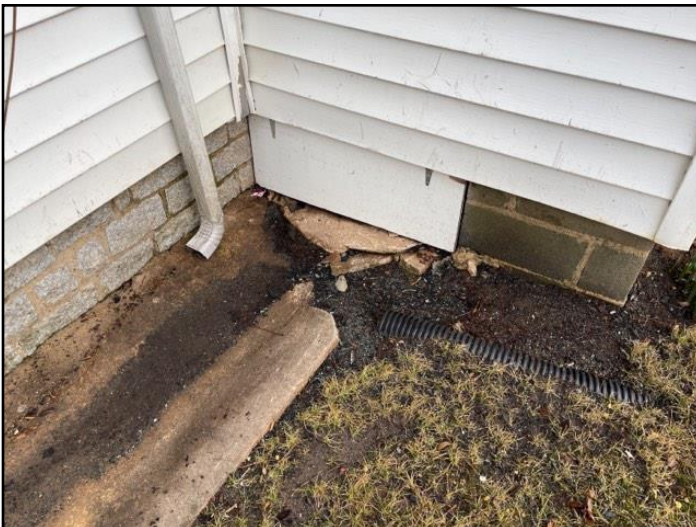
78. Improper slope or drainage

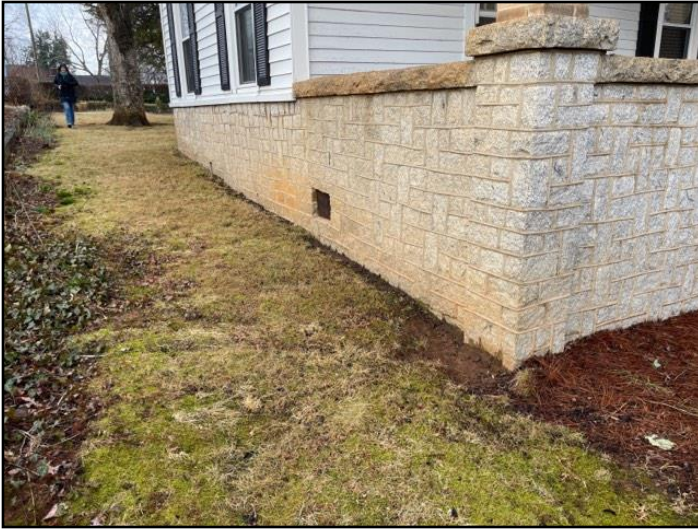
80. Improper slope or drainage

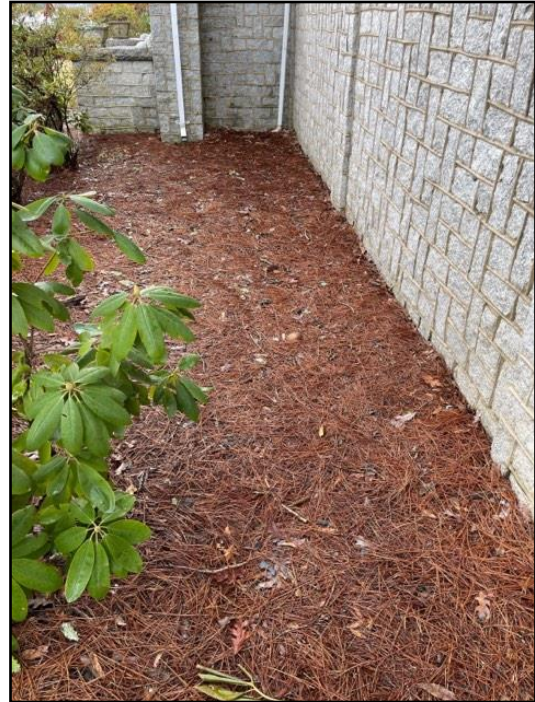
81. Improper slope or drainage

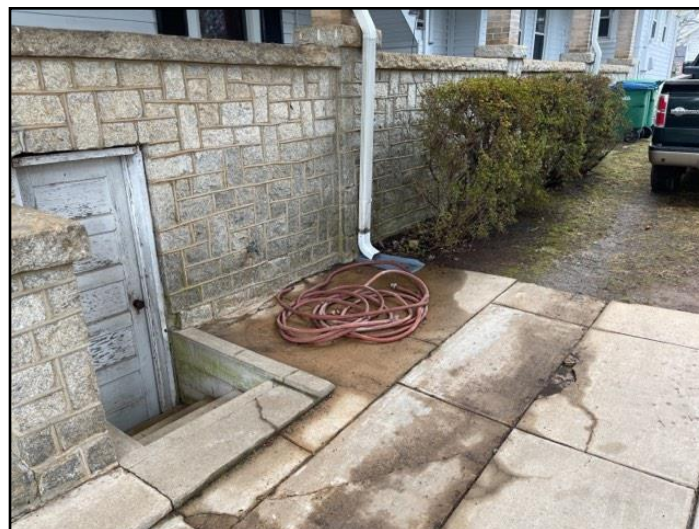
82. Improper slope or drainage

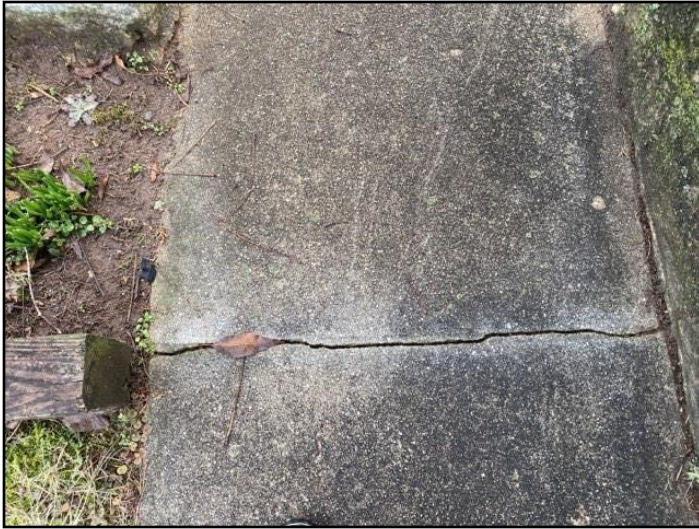
33. Condition: • [Cracked or damaged surfaces](#)

Implication(s): Trip or fall hazard

83. Cracked or damaged surfaces

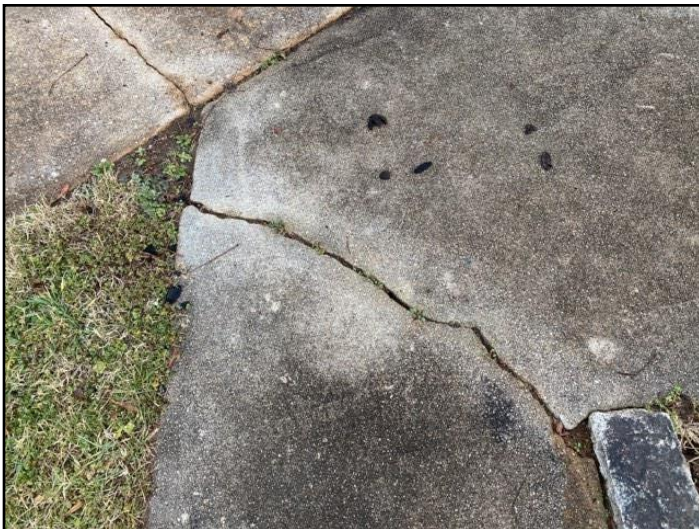
85. Cracked or damaged surfaces

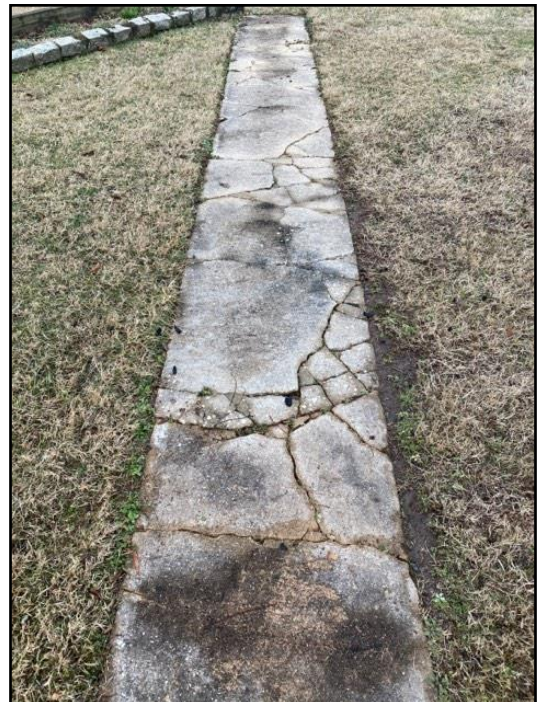
86. Cracked or damaged surfaces
