# YOUR Inspection Report

175 Some Street  
Any Town, NC

Tuesday, February 8, 2022

RE: Report No. 6580  
175 Some Street  
Any Town, NC

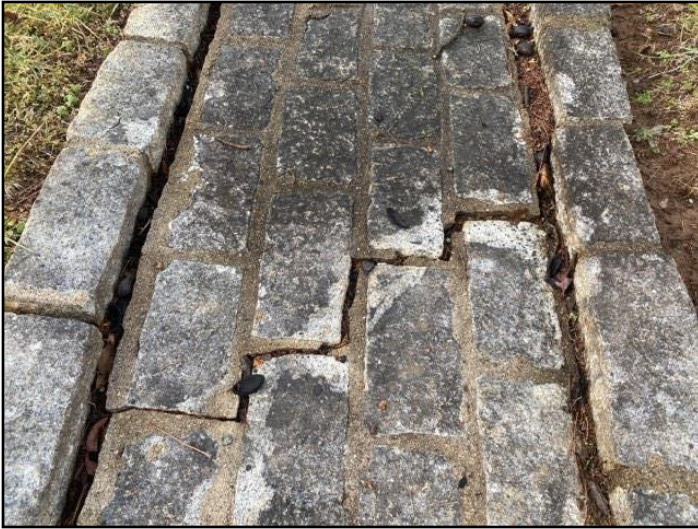
33. Condition: • [Cracked or damaged surfaces](#)

Implication(s): Trip or fall hazard

87. Cracked or damaged surfaces

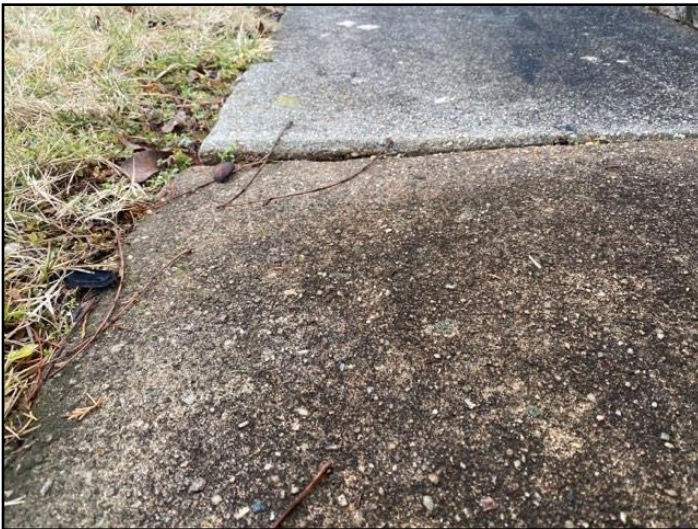
34. Condition: • [Uneven \(trip hazard\)](#)

89. Uneven (trip hazard)

Task: Repair

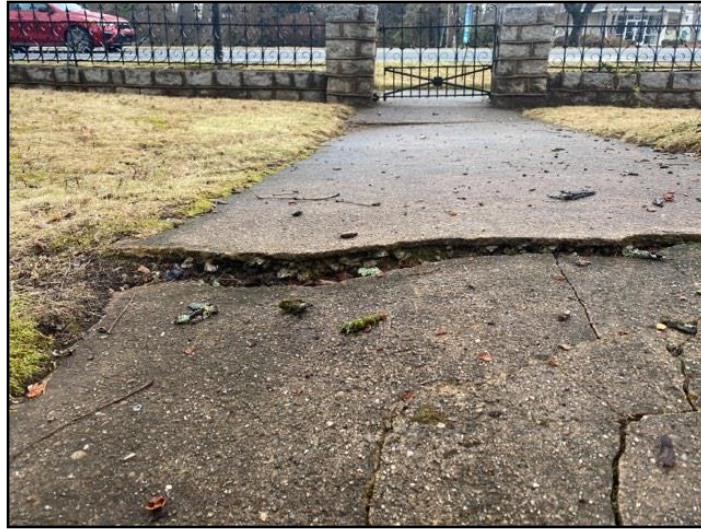
91. Uneven (trip hazard)

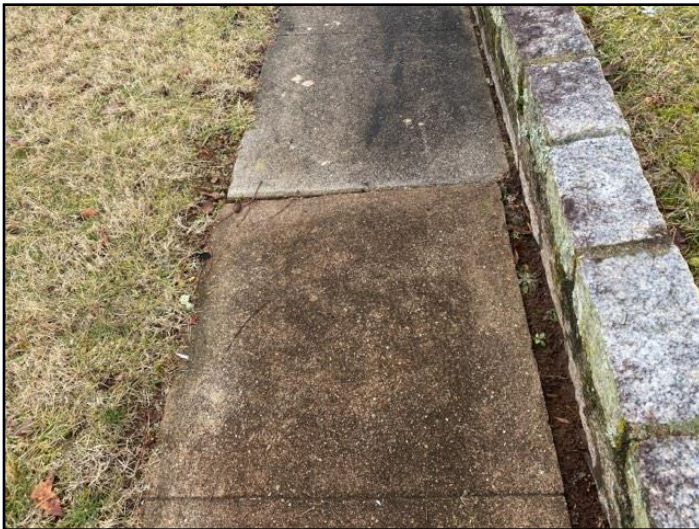
**35. Condition:** • Settlement

92. Settlement

**Task:** Further Evaluation

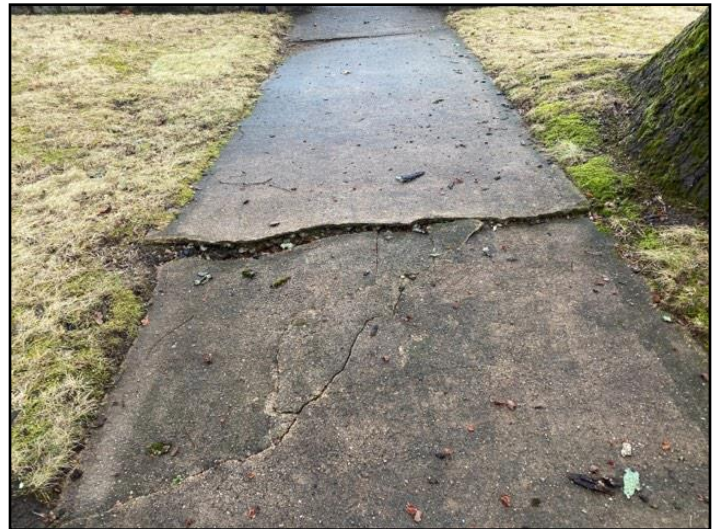
93. Settlement

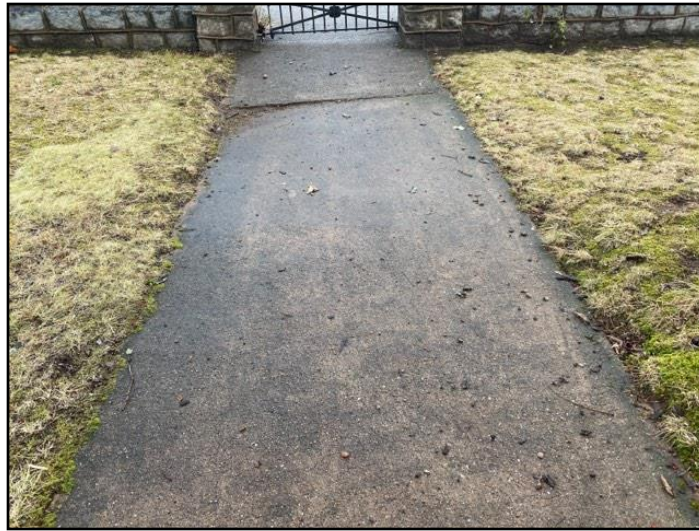
94. Settlement

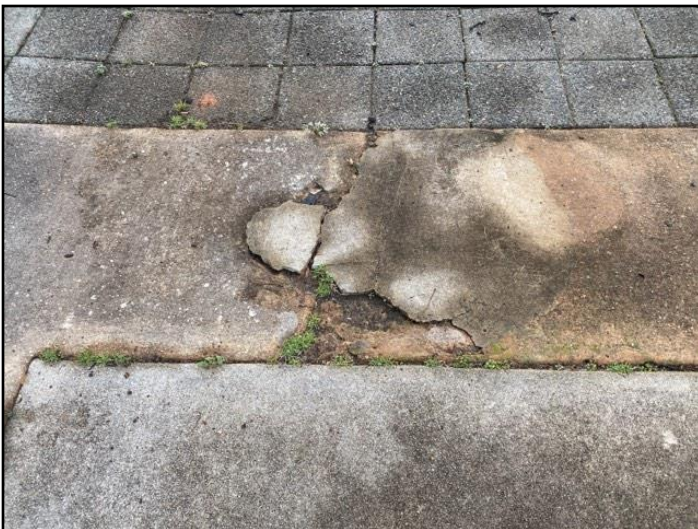
36. Condition: • Cracked or damaged surfaces

95. Cracked or damaged surfaces

Task: Repair

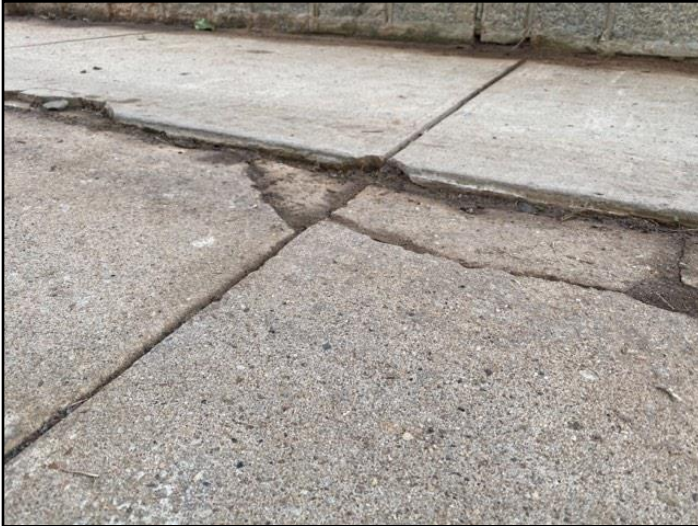
37. Condition: • [Uneven \(trip hazard\)](#)

**97.** Uneven (trip hazard)

Task: Repair

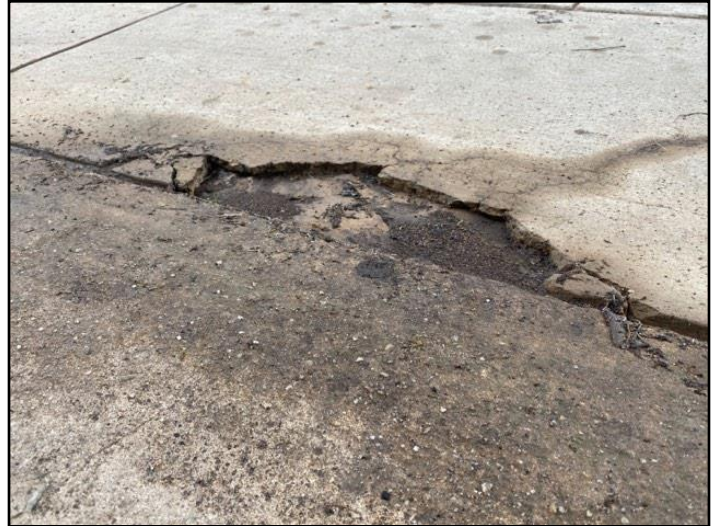
**98.** Uneven (trip hazard)

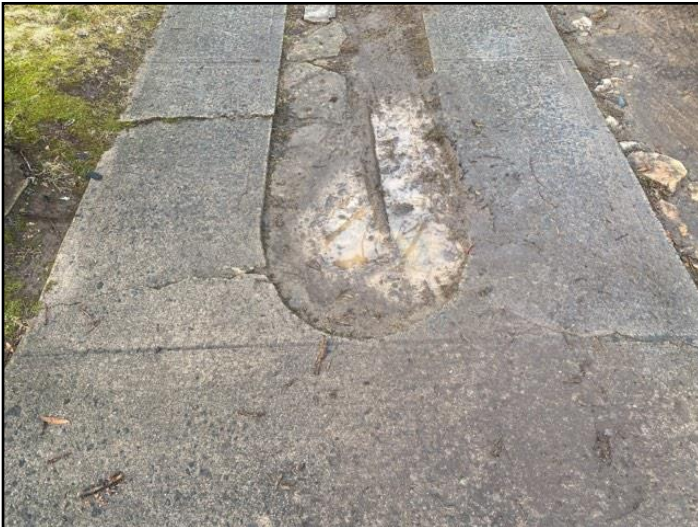
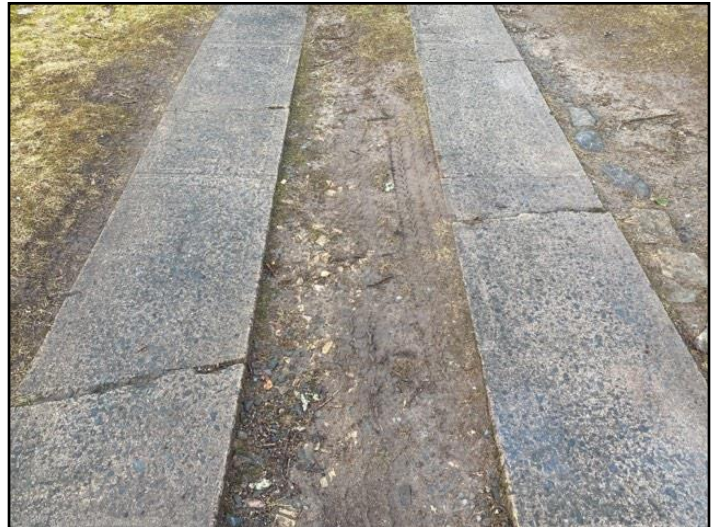
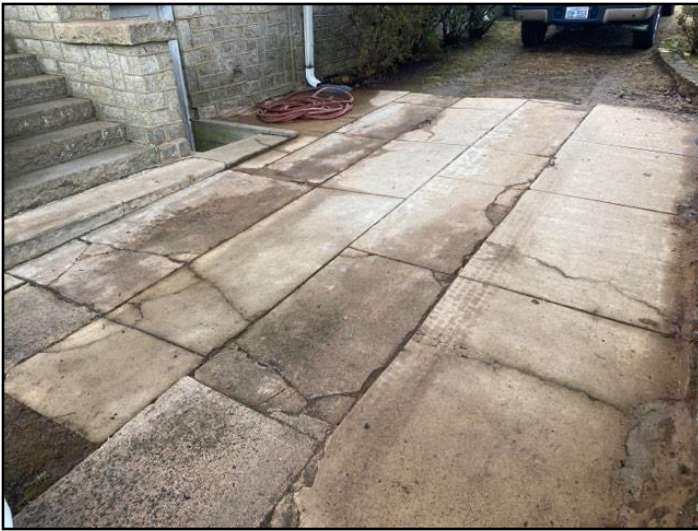
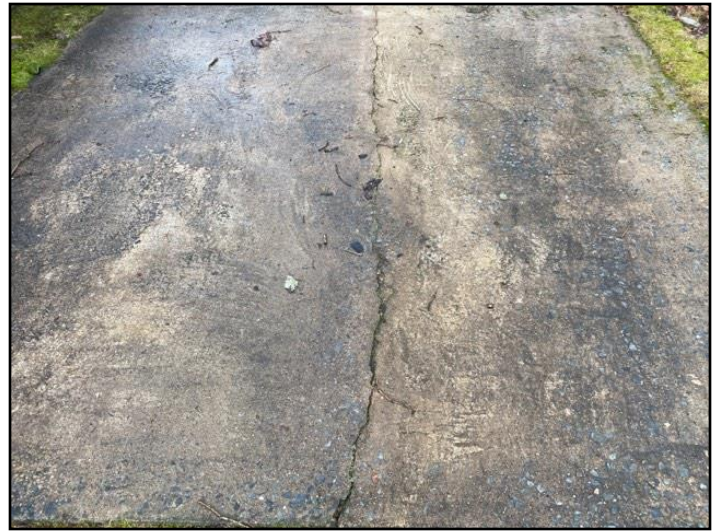
**38. Condition:** • The driveway shows evidence of minor cracking. This does not appear to be cause for concern and is usually caused by improperly placed crack control joints during the original installation. The driveway is serviceable although the cracks may not be aesthetically pleasing.

**Task:** Monitor

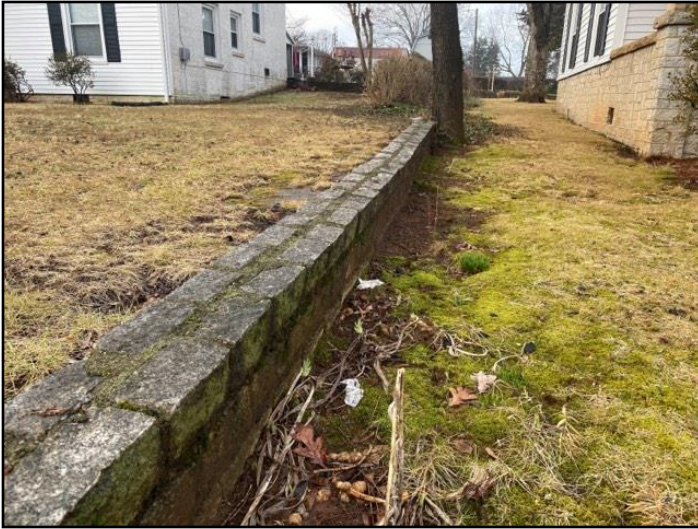
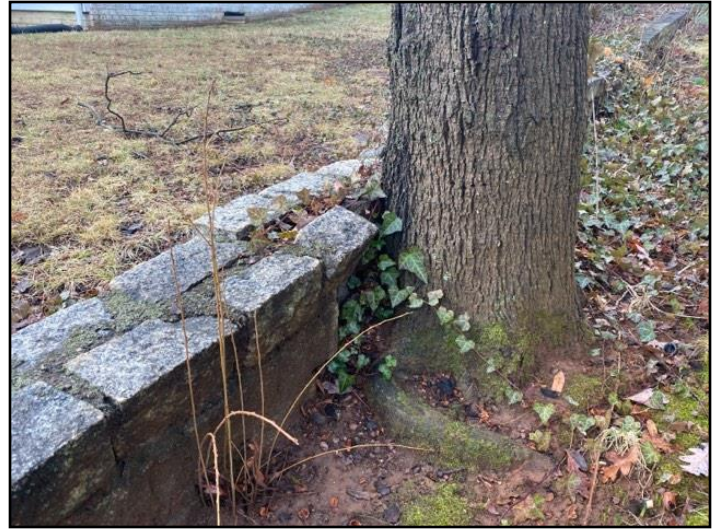
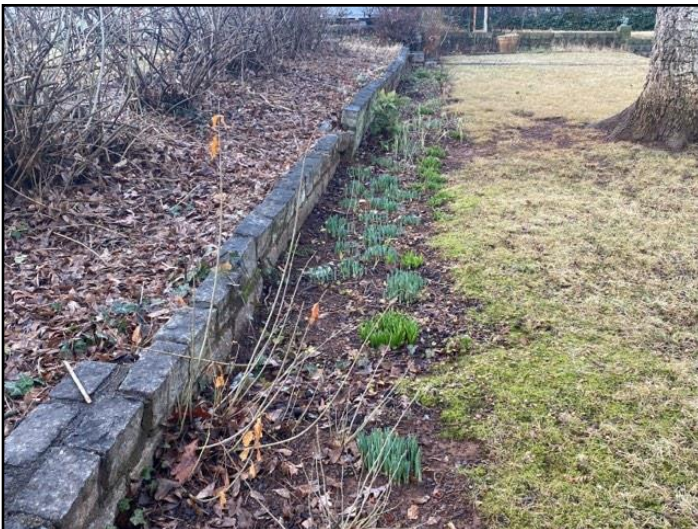
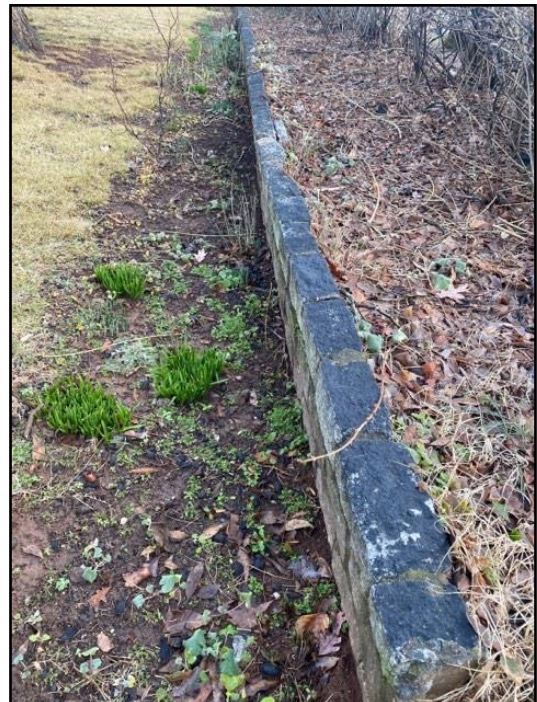
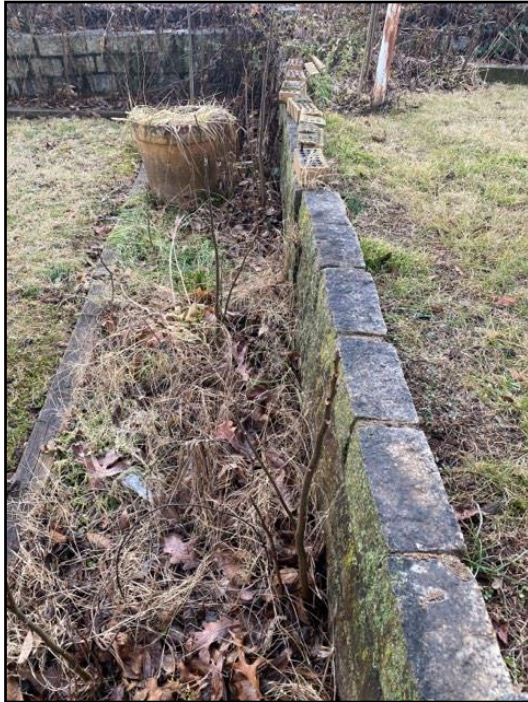
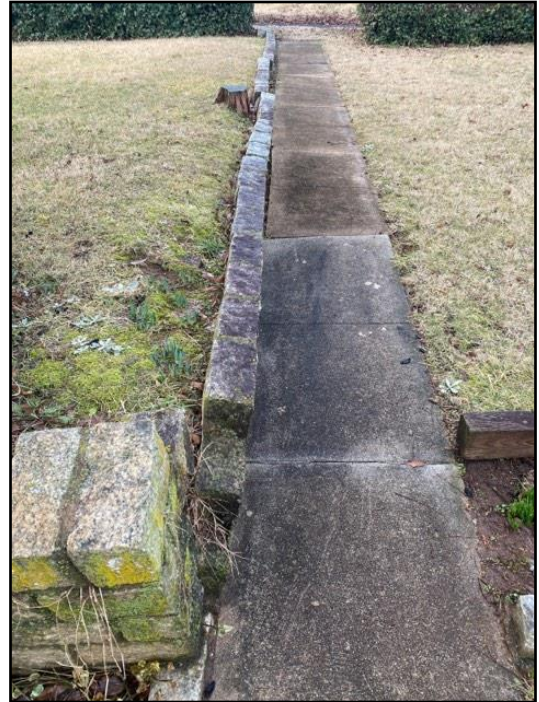
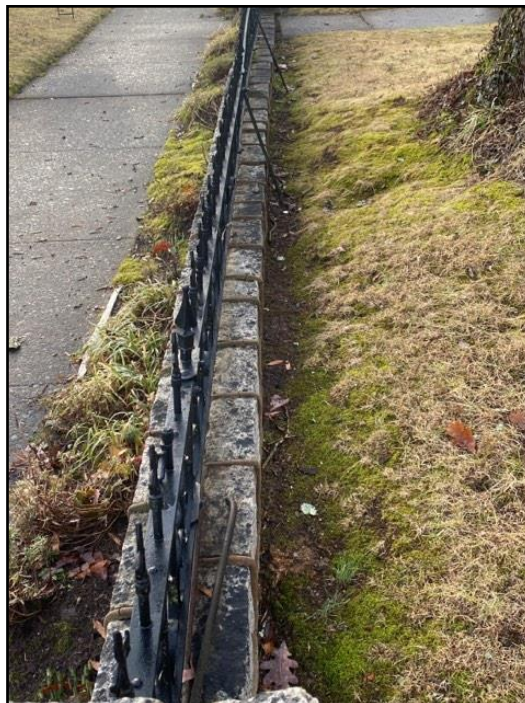
39. Condition: • [Leaning](#)

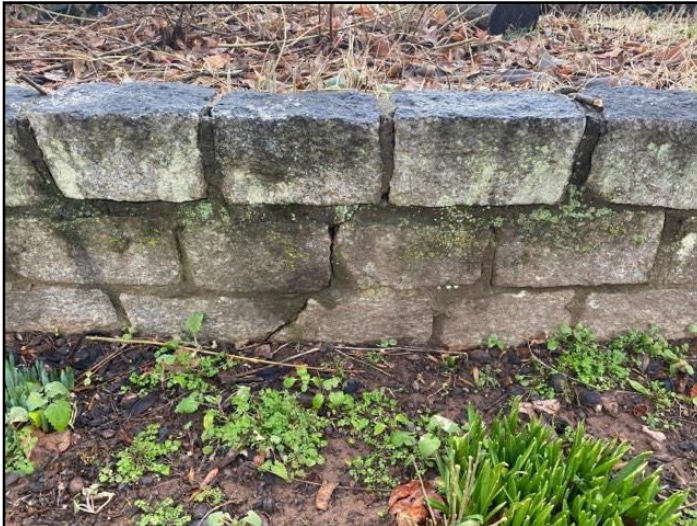
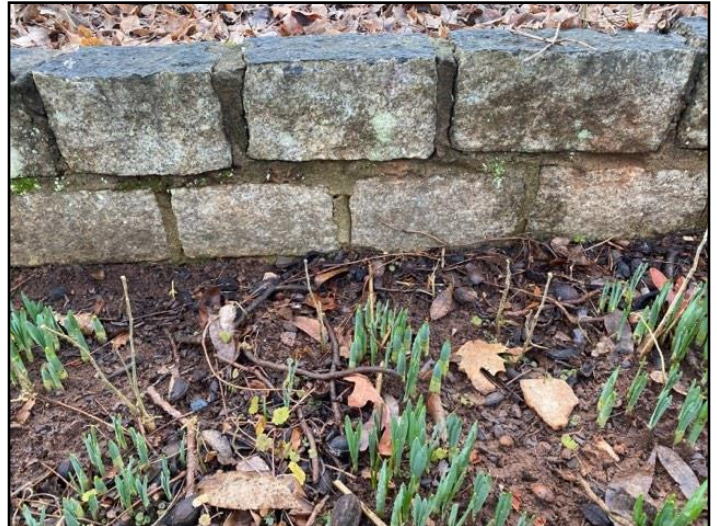
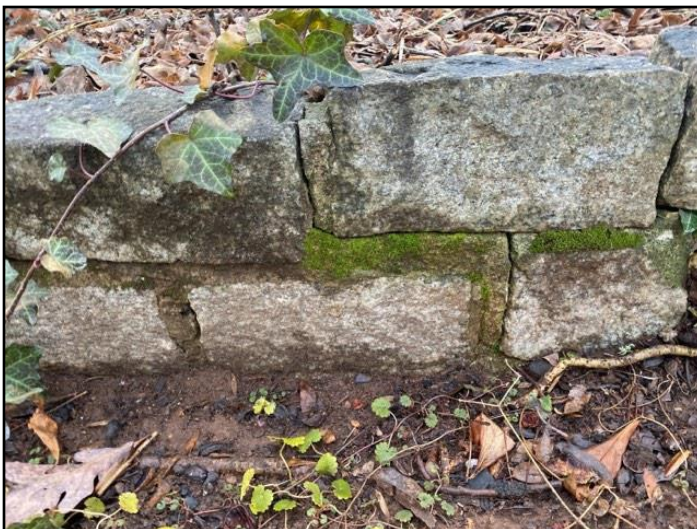
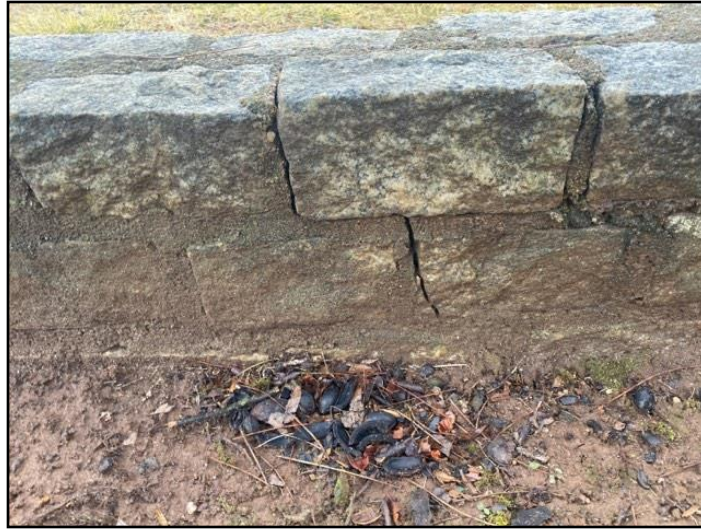
40. Condition: • [Cracked](#)

**Task:** Monitor

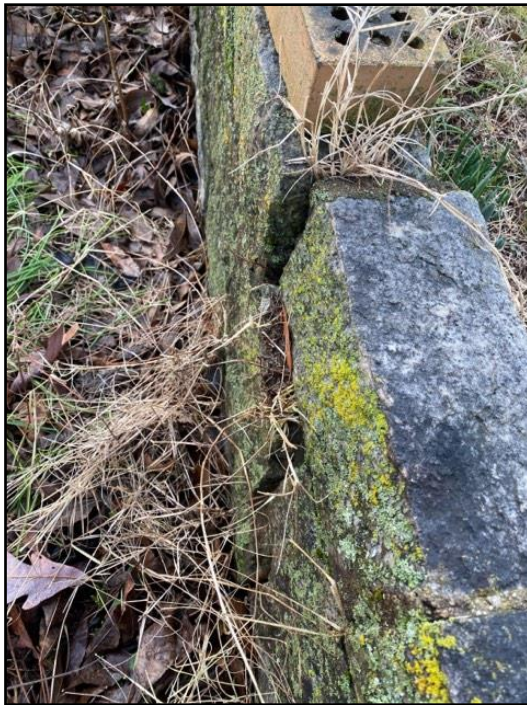
41. Condition: • [Settling or shifting](#)

115. Settling or shifting

Task: Further Evaluation

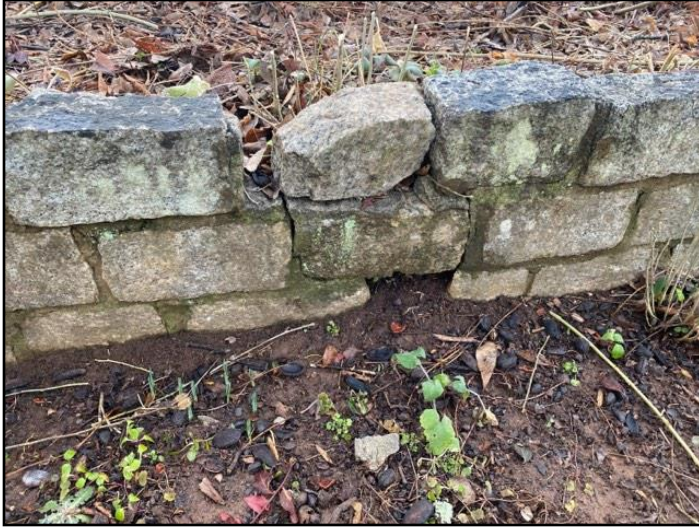
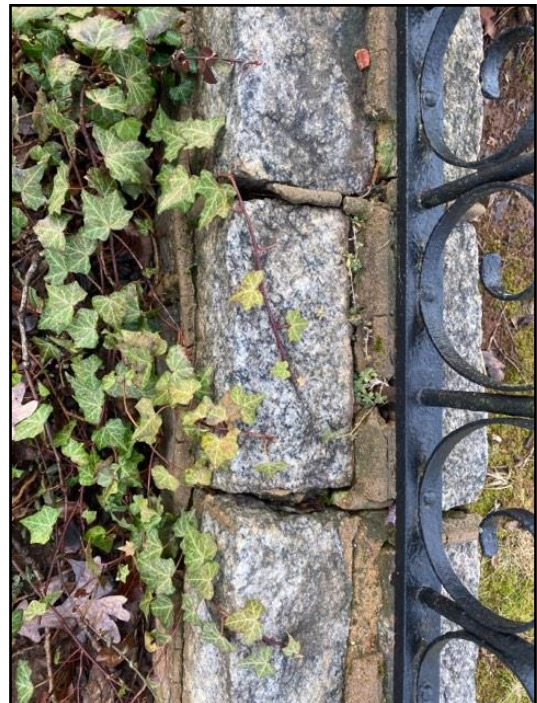
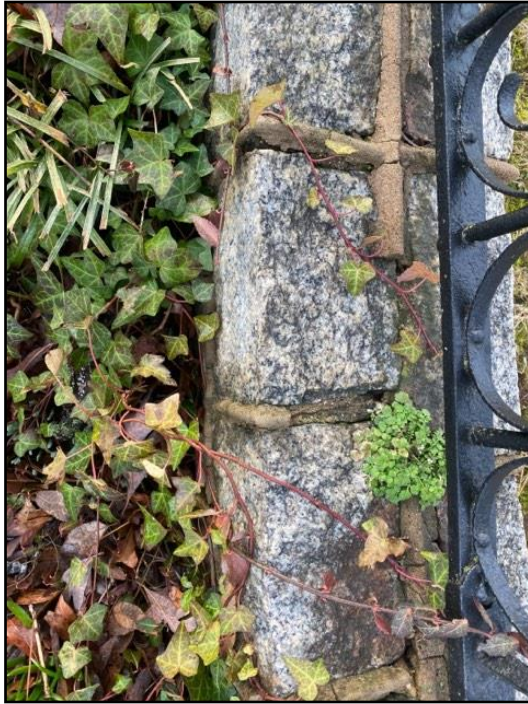
42. Condition: • [Mortar - deteriorated, missing](#)

**Task:** Repair

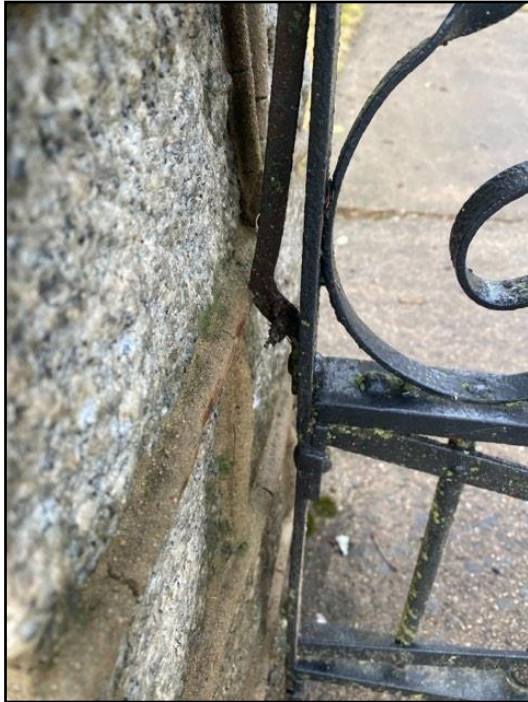
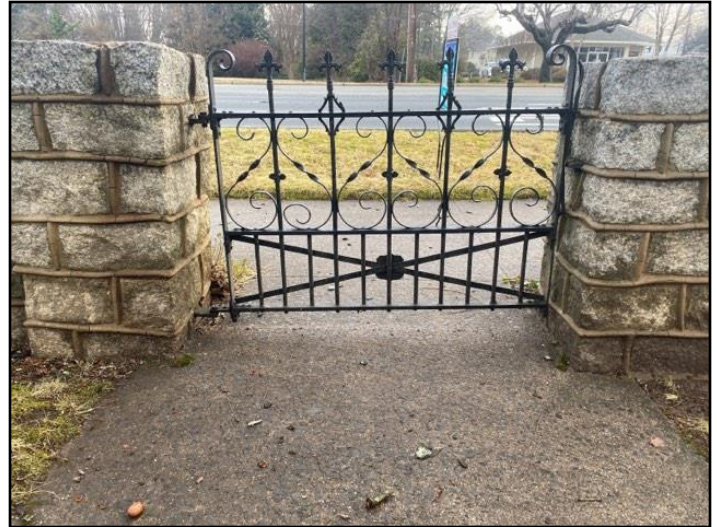
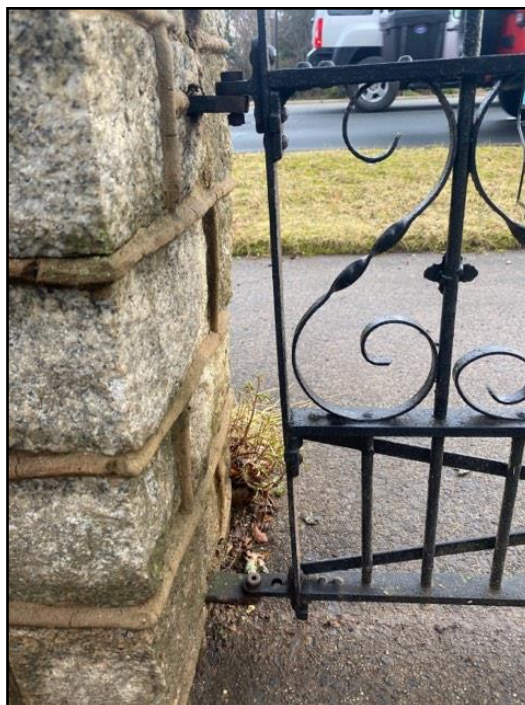
**43. Condition:** • Gate - adjustment needed

**Task:** Repair

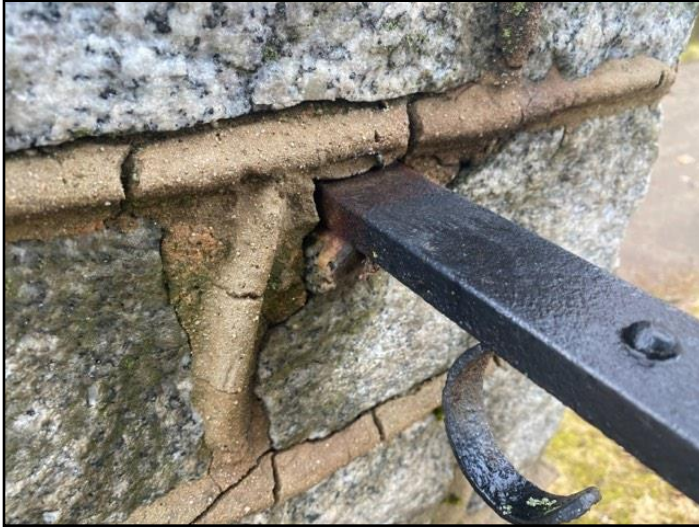
**44. Condition:** • Loose Fence

126. Loose Fence

**Task:** Repair

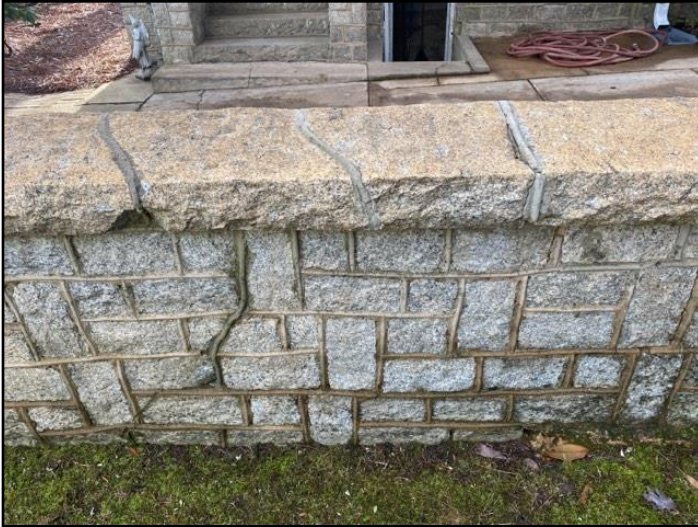
## 46. Condition: • Patched Cracks

129. Patched Cracks

Task: Monitor

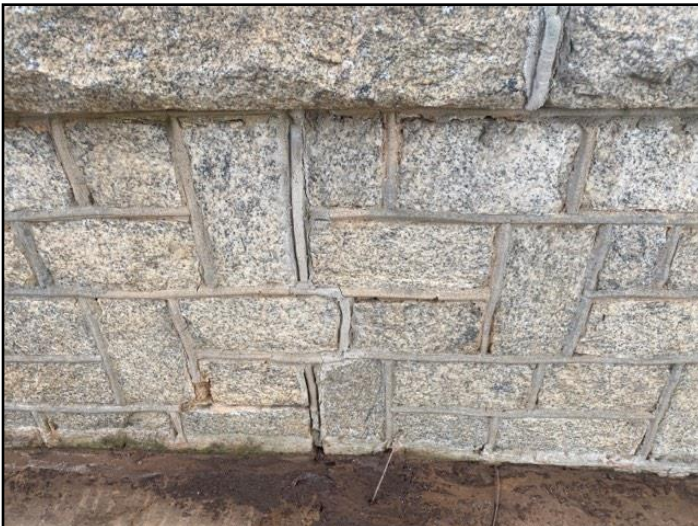
131.

## 47. Condition: • Cracked

Task: Monitor

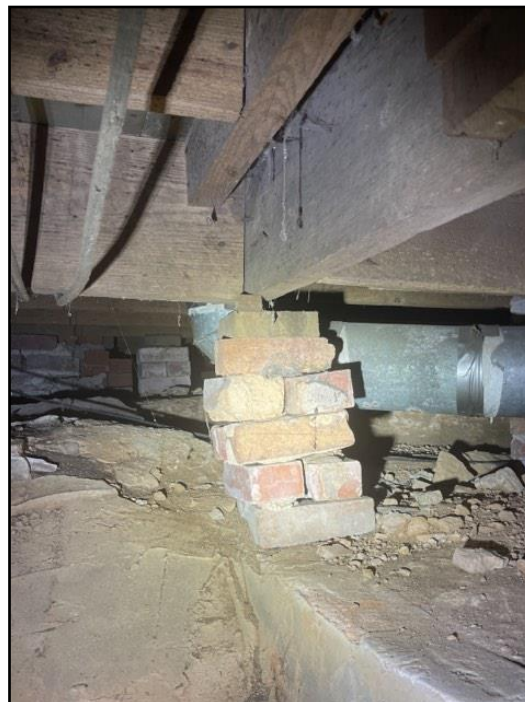
137. Leaning

**48. Condition:** • [Leaning](#)

**Task:** Repair

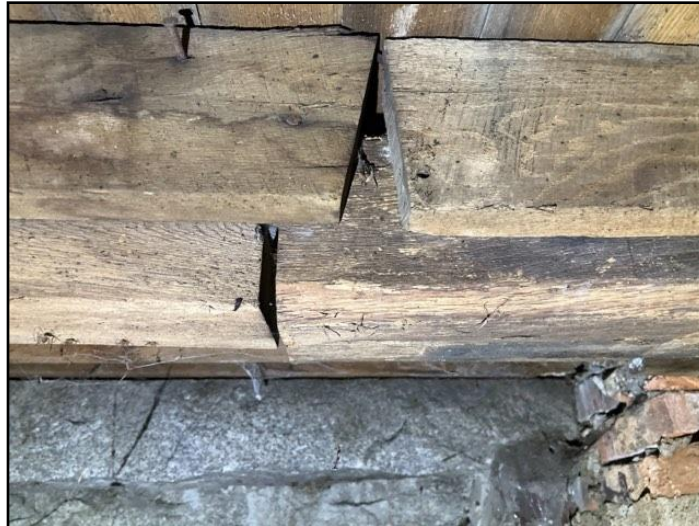
138. Missing Support Columns

49. Condition: • [Missing](#)

**Task:** Repair

**Time:** Immediate

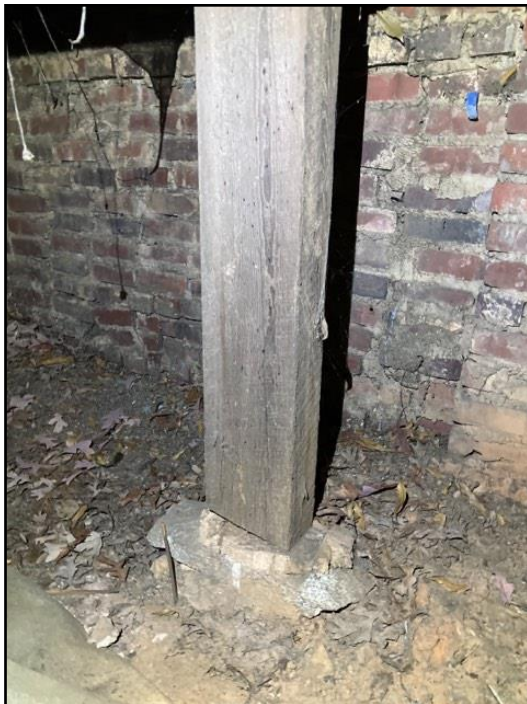
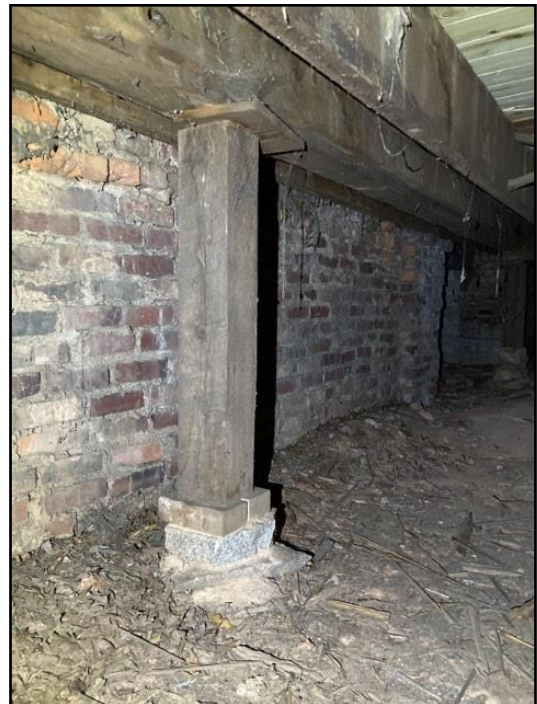
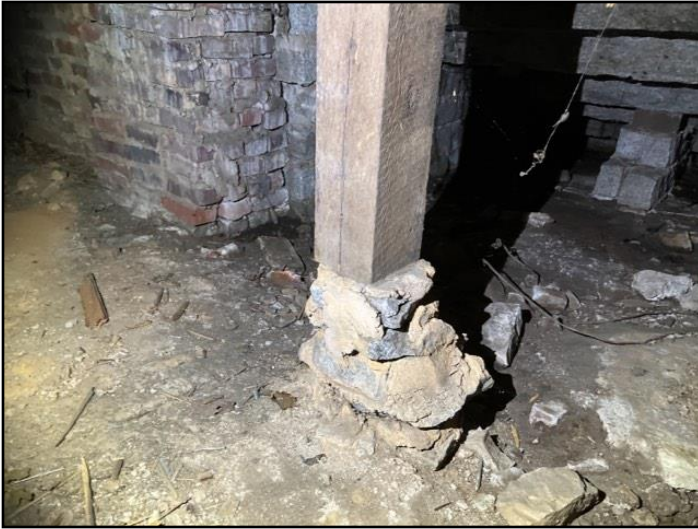
**50. Condition:** • Poorly secured footing

139. Poorly secured footing

**Task:** Repair

**Time:** Immediate

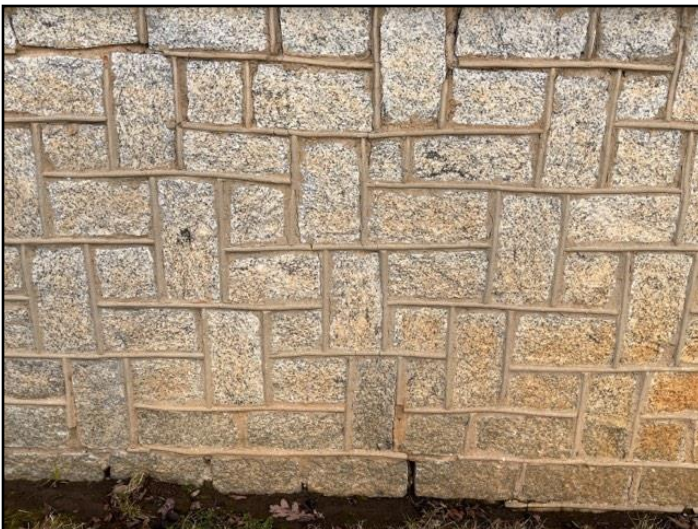
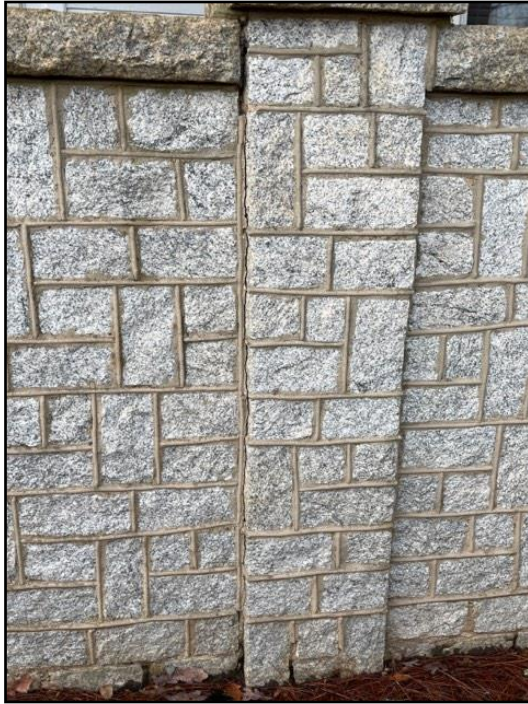
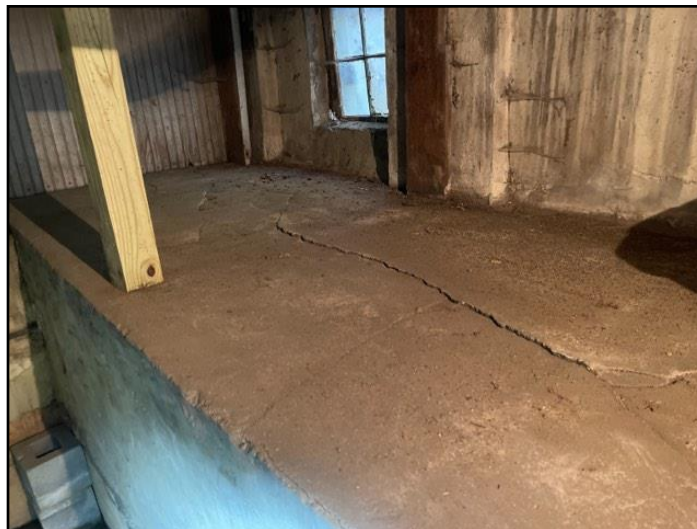
**51. Condition:** • Typical minor cracks

143. Typical minor cracks

**Task:** Monitor

**Time:** Ongoing

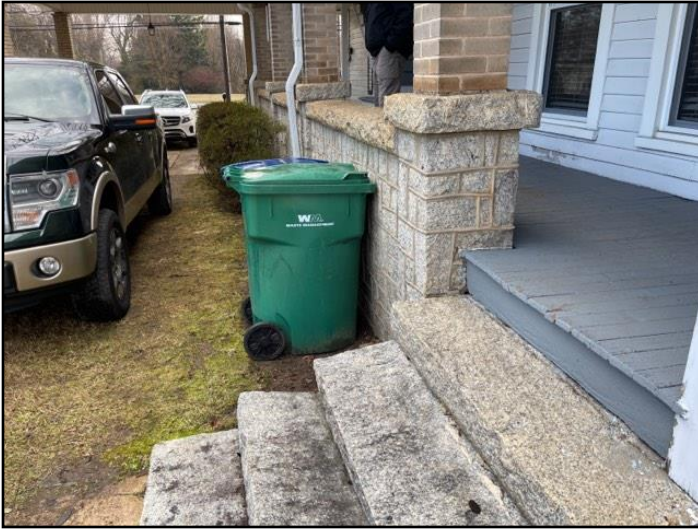
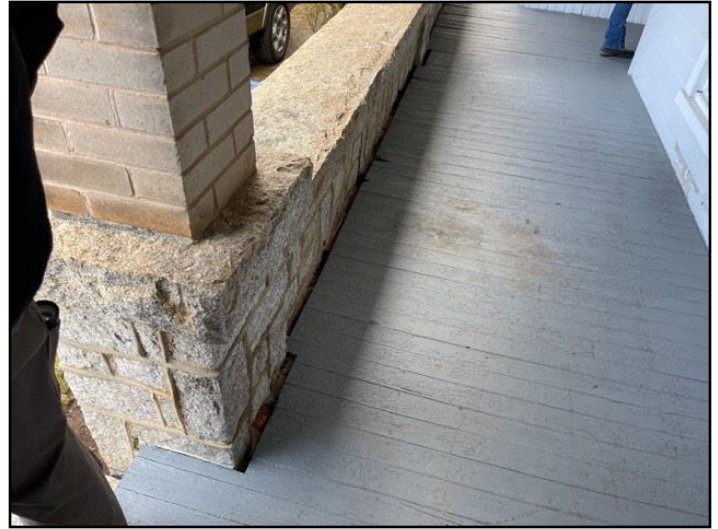
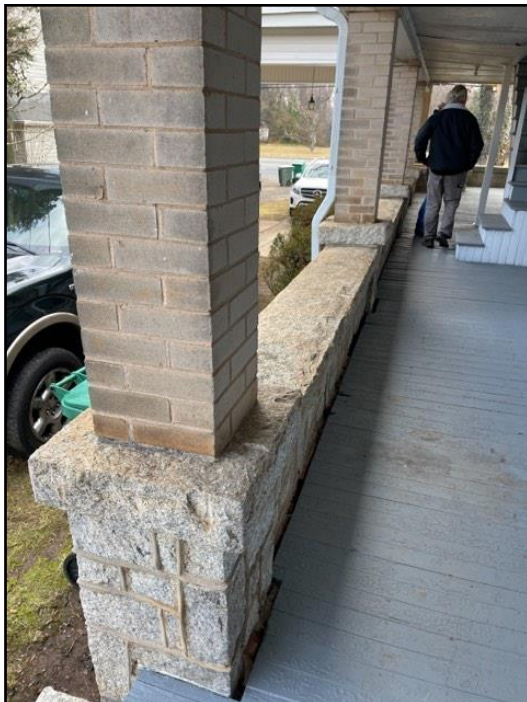
**52. Condition:** • [Bowed, bulging or leaning](#)

**Location:** Right Foundation

148. Bowed, bulging or leaning

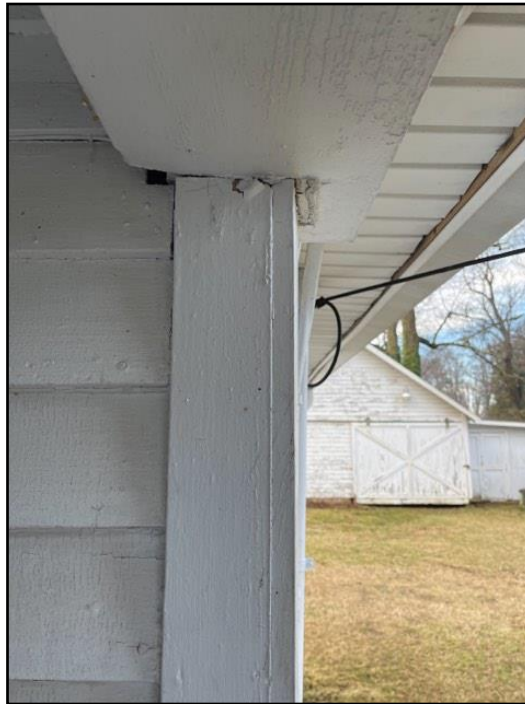
**152.** *Movement caused by foundation movement*

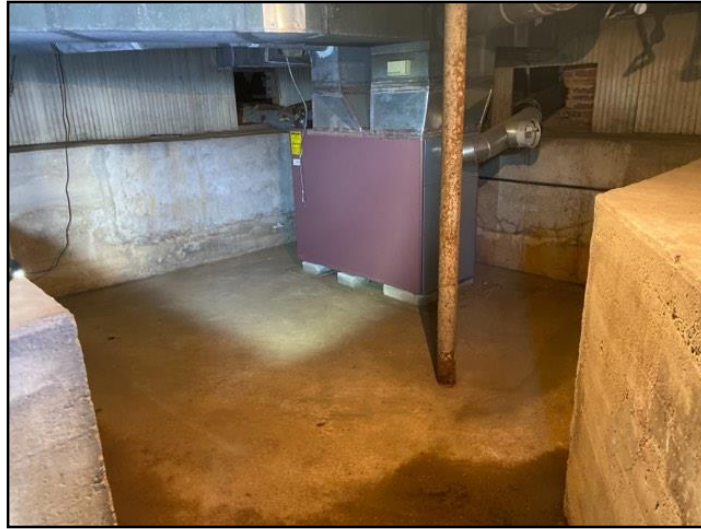
153. Basement lowered

**53. Condition:** • Basement lowered

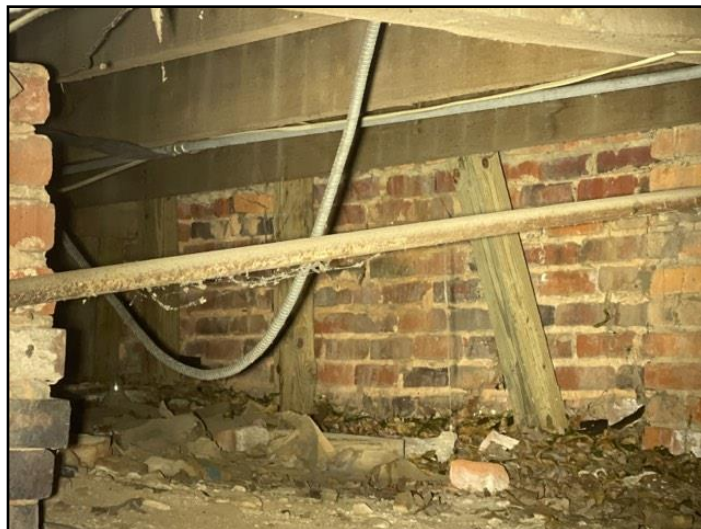
154. Prior repairs

54. Condition: • [Prior repairs](#)

Task: Further Evaluation

Time: Immediate

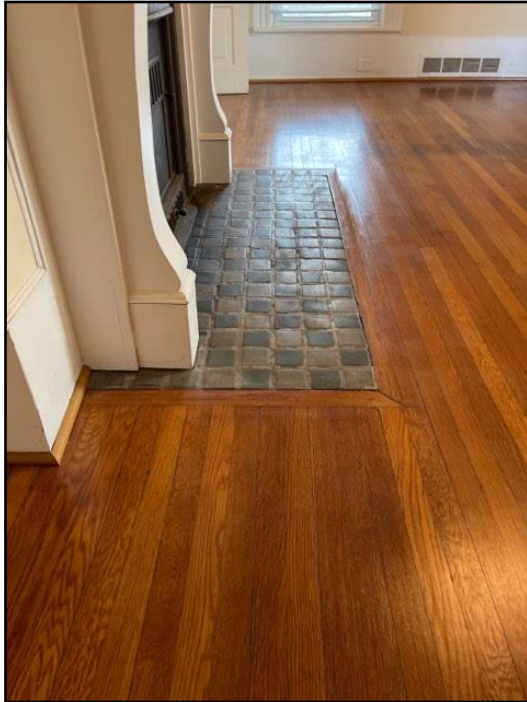
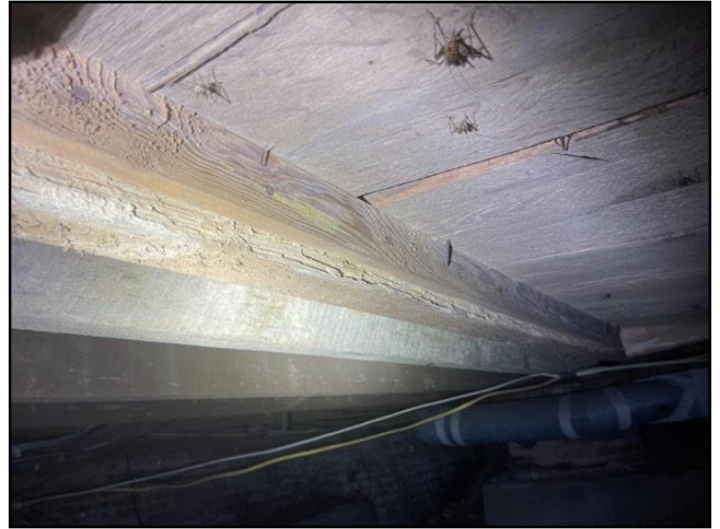
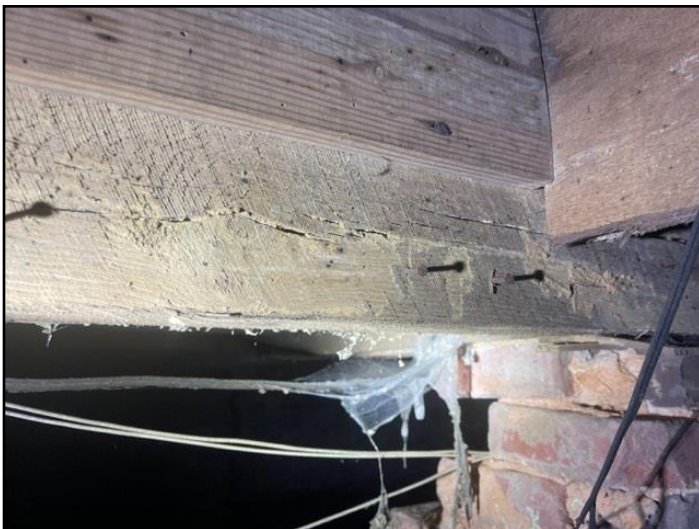
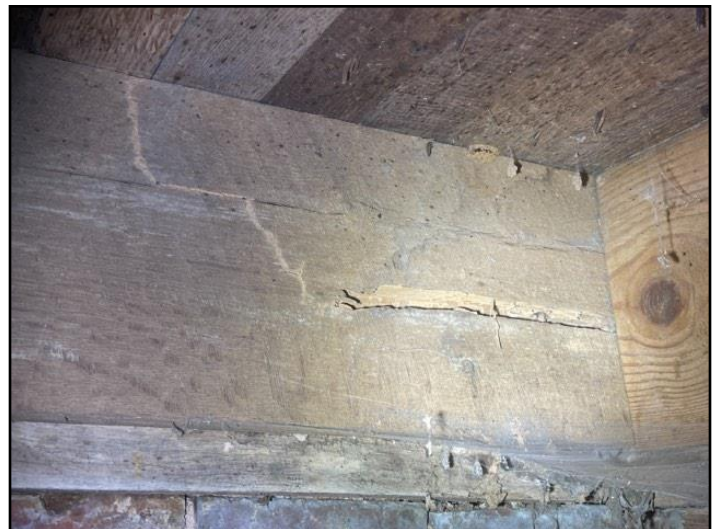
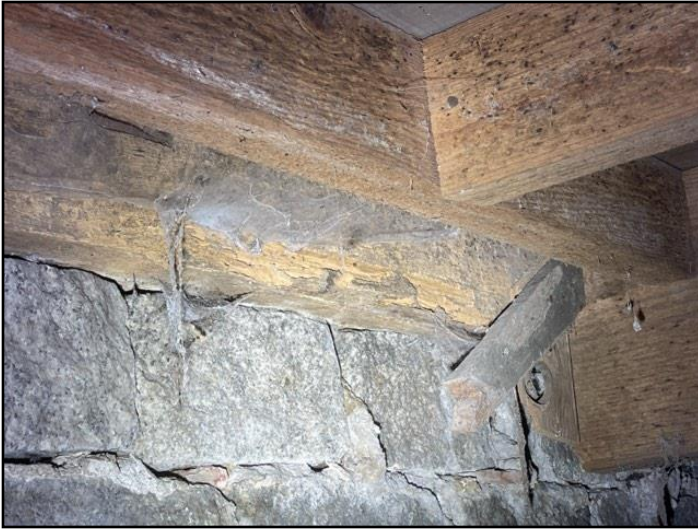
55. Condition: • Evidence of wood destroying insects.

**155.** Evidence of wood destroying insects.

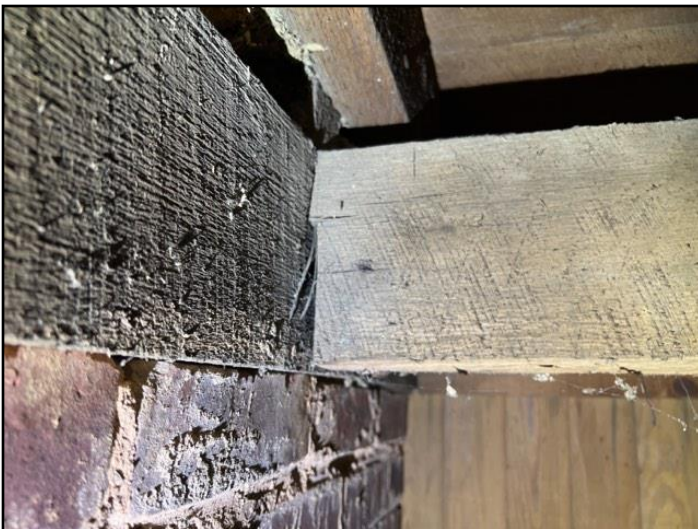
161. Poor bearing, crushed or loose shims

56. Condition: • [Poor bearing, crushed or loose shims](#)

Task: Repair

Time: Immediate

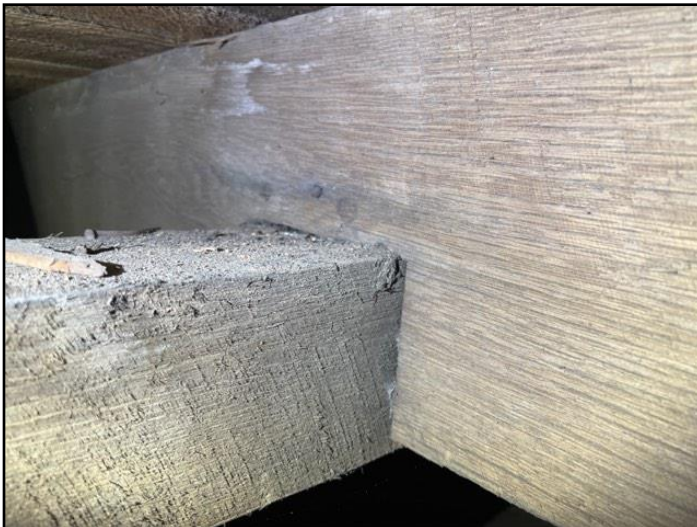
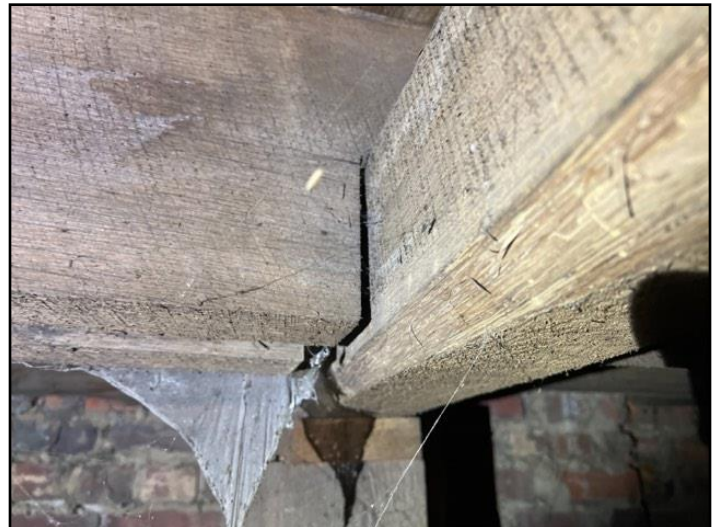
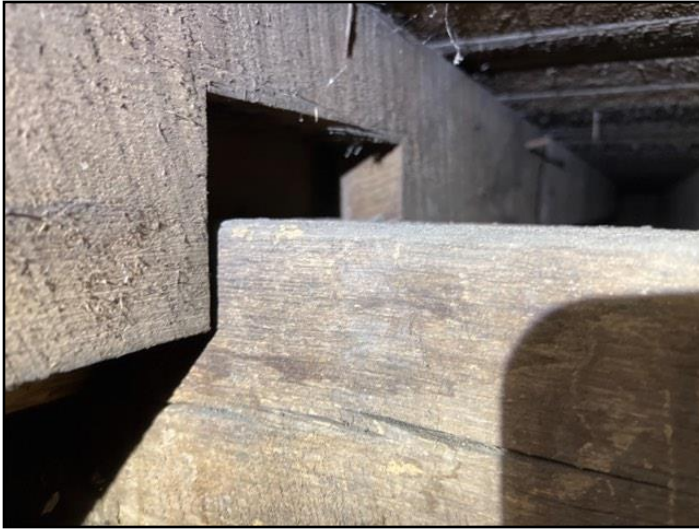
57. Condition: • [Notches or holes](#)

163. Notches or holes

Task: Repair

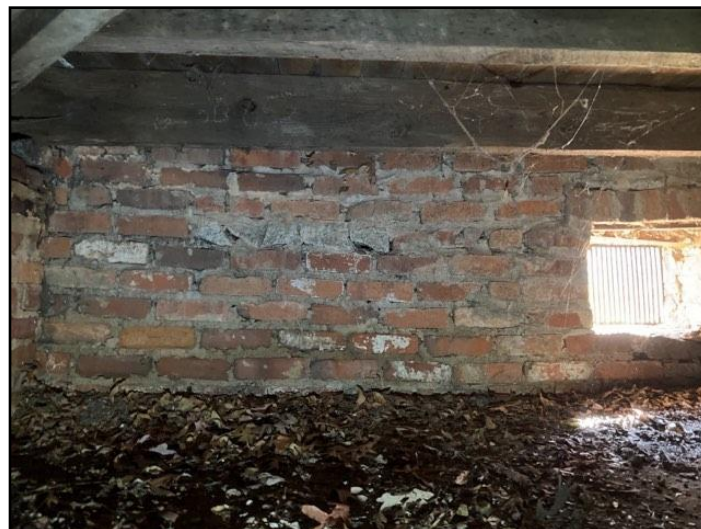
167. Sag

### 59. Condition: • [Sag or springy](#)

**Implication(s):** Chance of structural movement | Bouncy, springy floors

**Task:** Repair

**Time:** Immediate

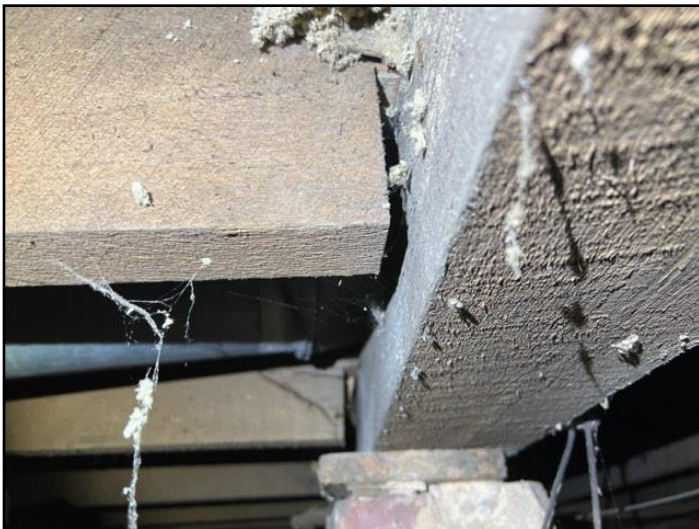
168. Poor end bearing, joist hanger connections

## 60. Condition: • [Poor end bearing, joist hanger connections](#)

**Task:** Repair

**Time:** Immediate

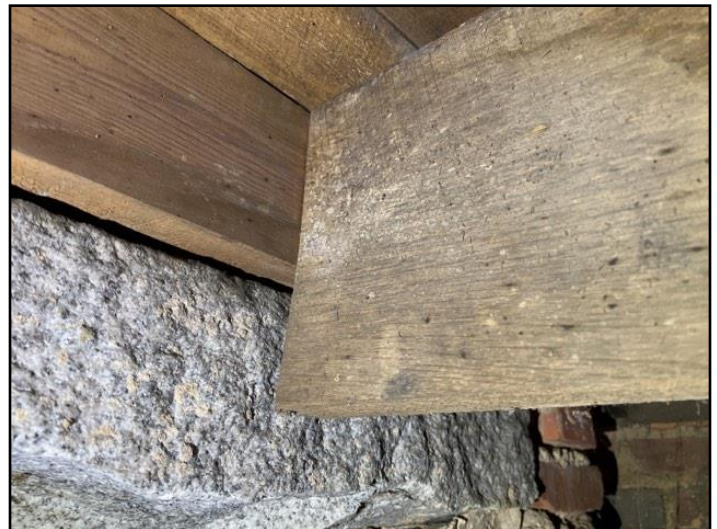
169. Poor end bearing, joist hanger connections
