# YOUR Inspection Report

175 Some Street  
Any Town, NC

Tuesday, February 8, 2022

RE: Report No. 6580  
175 Some Street  
Any Town, NC

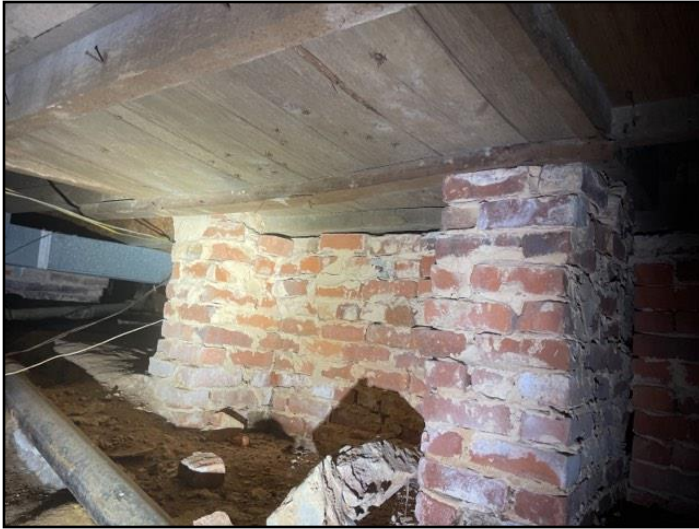
170. Poor end bearing, joist hanger connections

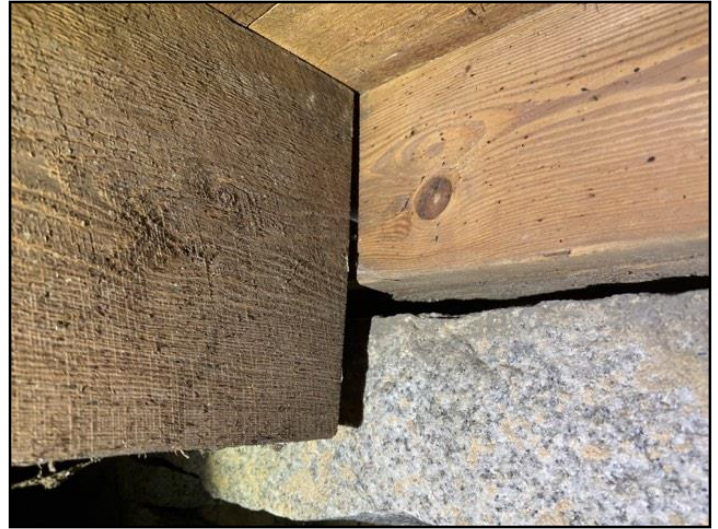
171. Poor end bearing, joist hanger connections

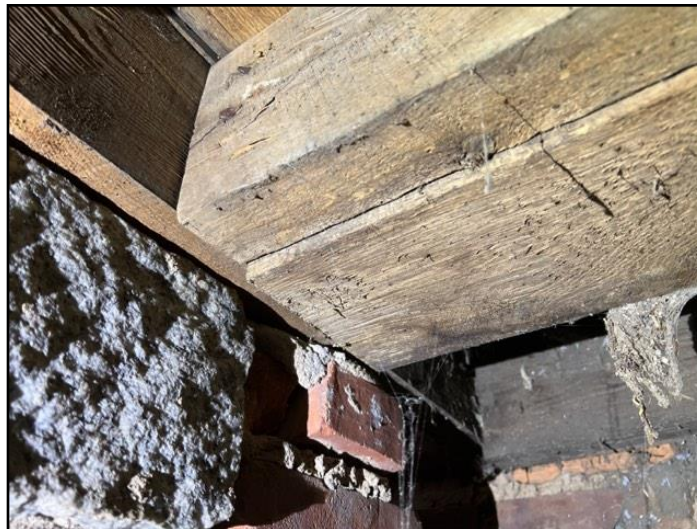
172. Poor end bearing, joist hanger connections

**Task:** Repair

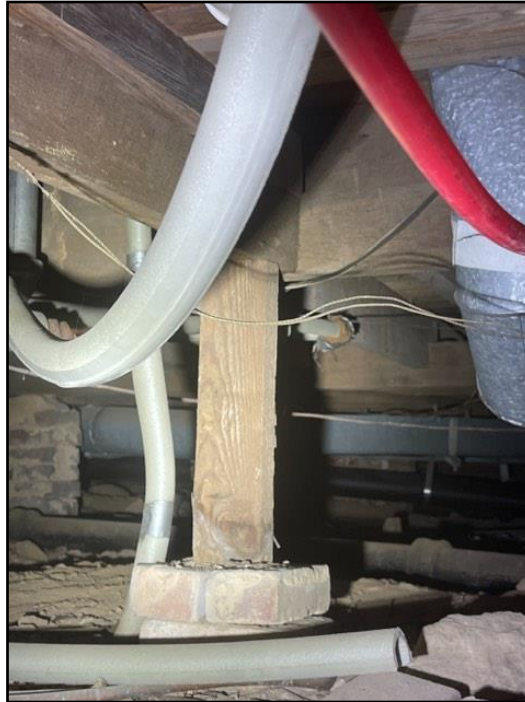
61. Condition: • [Prior repairs](#)

173. Prior repairs

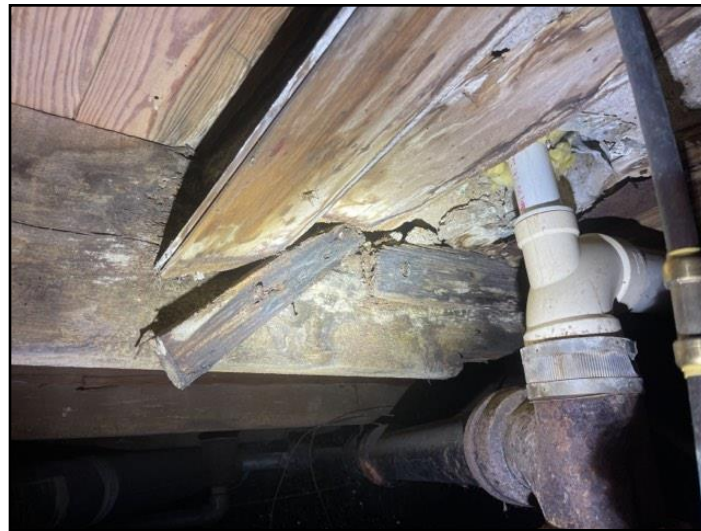
**62. Condition:** • [Rot](#)

174. Rot

**Task:** Repair

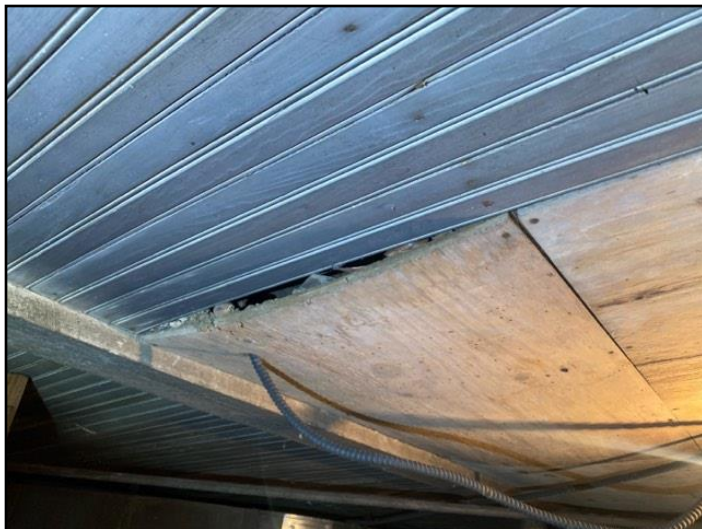
**63. Condition:** • Sagging

175. Sagging

**Task:** Repair

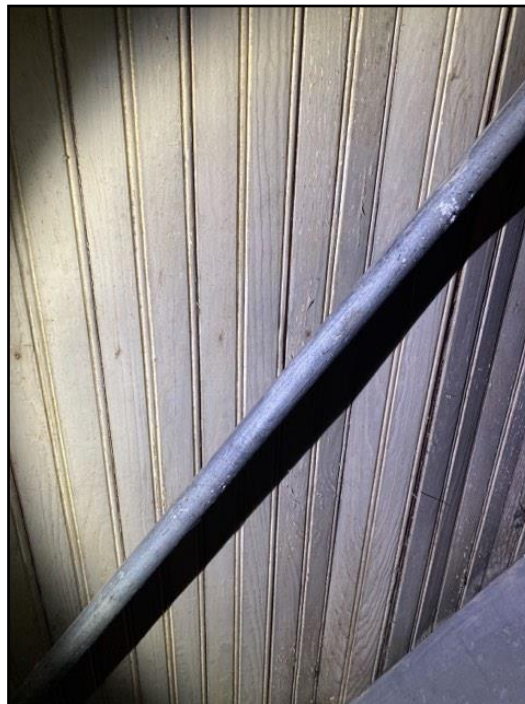
176. Sagging

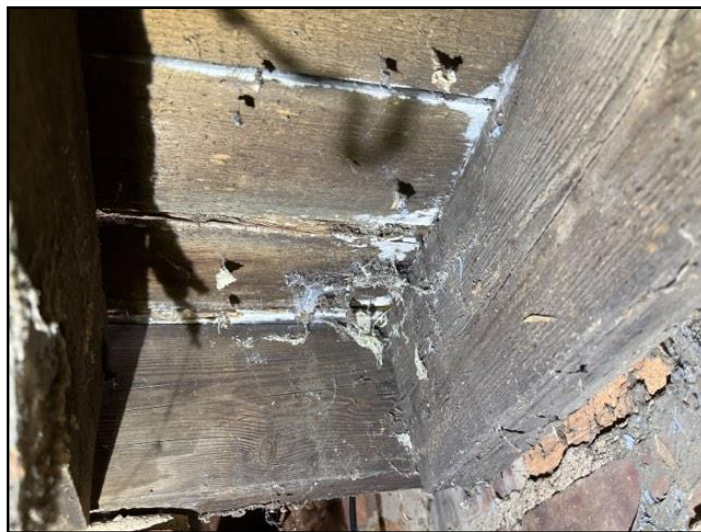
64. Condition: • Rot

177. Rot

Task: Further Evaluation

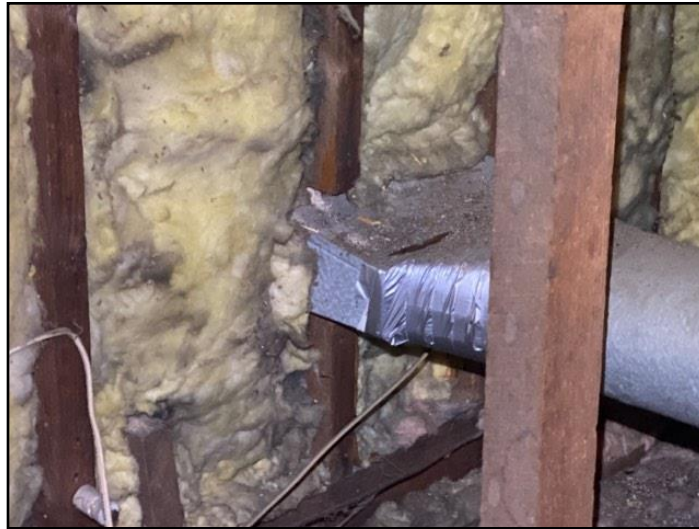
65. Condition: • [Notches or holes](#)

178. Notches or holes

**Task:** Repair

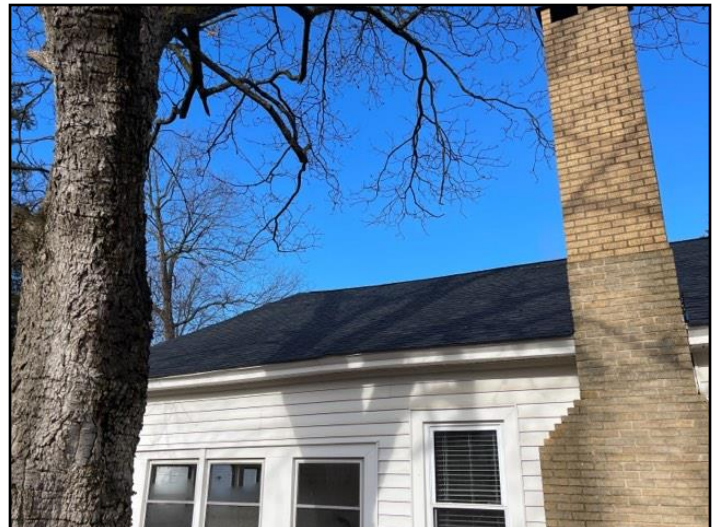
181. Sagging Rafters

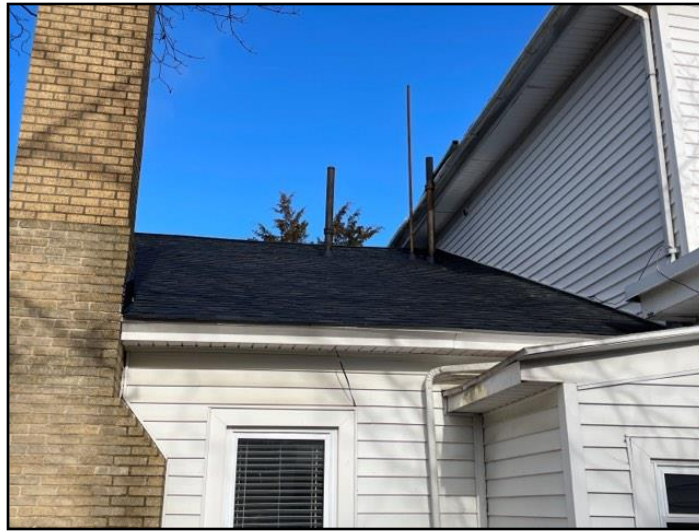
182. Sagging Rafters

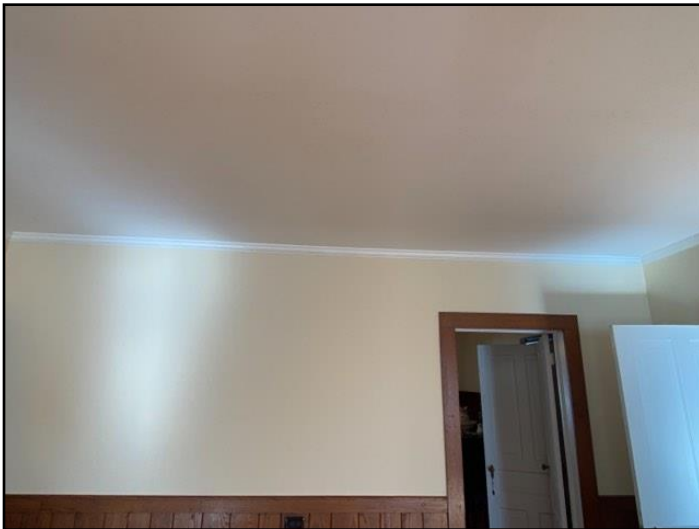
68. Condition: • Sag

183. Sag

Task: Further Evaluation

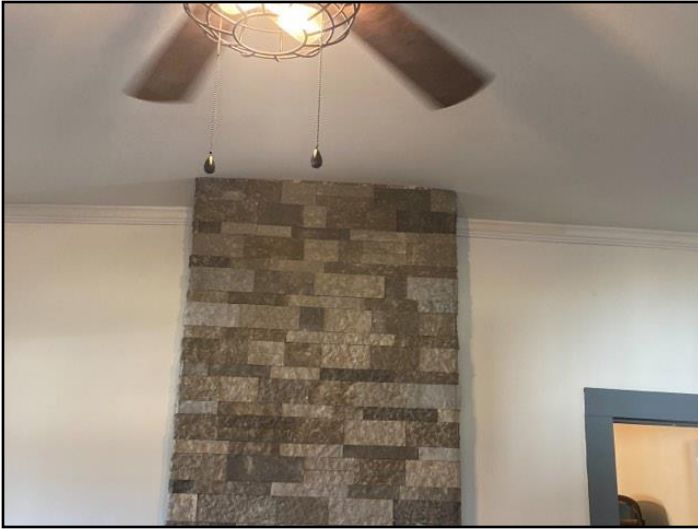
69. Condition: • Sag

185. Sag

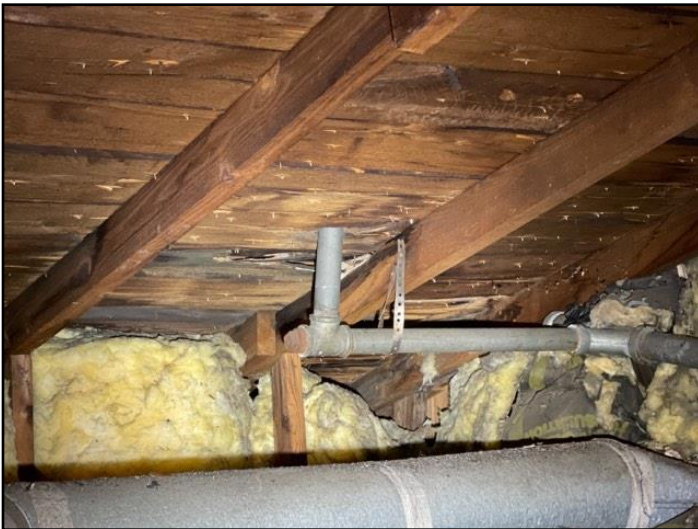
**70. Condition:** • Water stains

**Implication(s):** Material deterioration, chance of water damage to structure, finishes and contents, This issue is commensurate with moisture issues and mold growth. A more detailed inspection, specifically addressing these concerns and mold testing, is advised.

187. Water stains

**Task:** Further Evaluation

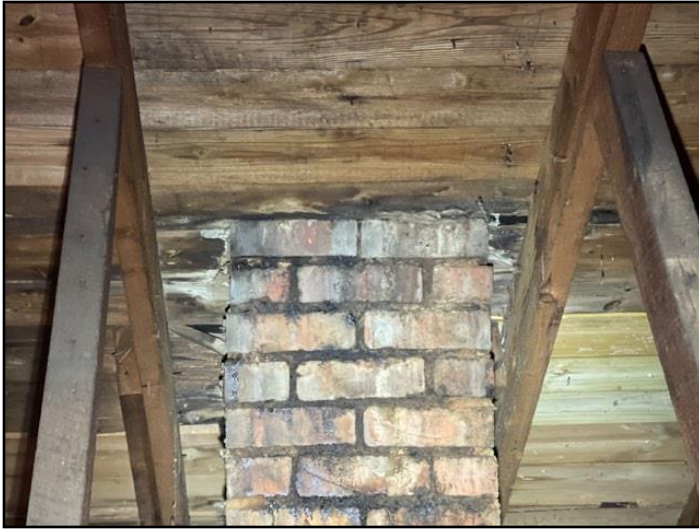
189. Water stains

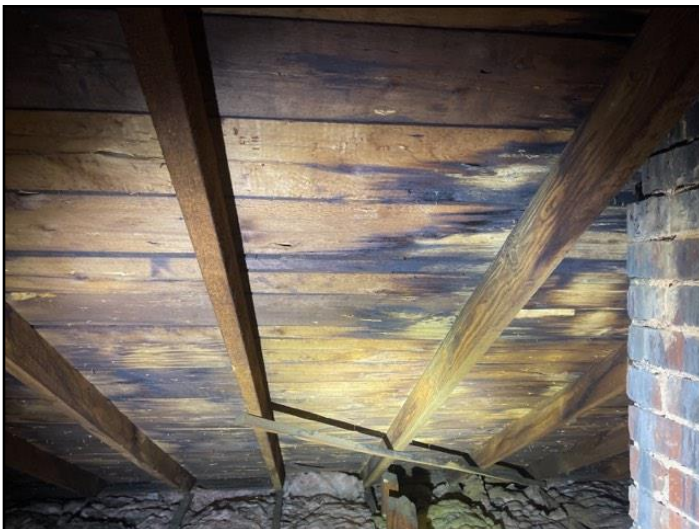
191. Water stains

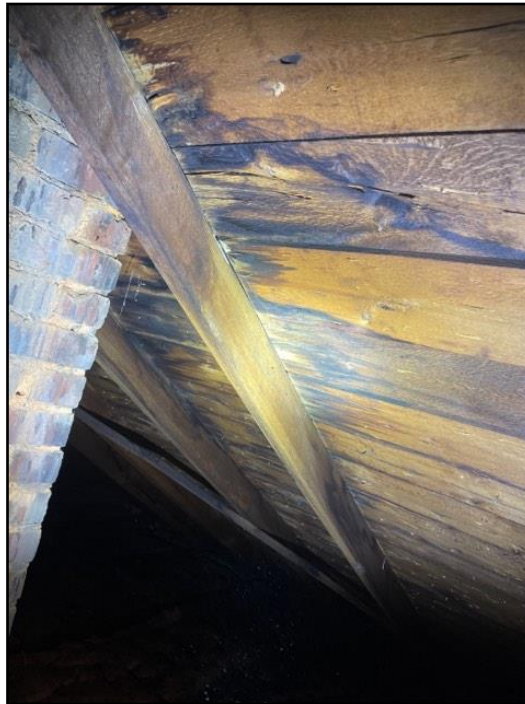
193. Water stains

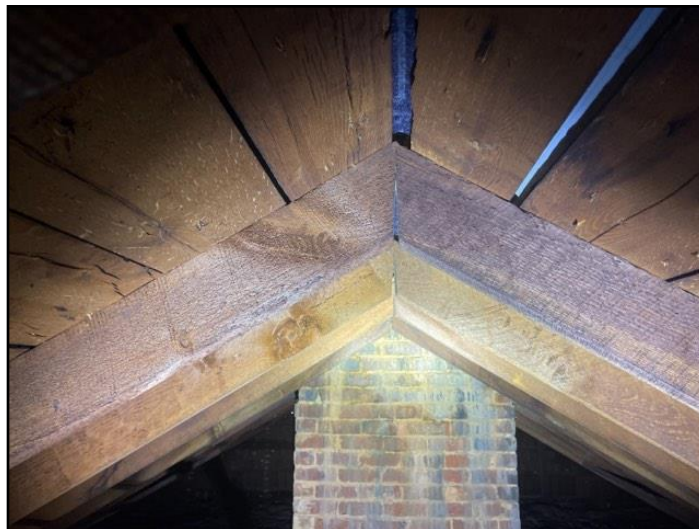
**71. Condition:** • Missing

Missing Ridge Beam

194. Missing Ridge Beam

**Task:** Repair

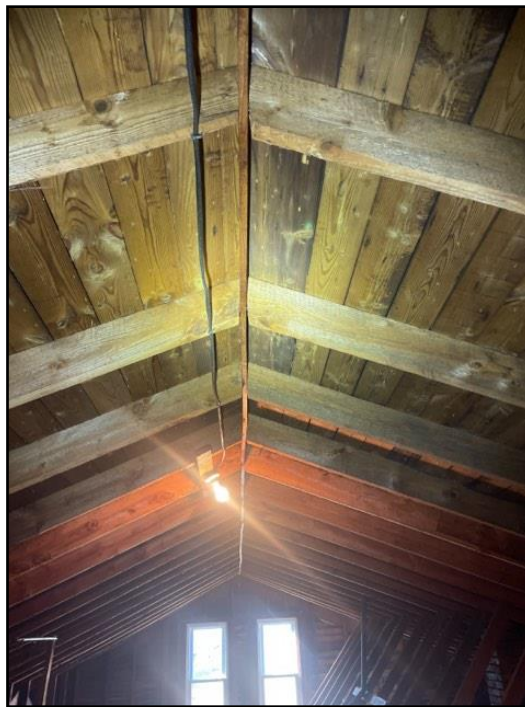
**72. Condition:** • Undersized Ridge Beam - Properly sized ridge beams should be a one size larger member than the rafters bearing on it, depending on roof pitch, or wider than the rafter angle cut bearing on it.

195. Undersized Ridge Beam - Properly sized ridg...

**Task:** Repair

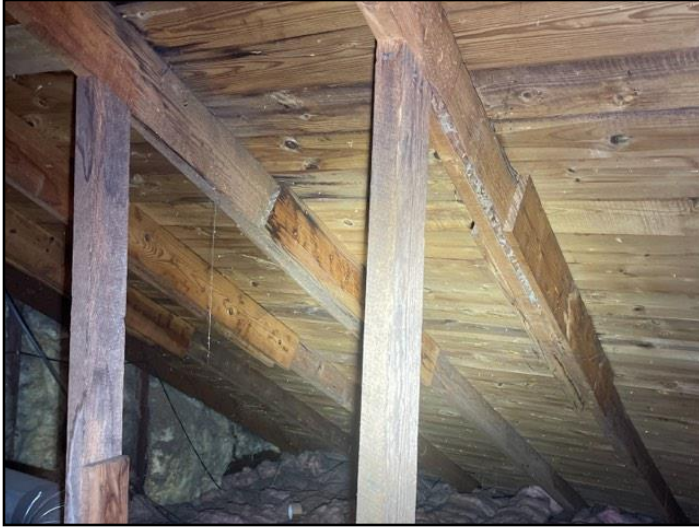
196.

73. Condition: • Spliced Rafters

**Task:** Further Evaluation

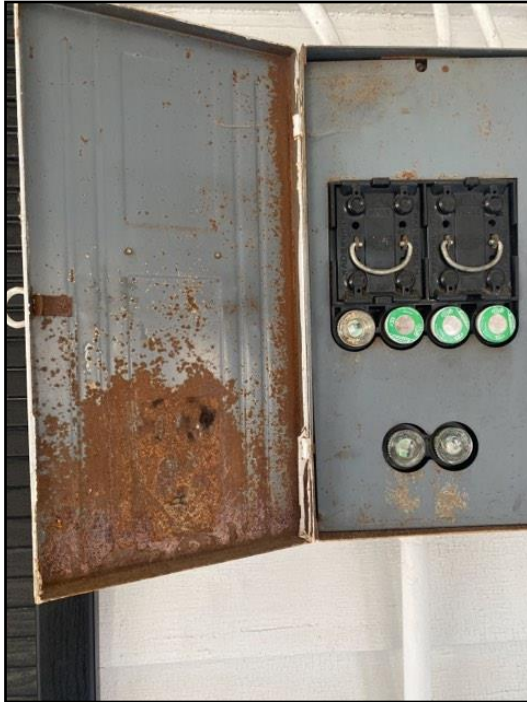
**76. Condition:** • Rust

**Implication(s):** Water Damage

206. Rust

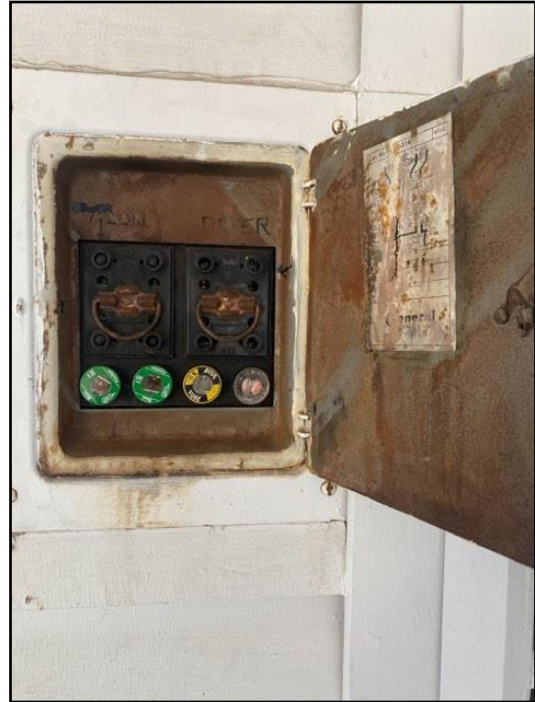
207. Rust

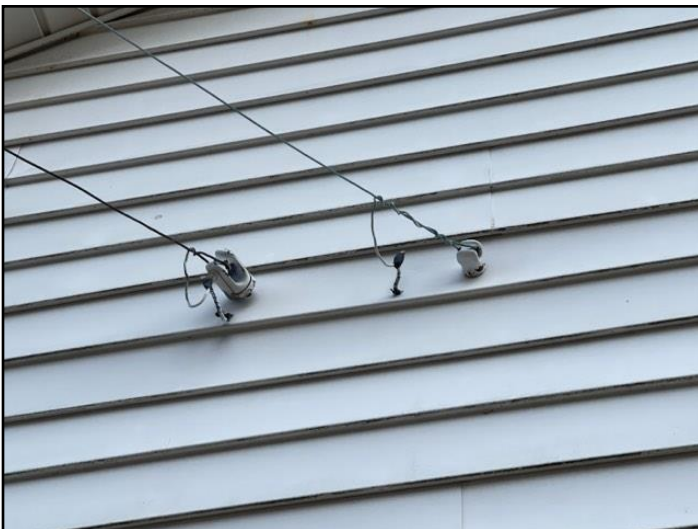
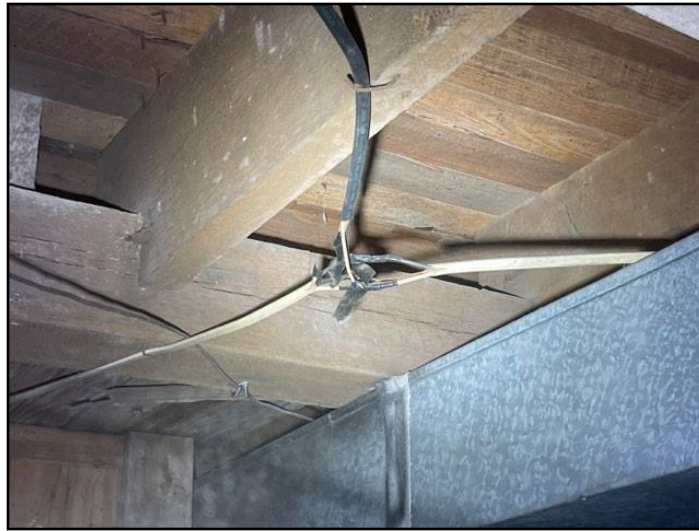
**79. Condition:** • [Open splices](#)

**Implication(s):** Electric shock | Fire hazard

**209.** Open splices

**210.** Open splices

211. Open splices

**Task:** Repair

**Time:** Immediate

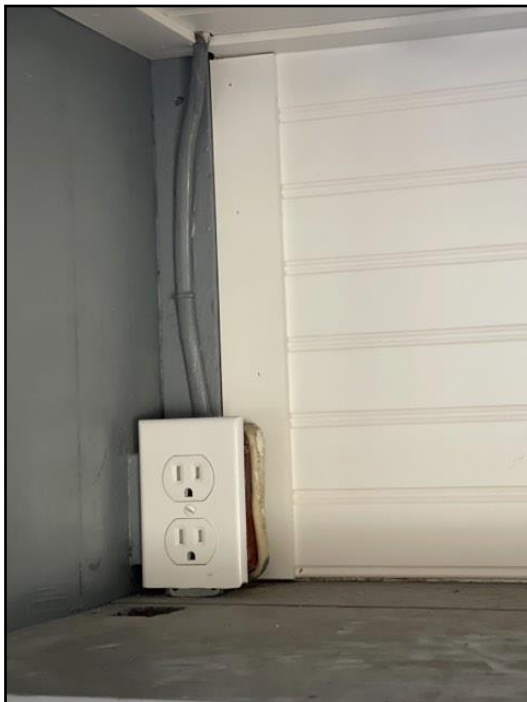
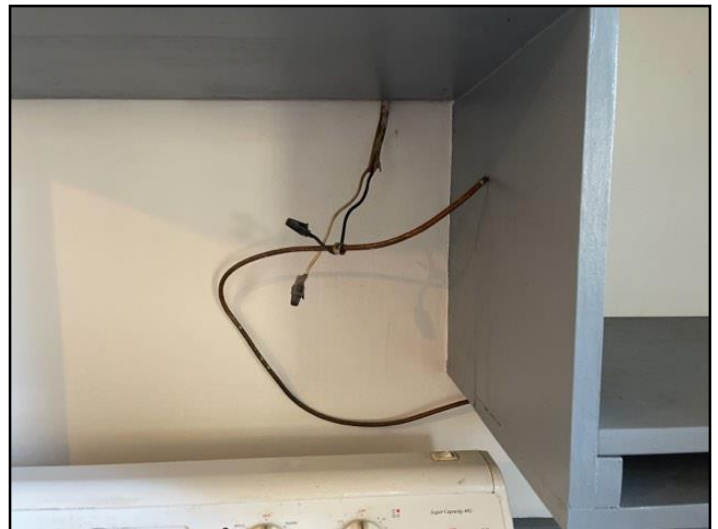
**80. Condition:** • Exposed Electrical Wiring

212. Exposed Electrical Wiring

213. Exposed Electrical Wiring

214. Exposed Electrical Wiring

**Task:** Repair

**Time:** Immediate

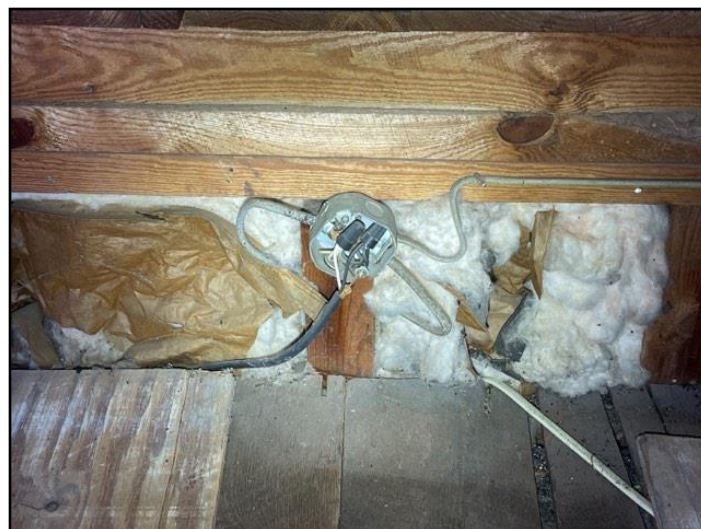
81. Condition: • [Cover loose or missing](#)

Implication(s): Electric shock | Fire hazard

215. Cover missing

Task: Repair

Time: Immediate

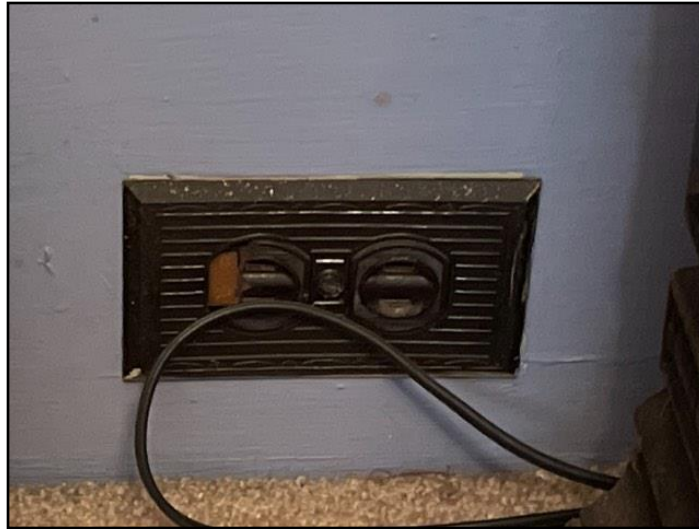
**82. Condition:** • [Damage](#)

**Implication(s):** Electric shock | Fire hazard

**216.** *Damaged Outlet*

**Task:** Repair

**Time:** Immediate

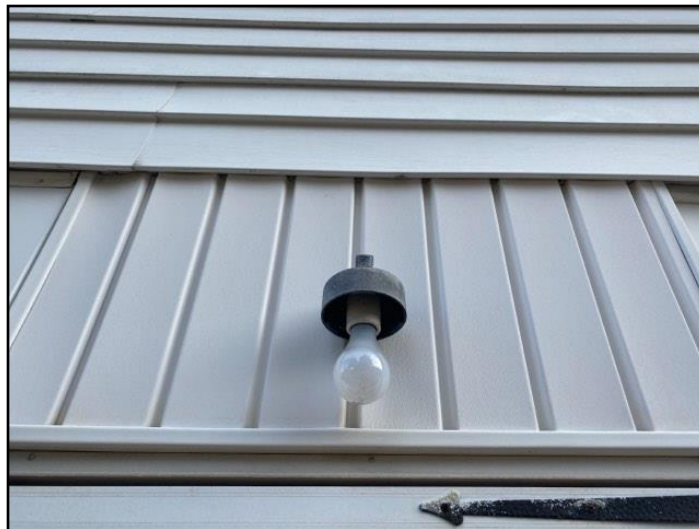
**88. Condition:** • Light fixture globe is missing.

**217.** *Light fixture globe is missing.*

**Task:** Repair

**Time:** Immediate

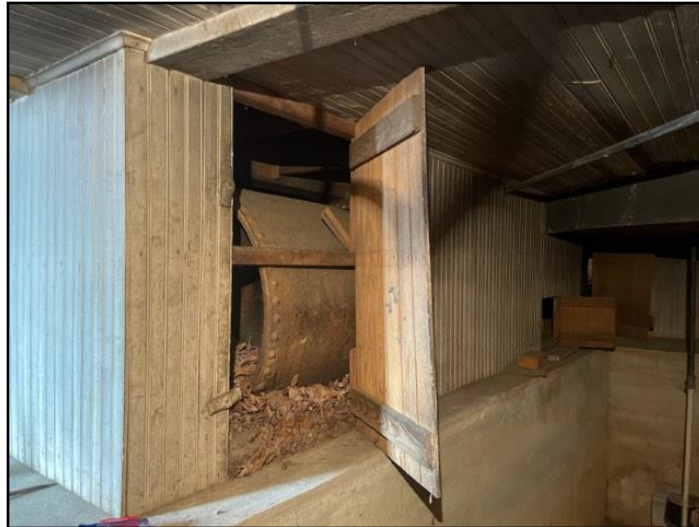
Abandoned Tank? - not verified

220. Abandoned Tank?

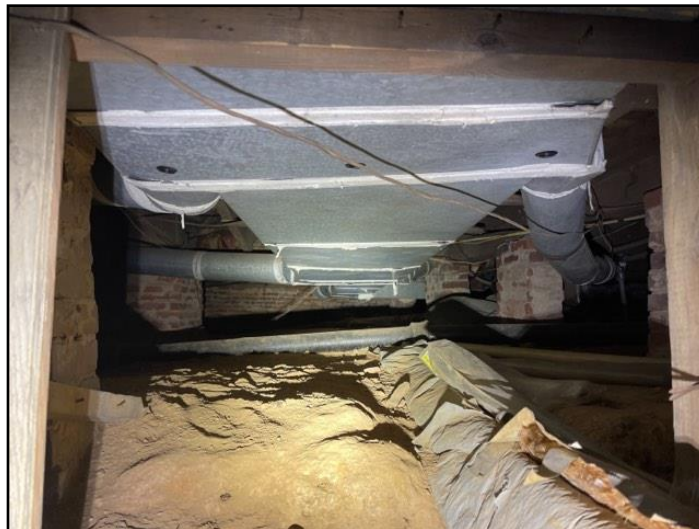
**93. Condition:** • Exposed joint tape on the furnace distribution duct may contain asbestos. The Environmental Protection Agency (E.P.A.) reports that asbestos represents a health hazard if friable (damaged, crumbling, or in any state that allows the release of fibers). If replacement of the duct necessitates the removal of the asbestos containing tape, an asbestos removal specialist should be engaged. If any sections of this tape are indeed friable, or become friable over time, a specialist should also be engaged. Further guidance is available from the Environmental Protection Agency (E.P.A.). Considering the age of this home there may be other materials within the home that contain asbestos but are not identified by this inspection report.

**230.** *Exposed joint tape on the furnace...*

**Task:** Repair

**Time:** Immediate

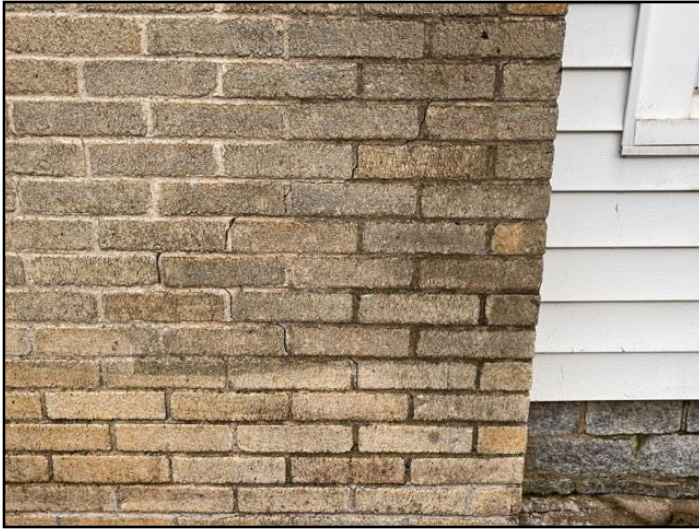
**96. Condition:** • Cracked

**Implication(s):** Chance of water damage to contents, finishes and/or structure | Fire hazard

231. Cracked

232. Cracked

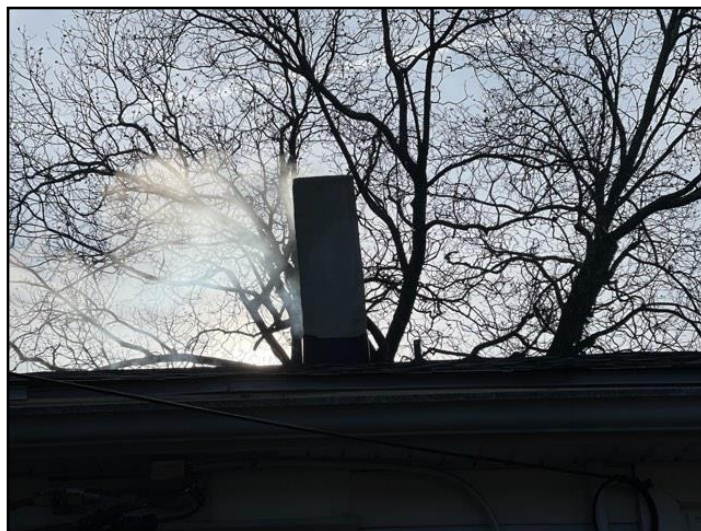
**97. Condition:** • [Settling or leaning](#)

**Implication(s):** Chance of water damage to structure, finishes and contents | Chance of chimney movement | Hazardous combustion products entering home

233. Settling or leaning

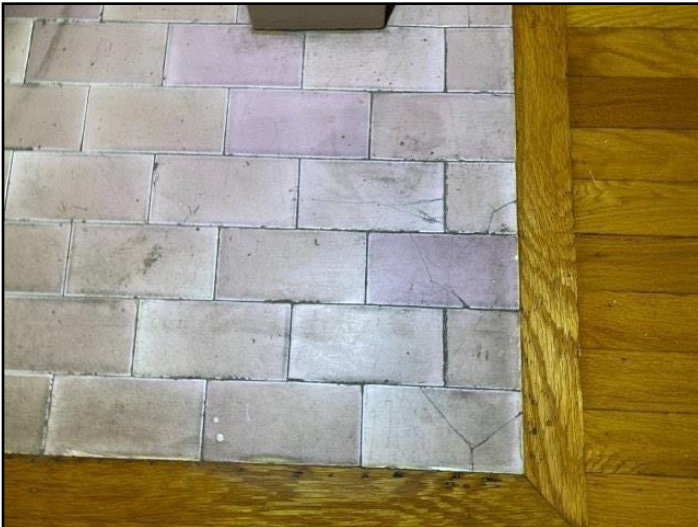
**99. Condition:** • [Gaps or cracks](#)

**Implication(s):** Fire hazard

234. Gaps or cracks

**Task:** Repair

**Time:** Immediate

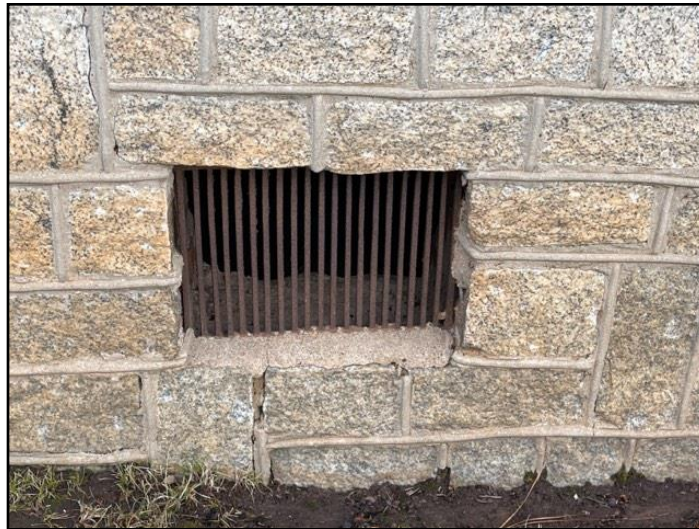
**236.** Damaged foundation vent screens....

**Time:** Immediate

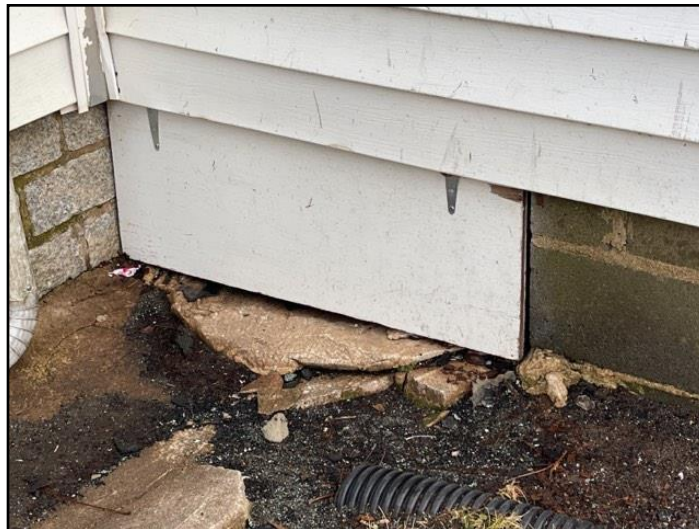
**237.** Does not fit tightly

**Task:** Repair

**Time:** Immediate

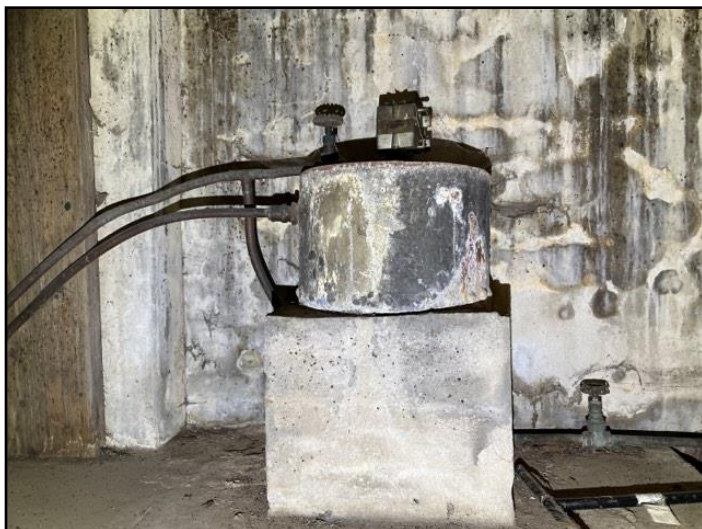
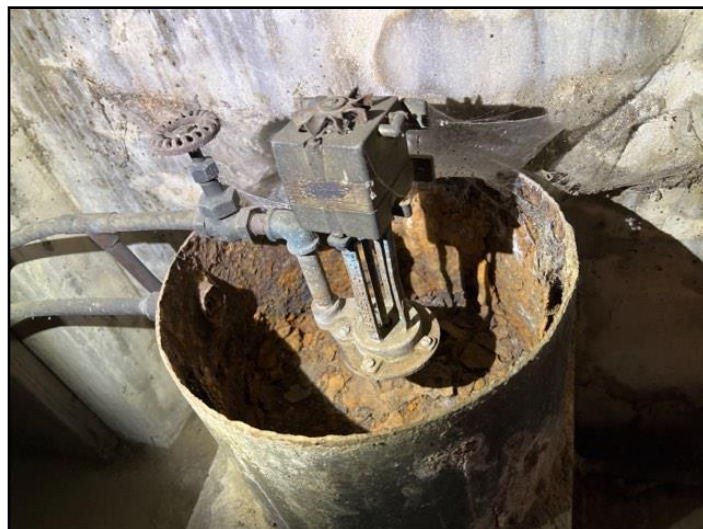
241. What is this?

242. What is this?

**Task:** Further Evaluation

**Time:** Discretionary

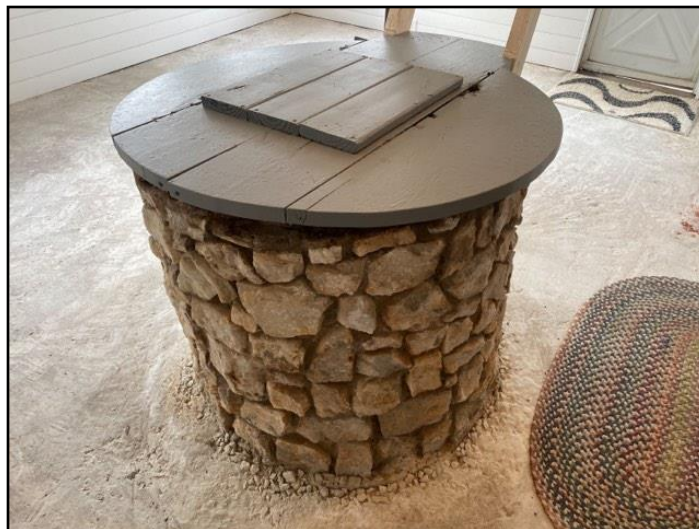
**243.** *Although water wells are not part of this...*

**Task:** Further Evaluation

**Time:** Immediate

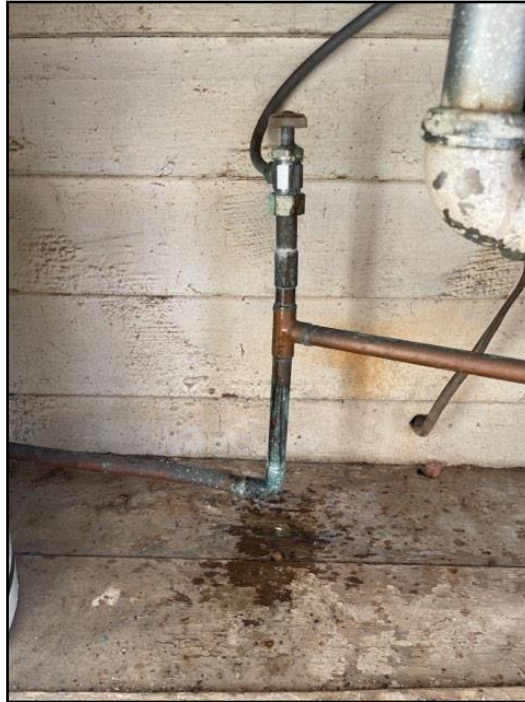
244. Leak

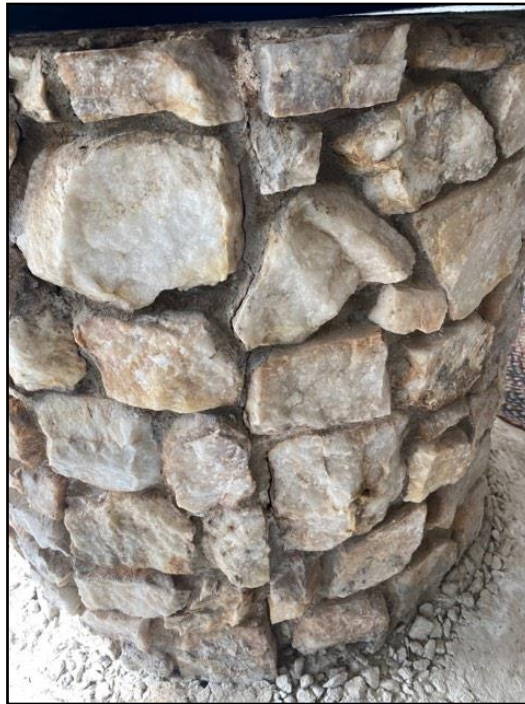
**108. Condition:** • Well cracked

245. Well cracked

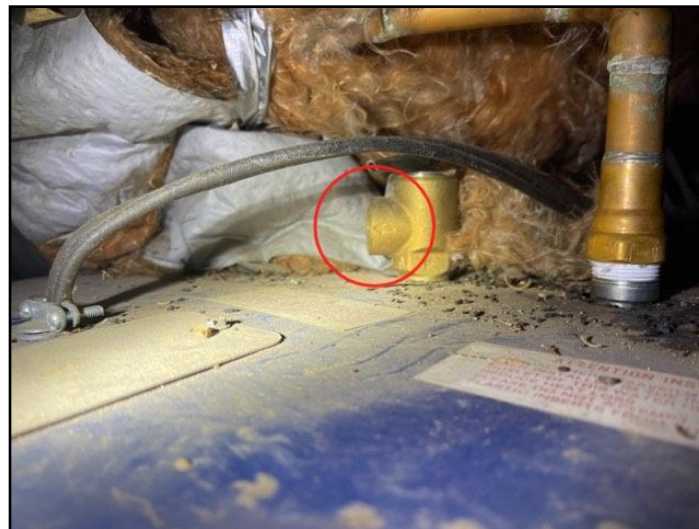
246. Discharge tube missing

Time: Immediate

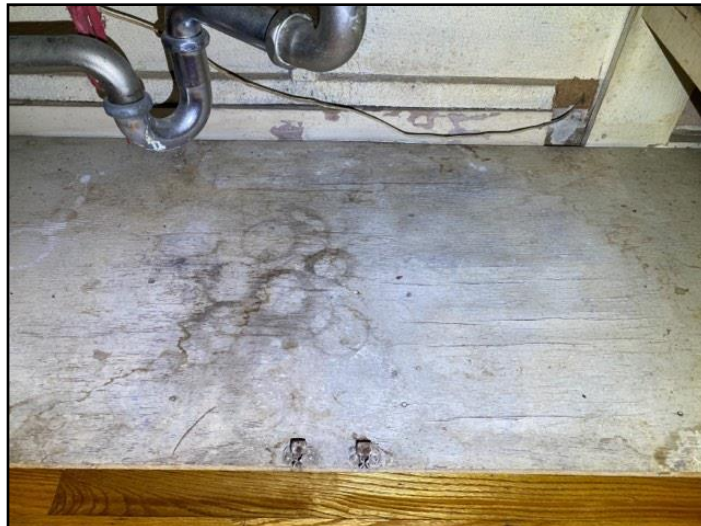
112. Condition: • Leak

**Implication(s):** Sewage entering the building. Chance of water damage to structure, finishes and contents. This issue is commensurate with moisture issues and mold growth. A more detailed inspection, specifically addressing these concerns and mold testing, is advised.

248. Leak

**Task:** Monitor

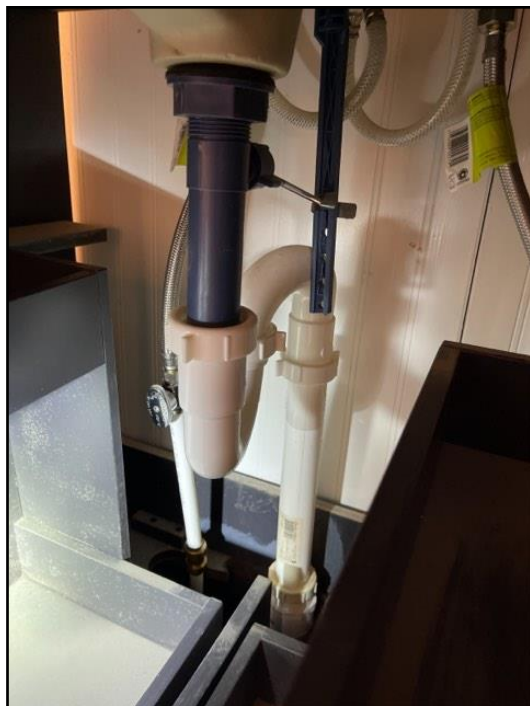
## S-traps can lead to siphoning

249. S Trap

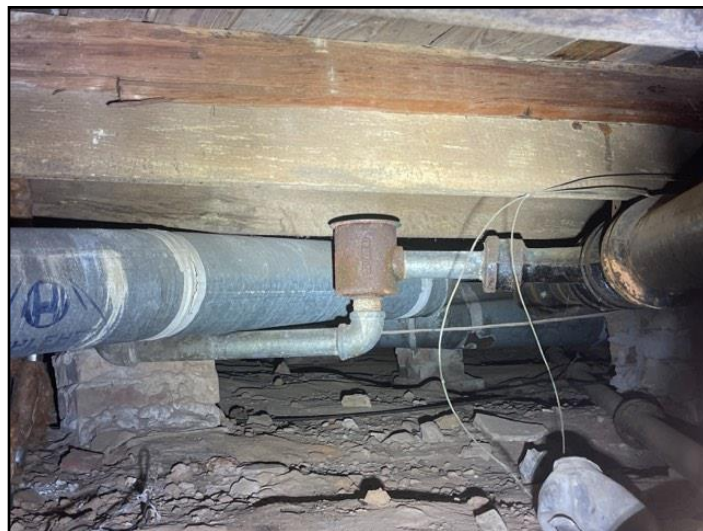
250. Drum Trap

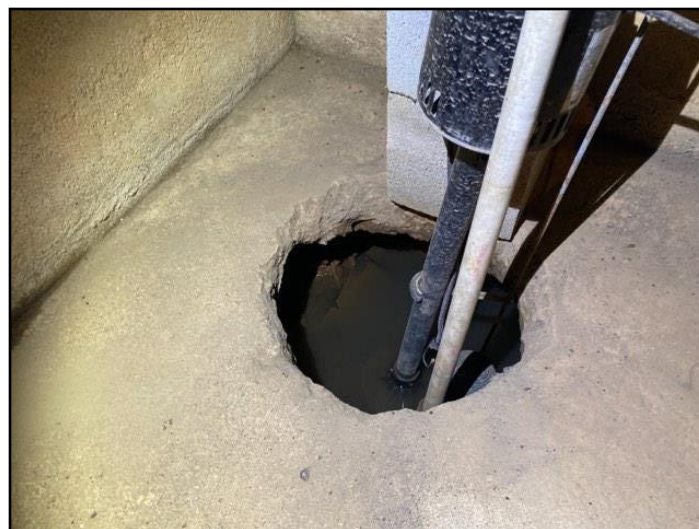
115. Condition: • [Lid missing, rotted or not secure](#)

**Implication(s):** Trip or fall hazard

251. Lid missing, rotted or not secure

**Task:** Repair

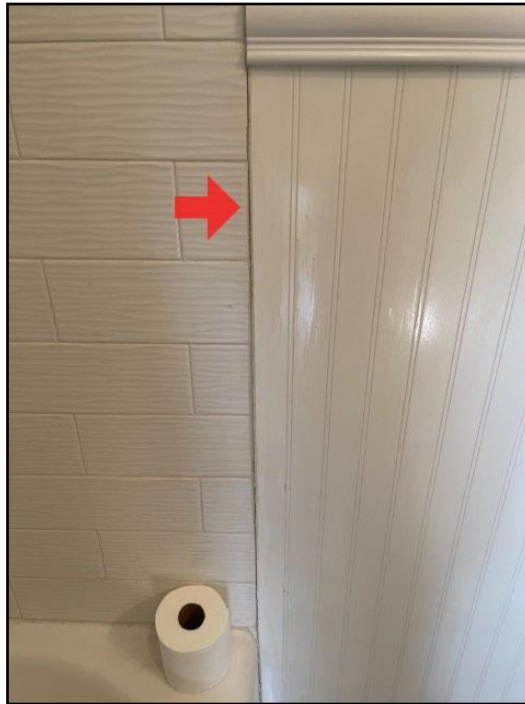
**119. Condition:** • [Caulking loose, missing or deteriorated](#)

**Implication(s):** Chance of water damage to structure, finishes and contents

252. Caulking loose, missing or deteriorated

**Task:** Repair

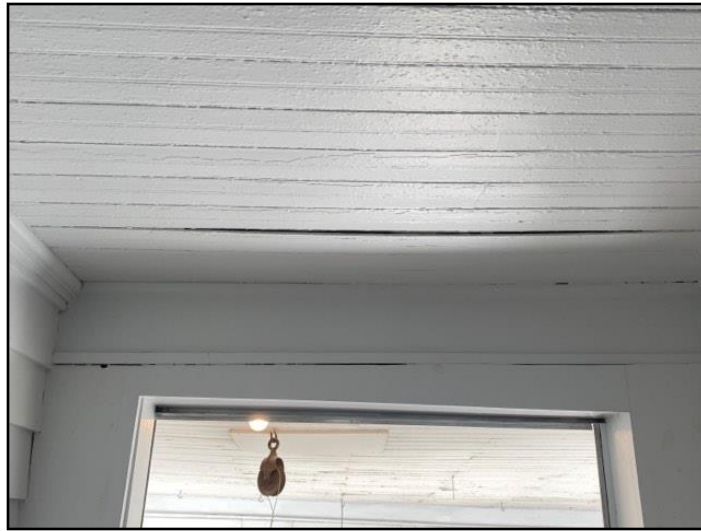
**122. Condition:** • [Loose](#)

**Implication(s):** Damage or physical injury due to falling materials

253. Loose

**Task:** Repair

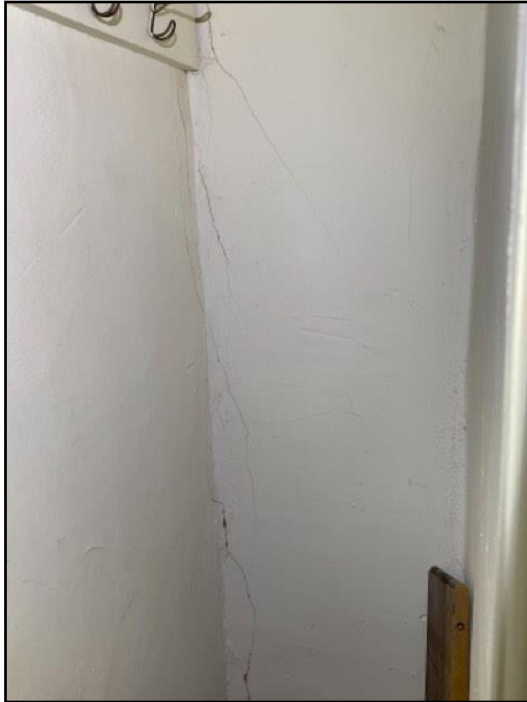
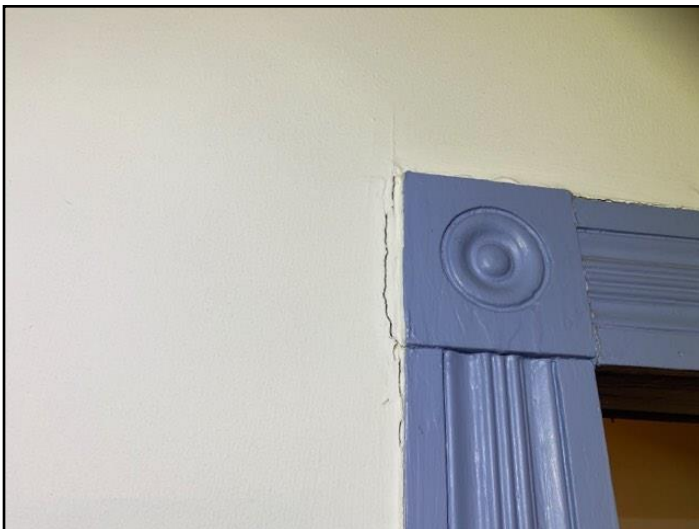
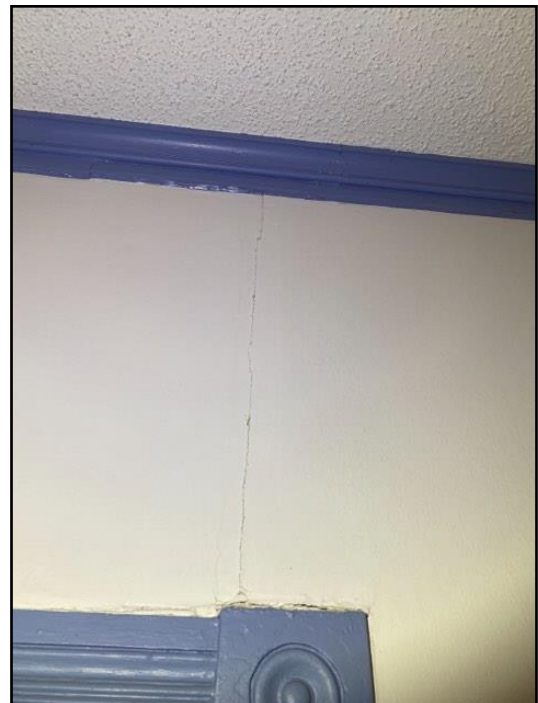
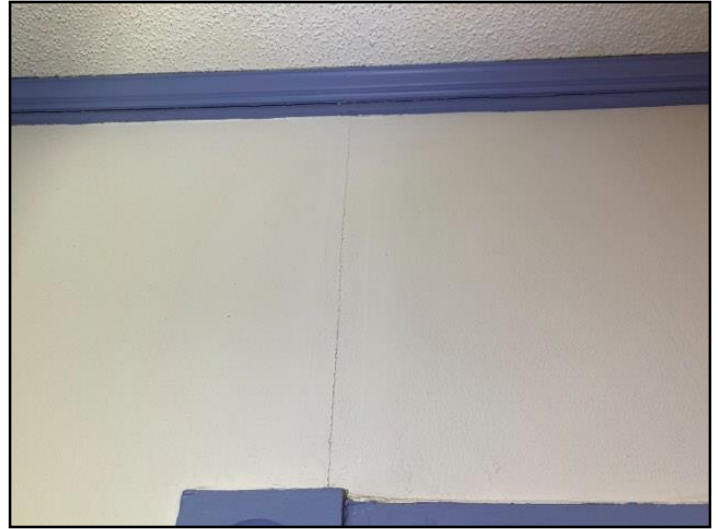
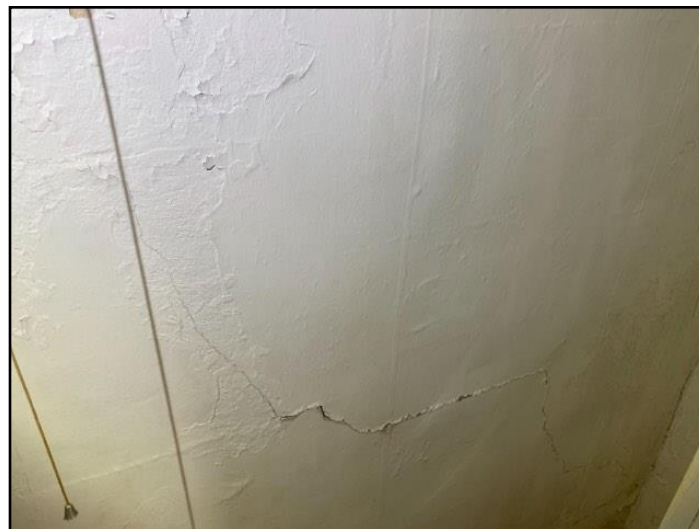
**125. Condition:** • Typical flaws

254. Typical flaws

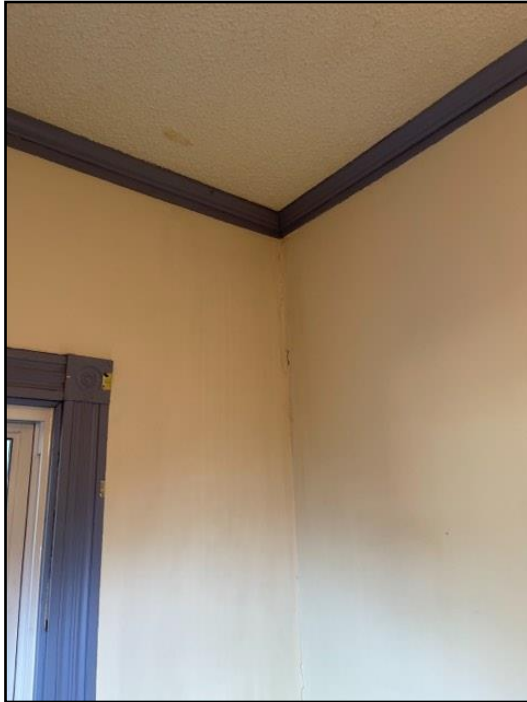
**126. Condition:** • Water stains

**Implication(s):** Chance of water damage to structure, finishes and contents, This issue is commensurate with moisture issues and mold growth. A more detailed inspection, specifically addressing these concern's and mold testing, is advised.

261. Water stains

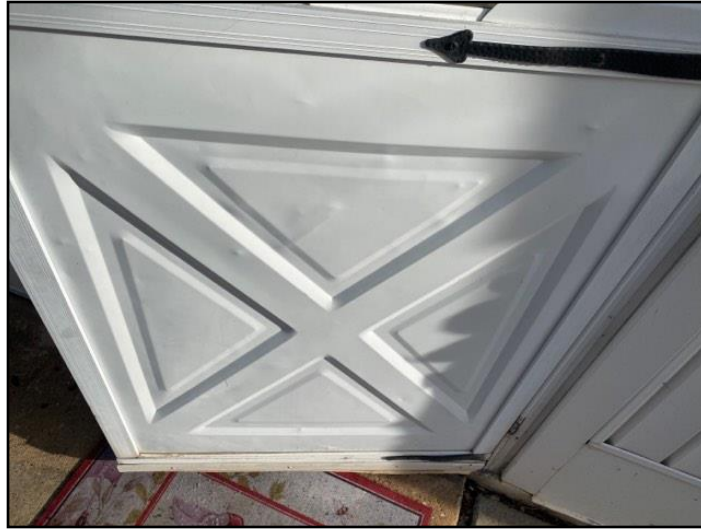
128. Condition: • [Damage](#)

Implication(s): Material deterioration | Increased heating and cooling costs | Reduced comfort

**263.** *Damaged Door*

Task: Repair

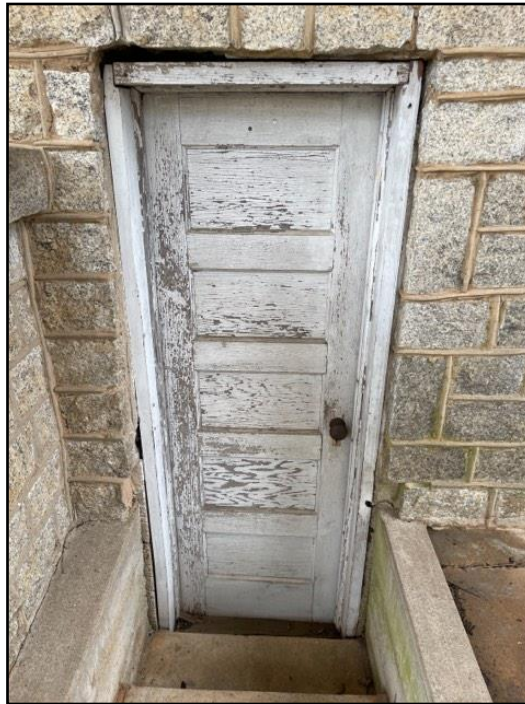
**130. Condition:** • [Weatherstripping missing or ineffective](#)

**264.** *Weatherstripping missing or ineffective*

**Task:** Repair

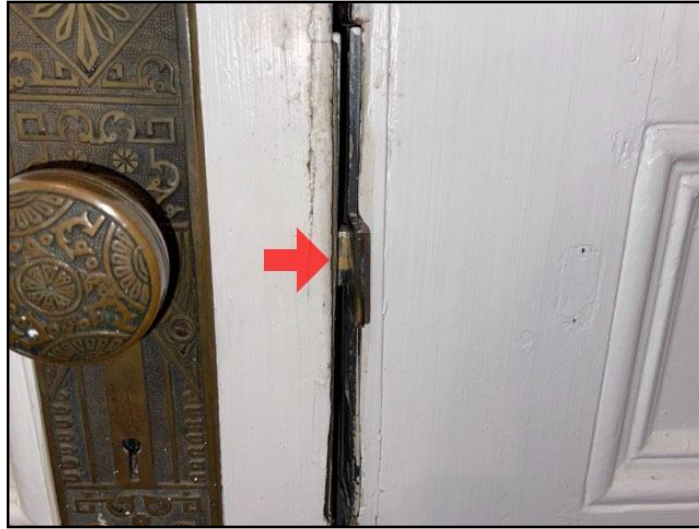
**132. Condition:** • Over wide jamb margin at door latch

265. Over wide jamb margin at door latch

**Task:** Repair

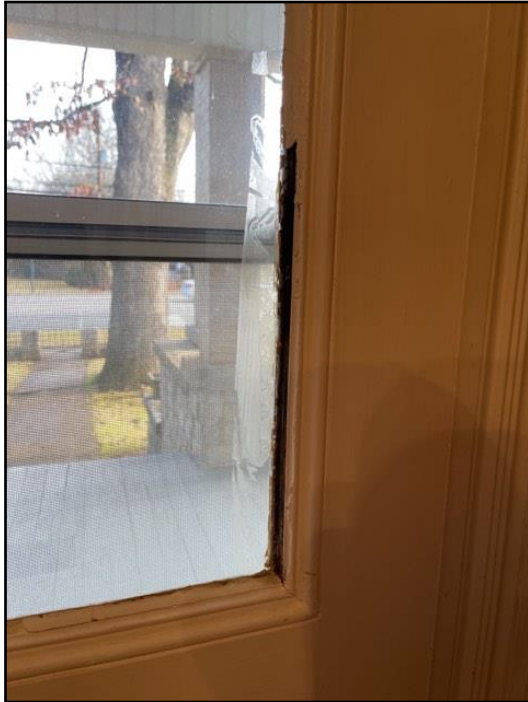
**134. Condition:** • Putty Missing

**Implication(s):** Loose Glass/Loss of heat

266. Putty Missing

**Task:** Repair
