# YOUR Inspection Report

175 Some Street  
Any Town, NC

Tuesday, February 8, 2022

RE: Report No. 6580  
175 Some Street  
Any Town, NC

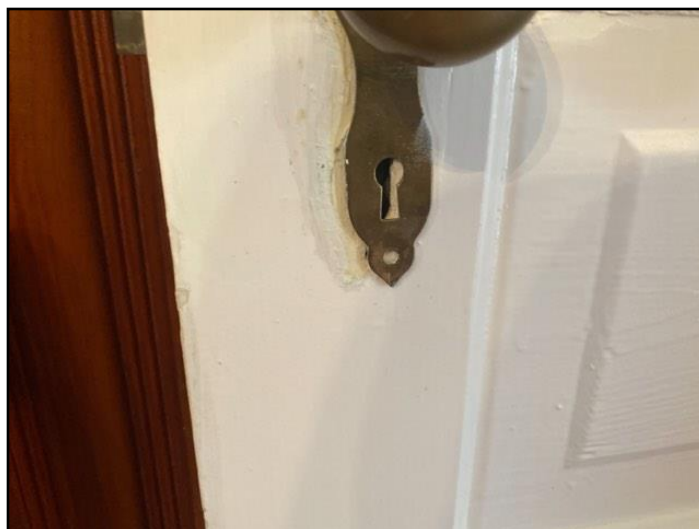
135. Condition: • [Loose](#)

Implication(s): Equipment failure

268. Loose Hardware

Task: Repair

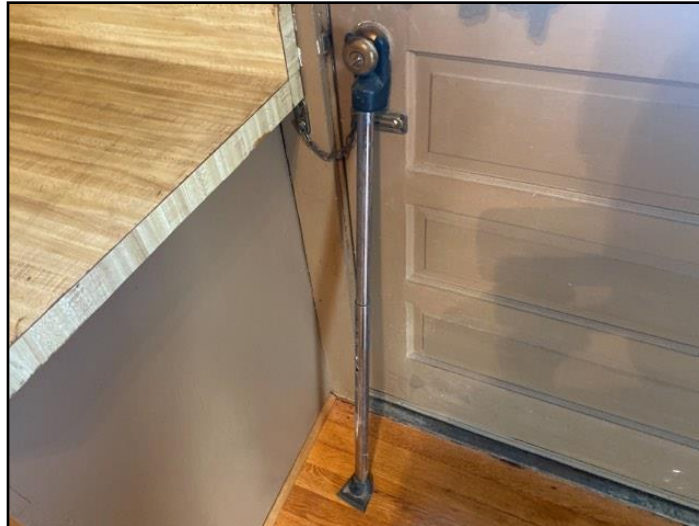
**136. Condition:** • Lock not effective on exterior door

**269.** Lock not effective on exterior door

**Task:** Repair

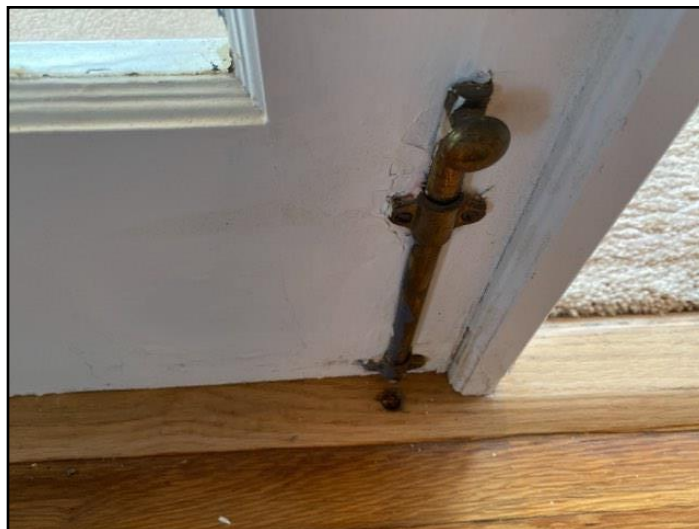
**137. Condition:** • Does not latch properly

**270.** Does not latch properly

**Task:** Repair

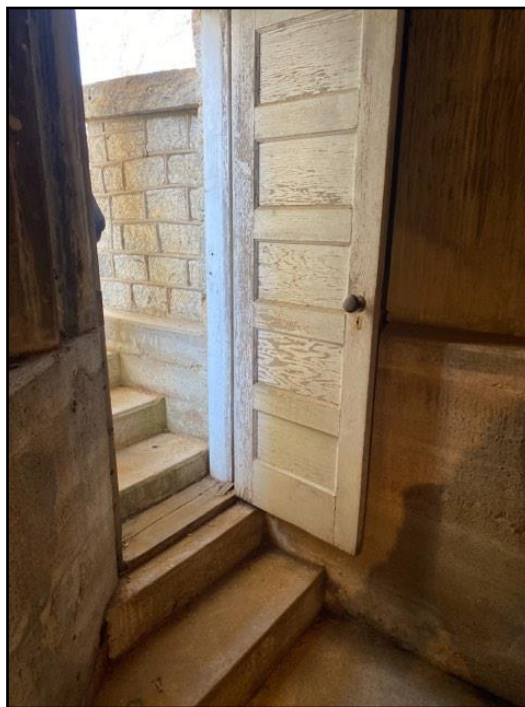
**139. Condition:** • The door at the top of the stairwell should open away from the stairs. It is recommended that this door be altered for improved safety. A person leaning against an inadequately latched door could fall down the stair.

**Implication(s):** Fall hazard

**271.** *The door at the top of the stairwell should...*

**Task:** Repair

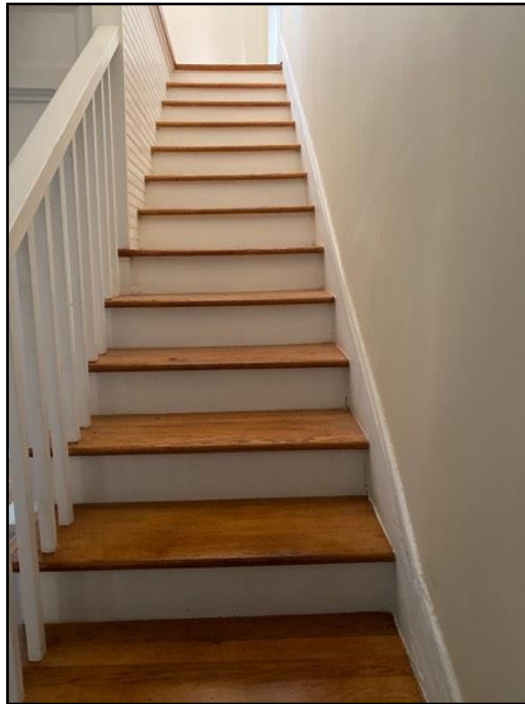
**140. Condition:** • [Sloped](#)

**Implication(s):** Trip or fall hazard

272. Sloped

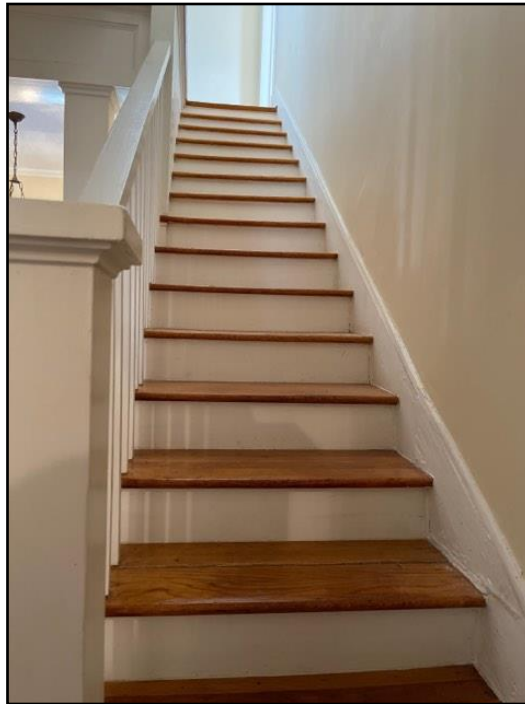
142. Condition: • [Missing](#)

Implication(s): Fall hazard

273. Missing Handrail

Task: Repair

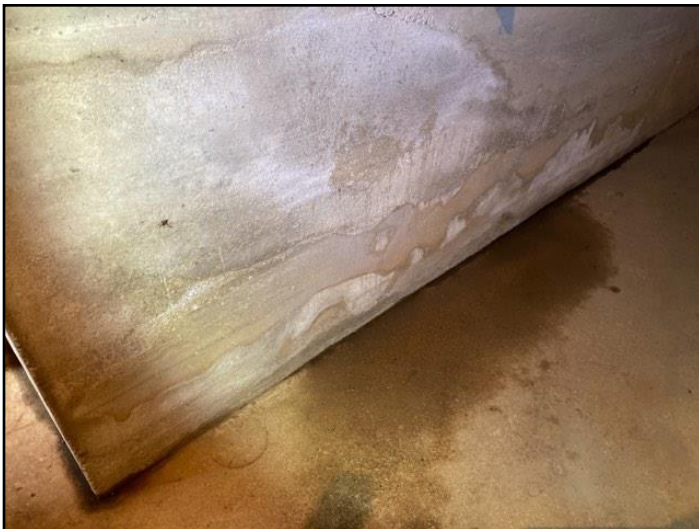
144. Condition: • [Stains](#)

**Implication(s):** Chance of water damage to structure, finishes and contents

274. Stains

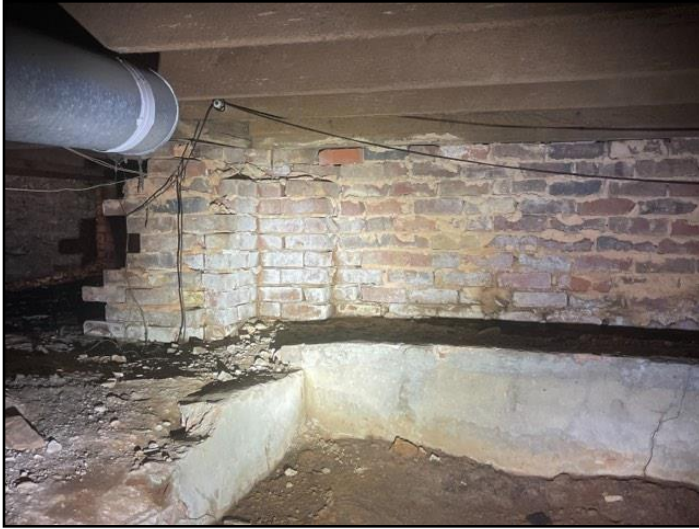
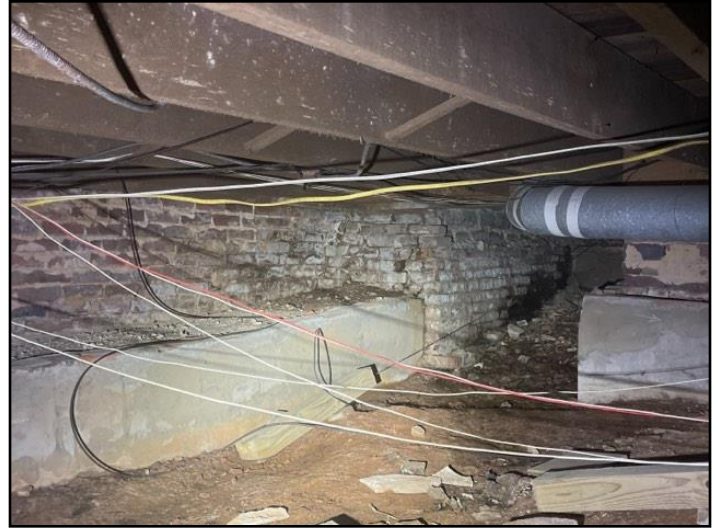
**145. Condition:** • Efflorescence

**Implication(s):** Chance of water damage to structure, finishes and contents, This issue is commensurate with moisture issues and mold growth. A more detailed inspection, specifically addressing these concerns and mold testing, is advised.

276. Efflorescence
